Location	Category	Site Description (Address)
Tal-Qortin, Manikata	Rural	Corbelled Hut at Tal-Qortin, Manikata
Eastings	Northings	Period
4090	7838	unknown
SS No1	SS No2	Description
4078		Square plan corbelled hut with two entrances. The entrance to the south on road (MNK05_003) has been blocked while the second, which faces east has an enclosure in front of it. The hut is not accessible since this second entrance is closed by a wooden door. The door has two triangular lintels with a keystone in between, while the manger in the northern wall of the enclosure has two triangular lintels. The hut is exceptionally large and in fact is buttressed by a low wall. The hut has a second enclosure to the right of the first one. This was once roofed by some perishable material, of which only one wooden beam survives.
SS No4	SS No3	
Date of survey sheet:	1992

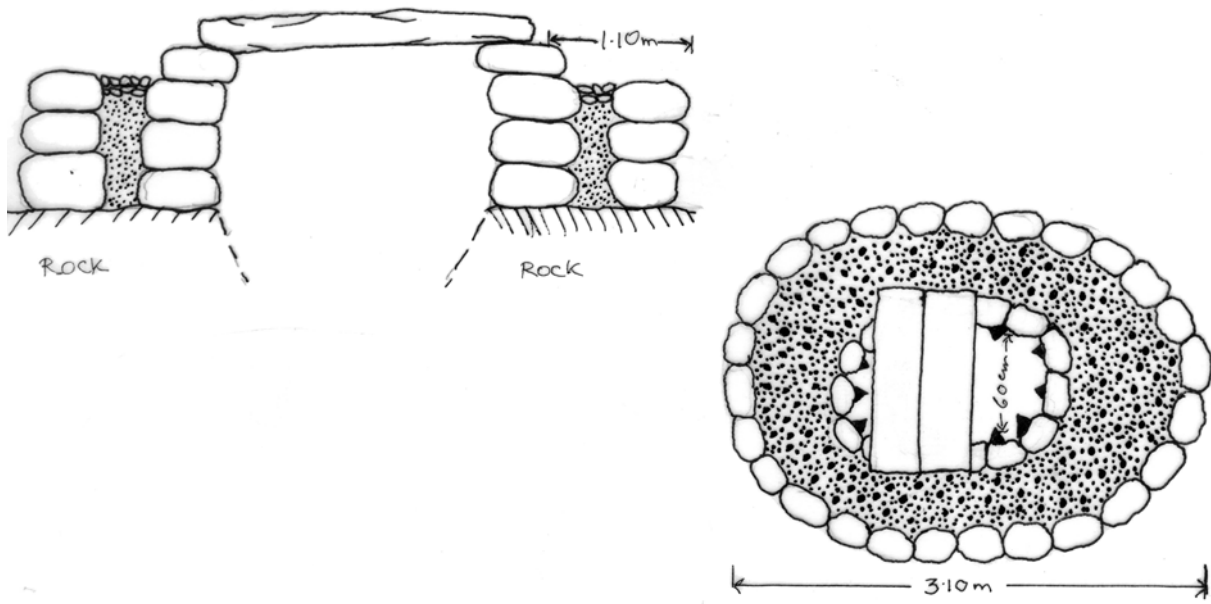
Location	Category	Site Description (Address)
Tal-Qortin, Manikata	Rock-cut	Bore Hole at Tal-Qortin, Manikata
Eastings	Northings	Period
4100	7834	unknown
SS No1	SS No2	Description
4078		Bore hole along road MNK05_003. It has a circular well-head, built of rubble which was plastered with deffun, and later cement. The opening of the well-head was covered with stone slabs, 2 of which are still extant. In the rubble wall, beside the well head is a channel to collect water from surface runoff. A modern bell-shaped well has been dug beside it to collect the water overflowing from the bore hole. This is shown by a connecting channel dug in the walls of the bell-shaped cistern in the direction of the borehole. Contemporary pipes leading to different fields show that this is still in use.
SS No4	SS No3	
Date of survey sheet: 1992

The bore hole was full of water at the time of survey

Condition
Good

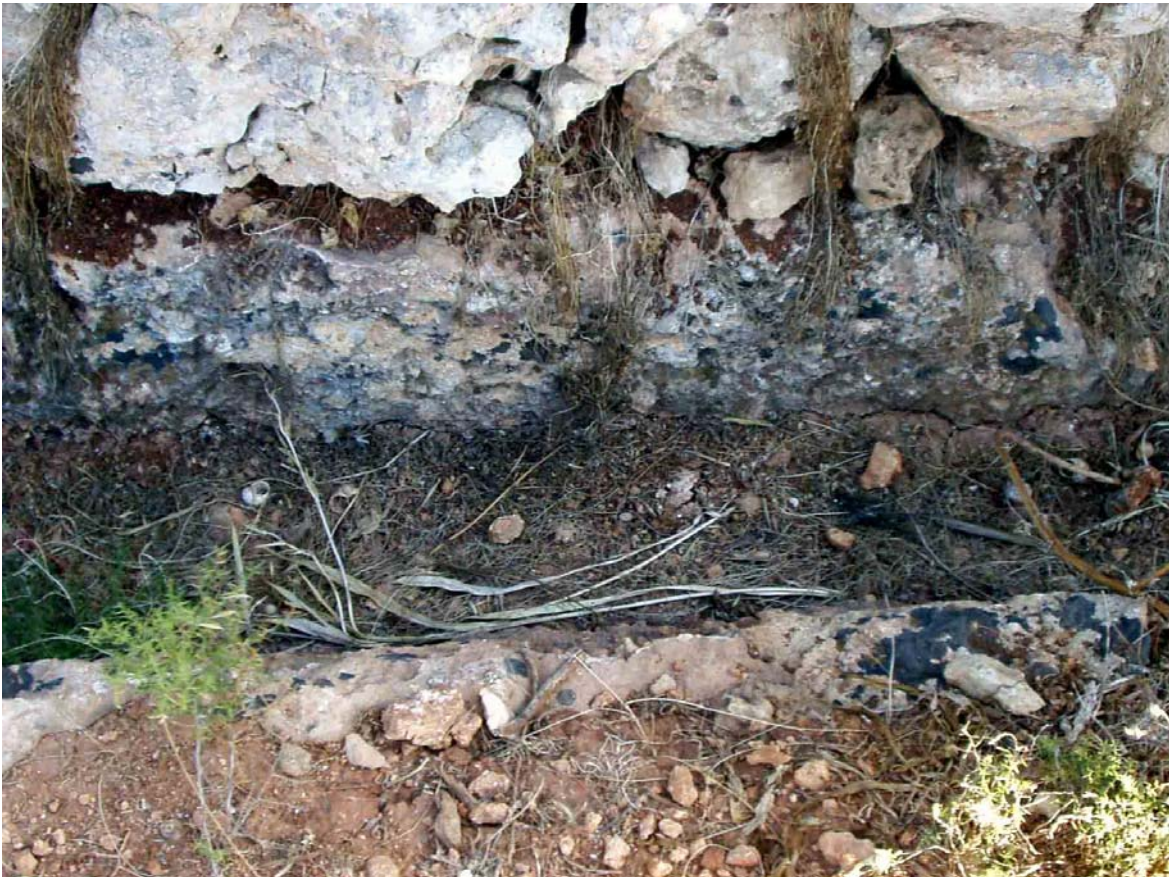
MNK05_023_002

Location Ix-Xatba, Manikata	Category Rock-cut	Site Description (Address) Water Channel (b) and Well (a) at Ix-Xatba, Manikata
Eastings 4123	Northings 7831	Period unknown
SS No1 4078	SS No2	Description Water channel (b) dug into the country track leading to a well (a). The well head consists of a built wall, one course high and partly constructed with medium sized boulders as well as with well-dressed squarish stones.
SS No4	SS No3

Condition
Fair

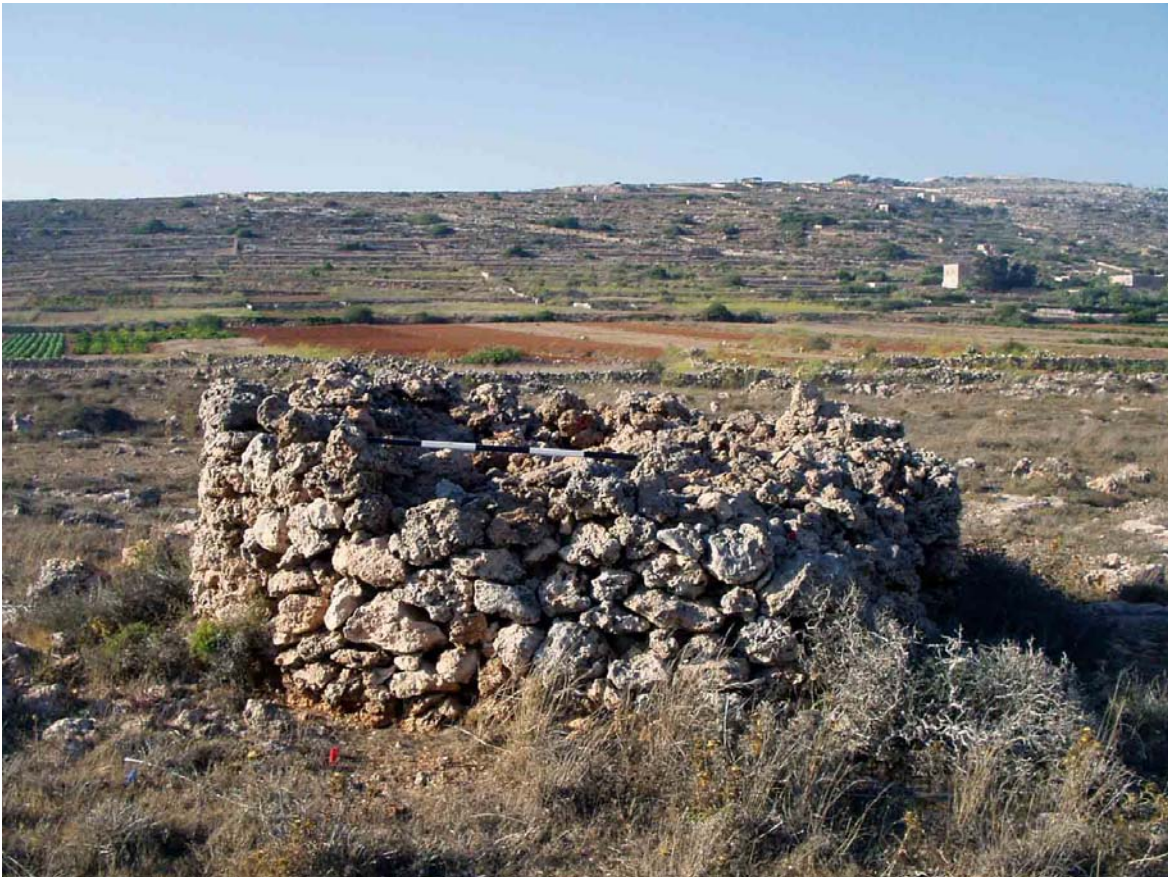
MNK05_024

Location Ix-Xagħra I-Ħamra, Manikata	Category Rural	Site Description (Address) Corbelled Hut at Ix-Xagħra I-Ħamra, Manikata
Eastings 4131	Northings 7821	Period unknown
SS No1 4078	SS No2	Description Collapsed circular corbelled hut. In close proximity is a depression in the rock surface probably used to store water.
SS No4	SS No3	
Date of survey sheet: 1992

Needs reconstruction

Bad

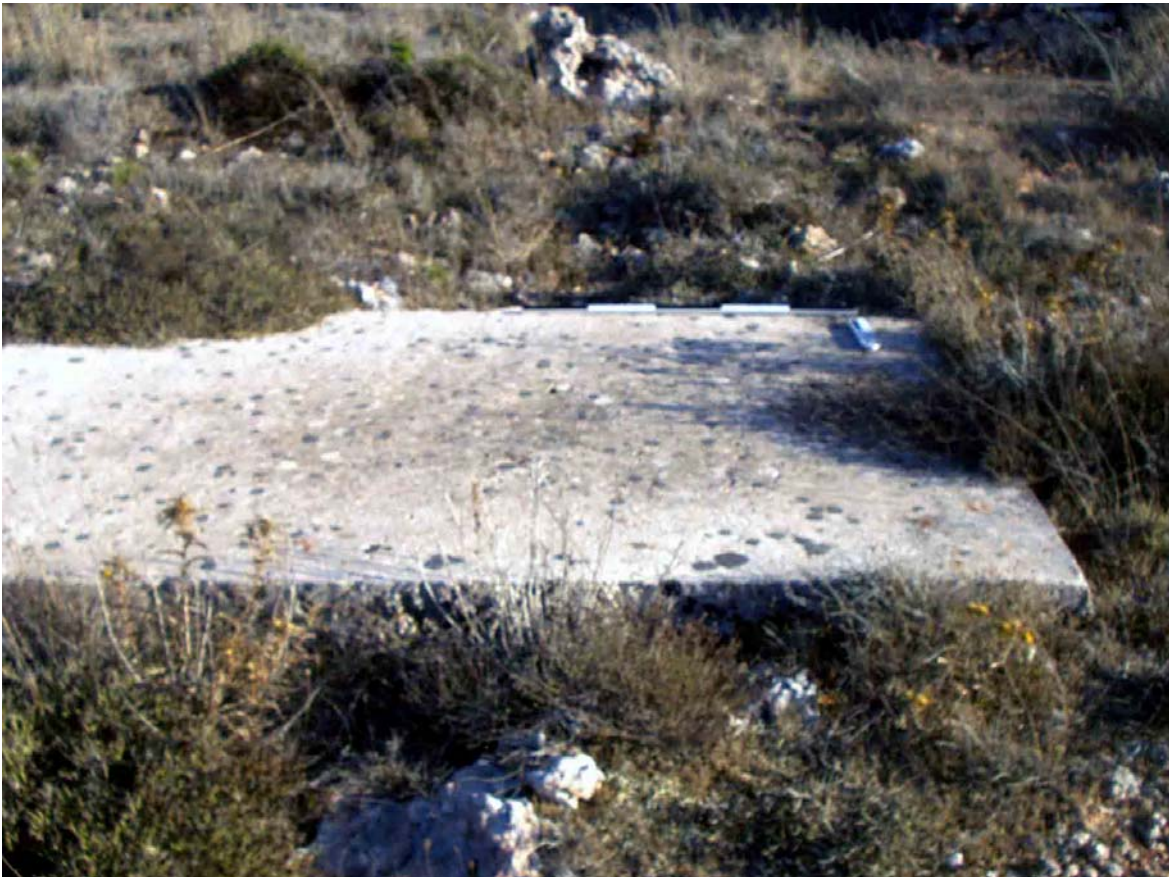
MNK05_025_001

Location Ix-Xagħra I-Ħamra, Manikata	Category Military	Site Description (Address) Concrete Platform at Ix-Xagħra I-Ħamra, Manikata
Eastings 4132	Northings 7817	Period British, 20th century, WWII
SS No1 4078	SS No2	Description Rectangular concrete platform built on the garigue. This platform seems to be a base for a tent. It is known that the British used such platforms for hospital tents in their encampments. The dimensions of this platform are 1.8m by 2.7m
SS No4	SS No3

Condition
Good

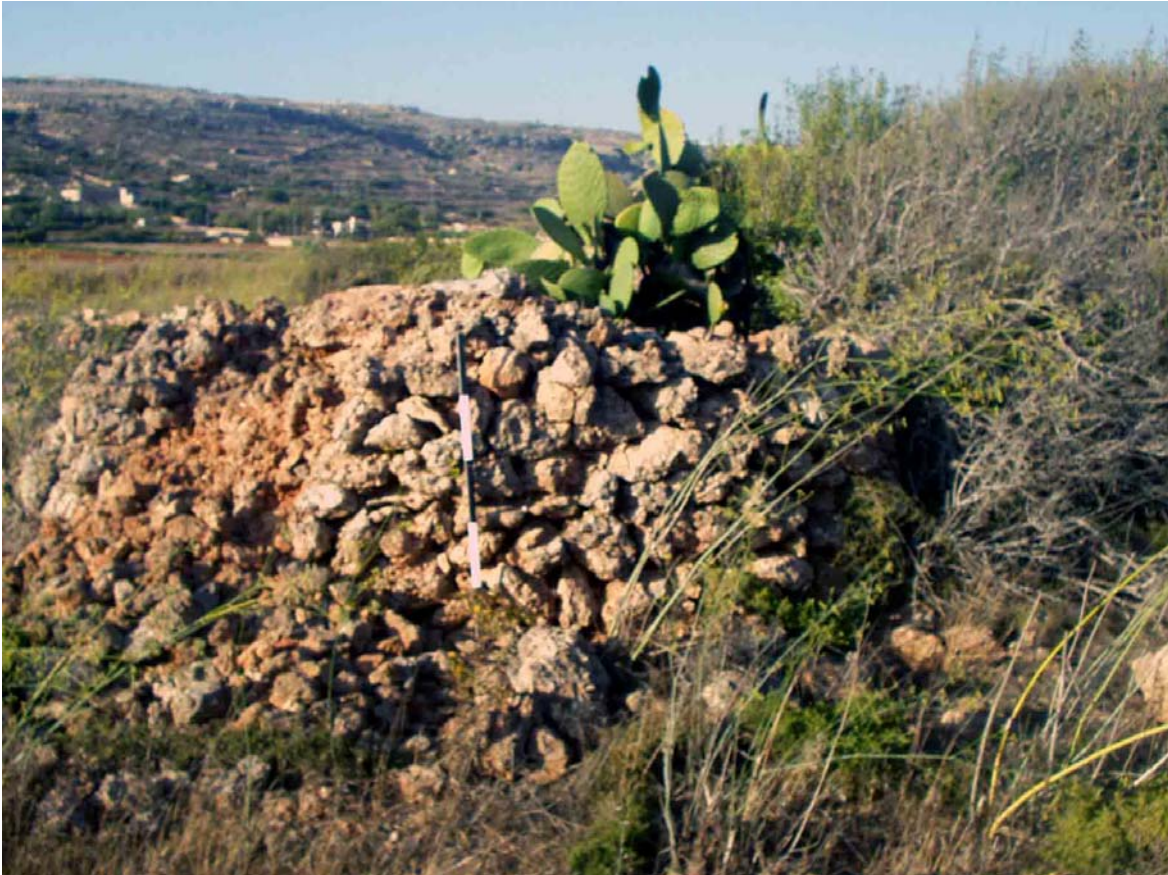
Location Ix-Xagħra I-Ħamra, Manikata	Category Rural	Site Description (Address) Collapsed Corbelled hut at Ix-Xagħra I-Ħamra, Manikata
Eastings 4136	Northings 7816	Period unknown
SS No1 4078	SS No2	Description Collapsed small circular corbelled hut. Due to its state no other features can be recorded.
SS No4	SS No3	
Date of survey sheet: 1992

Condition
Collapsed

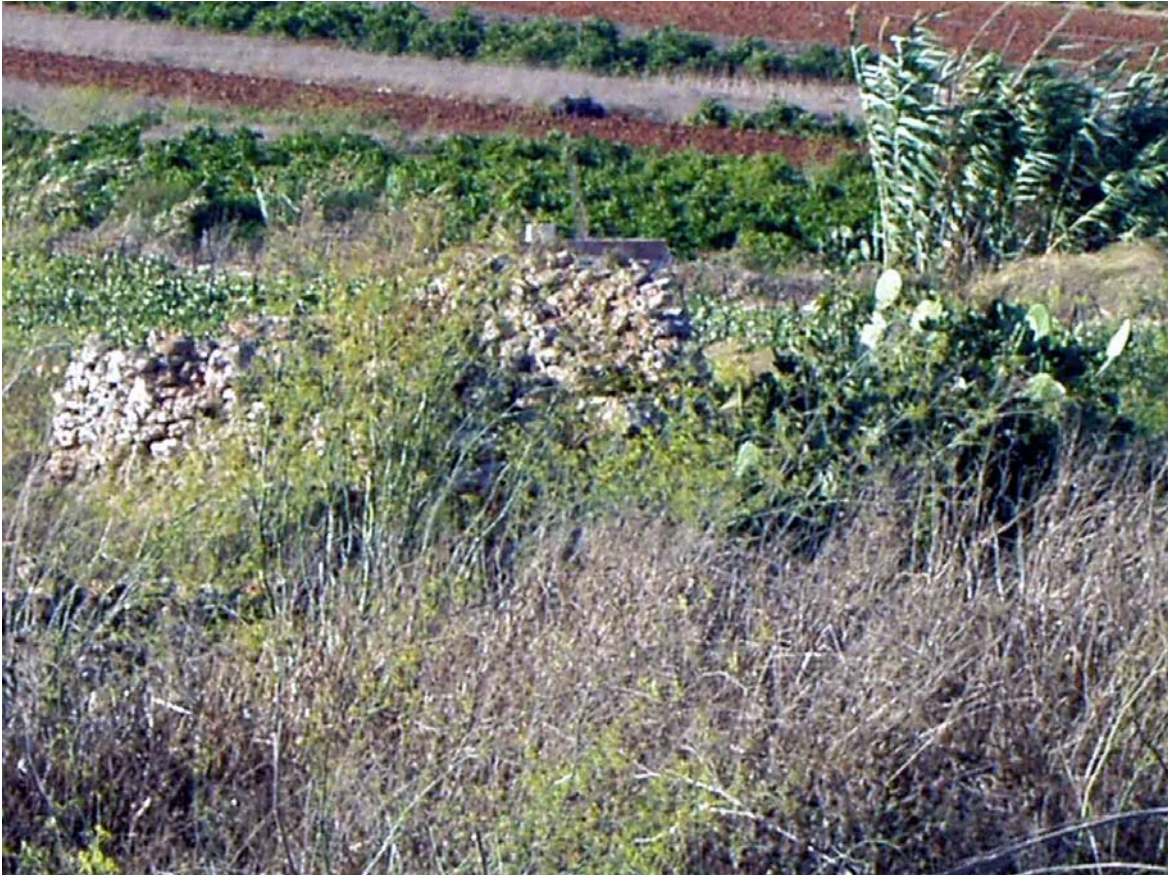
SS No1 4078	SS No2	Description Inaccessible collapsed circular corbelled hut
-----------------------	---------------	---

Condition
Collapsed

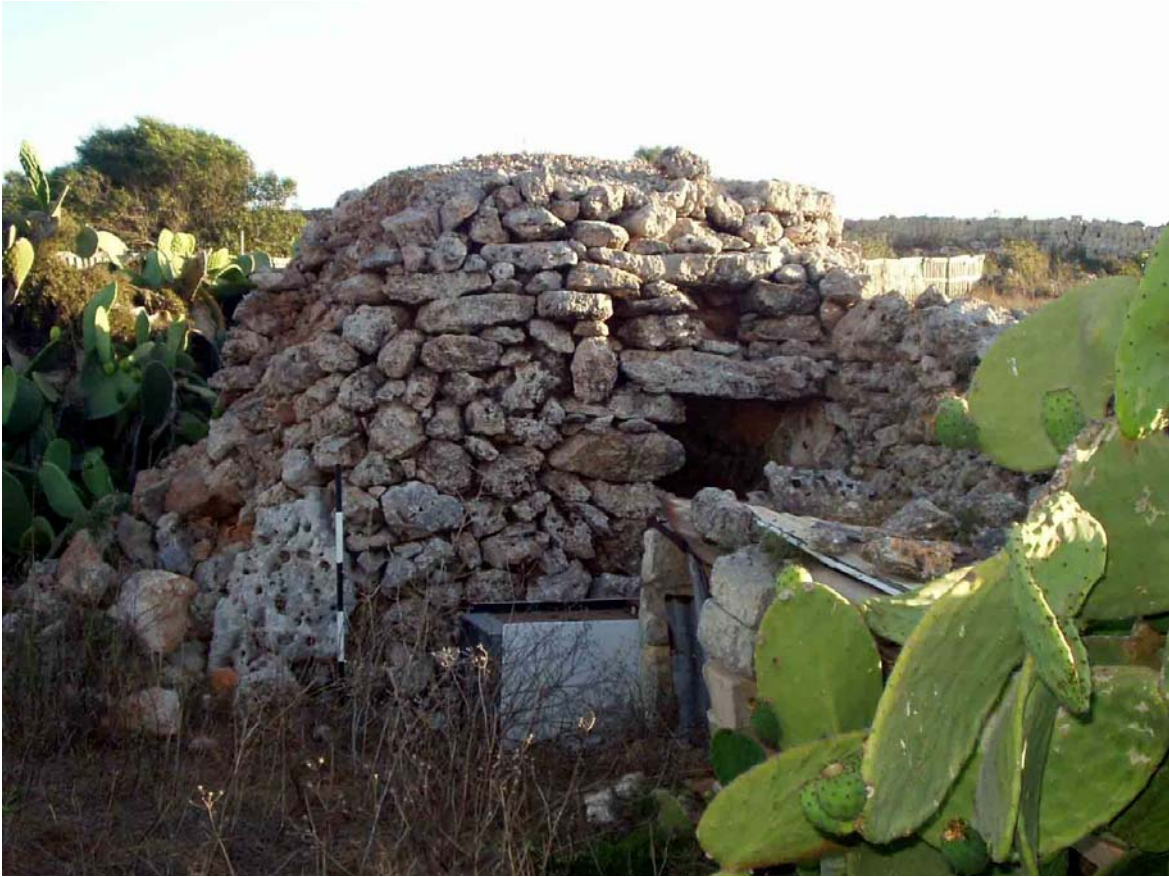
Location Il-Mejjieli, Manikata	Category Rural	Site Description (Address) Corbelled Hut at Il-Mejjieli, Manikata
Eastings 4186	Northings 7820	Period unknown
SS No1 4078	SS No2	Description Small oval corbelled hut built abutting a boundary wall. It has a low entrance with a flat lintel on top of which is a square niche. The entrance faces north and part of the eastern wall has collapsed exposing the section.
SS No4	SS No3	
Date of survey sheet:	1992

Needs reconstruction

Condition
Fair

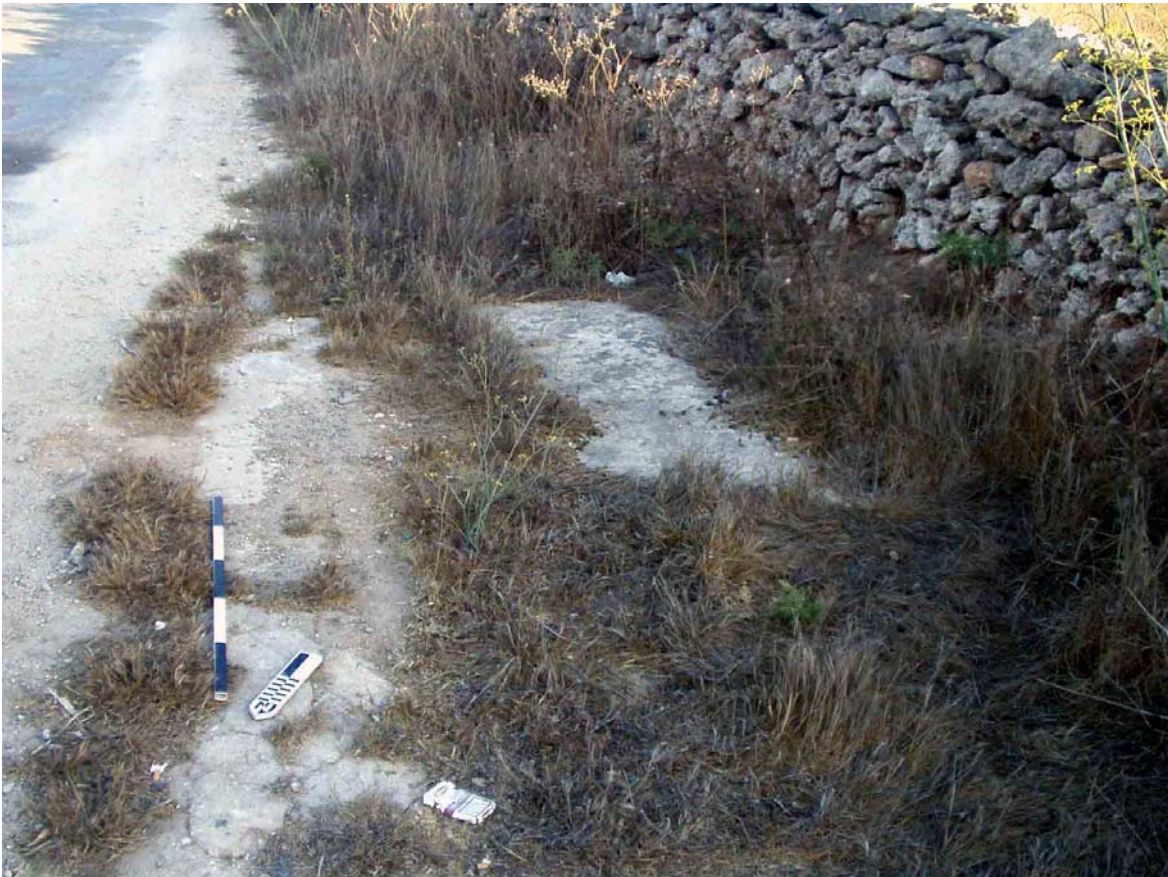
MNK05_029

Location Ix-Xagħra I-Hamra, Manikata	Category Military	Site Description (Address) Concrete Platform at Il-Mejjieli, Manikata
Eastings 4173	Northings 7827	Period British, 20th century, WWII
SS No1 4078	SS No2	Description Rectangular concrete platform built at the side of the road and similar to MNK 05_25. This platform seems to be a base for a tent. It is known that the British used such platforms for hospital tents in their encampments. The dimensions of this platform are 2.1m by 2.1m
SS No4	SS No3	
Date of survey sheet: 1992

Overgrown, and partly destroyed by the road

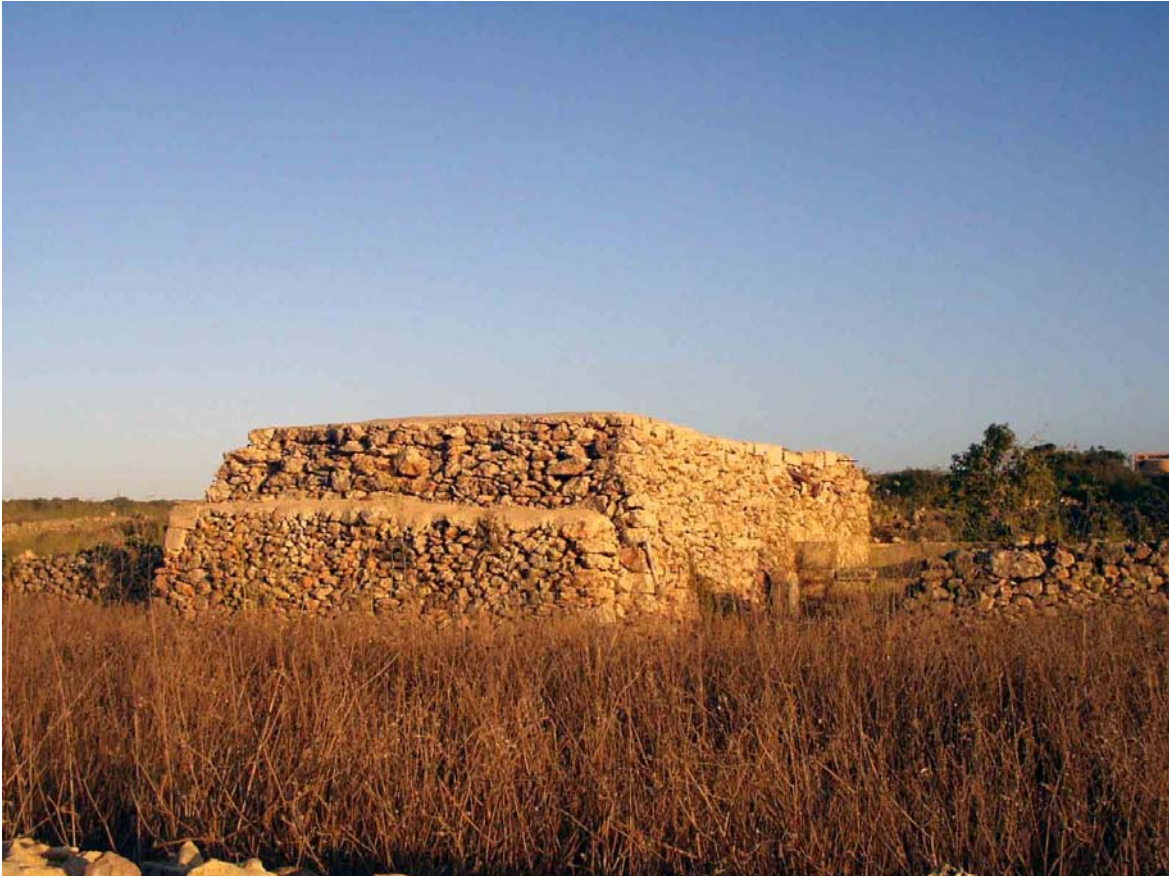
Location	Category	Site Description (Address)
Ix-Xagħra I-Ħamra, Manikata	Rural	Field room at Ix-Xagħra I-Ħamra, Manikata
Eastings	Northings	Period
4167	7833	unknown
SS No1	SS No2	Description
4078		Rectnagular field room built in the dry stone technique. Its entrance faces the east. The roof is cemented over, probably part of its restoration/consolidation. The northern wall is buttressed. The interior of the room could not be recorded since it is inaccessible.
SS No4	SS No3

Possibly this was a corbelled hut that was enlarged/converted into a field room in modern times. A local farmer informed the surveyors that this room was originally a corbelled hut.

Good and well-kept
