ref no MNK05 031

Corbelled Hut at Ix-Xaghra I-Hamra, Manikata

Date of survey sheet: 1992

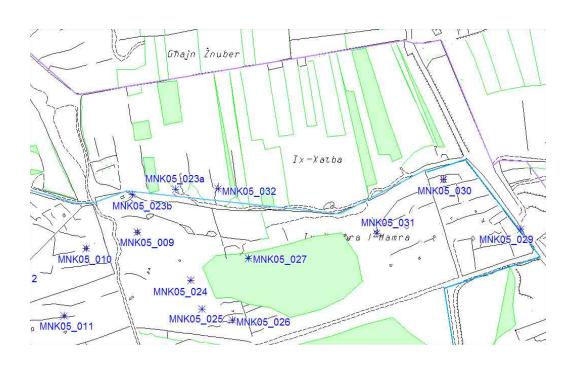
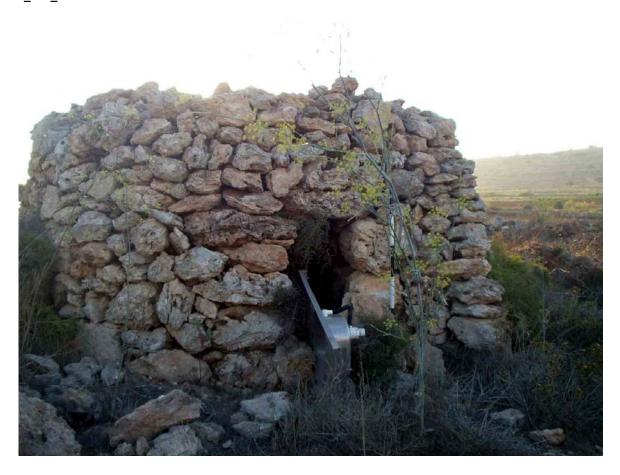
Small circular corbelled hut with a low entrance and a flat lintel. The door faces west and part of the right door jamb has partly collapsed as is part of the roof.

**Condition**Parlty collapsed

Needs consolidation and restoration

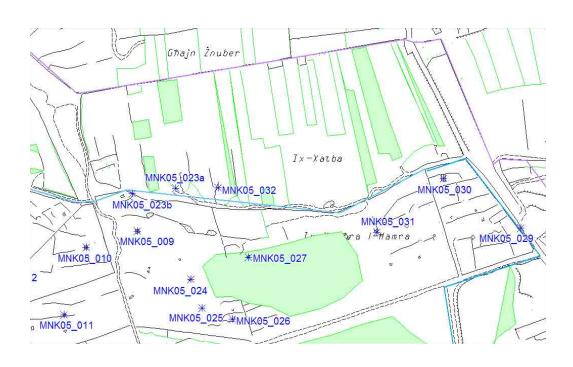
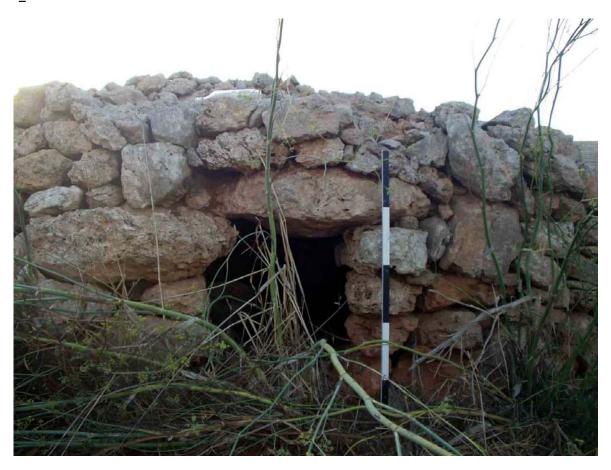
Very small sqaure field room with its entrance facing the east. The external skin of the wall is partly collapsed.

**Condition**Partly collapsed

Needs consolidation and restoration

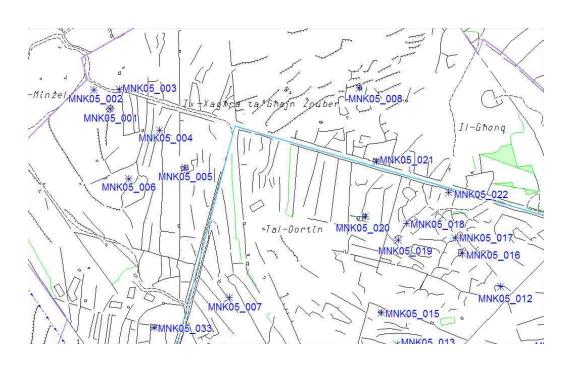
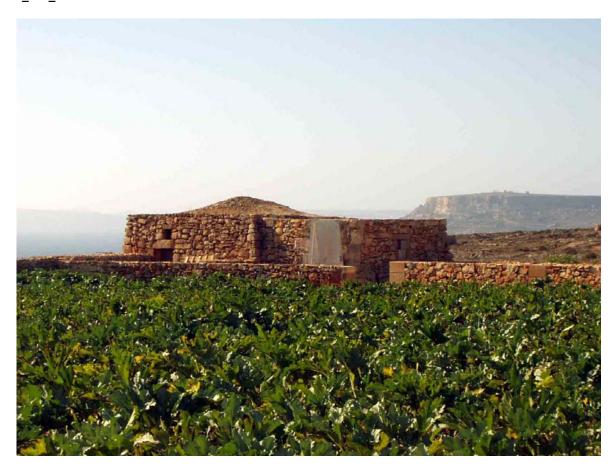
Square-plan corbelled hut with domed roof. The corbelled hut has been substantially altered with a field room built on its eastern wall. Its entrance lies to the south and has a niche above the flat

**Condition**Well maintained

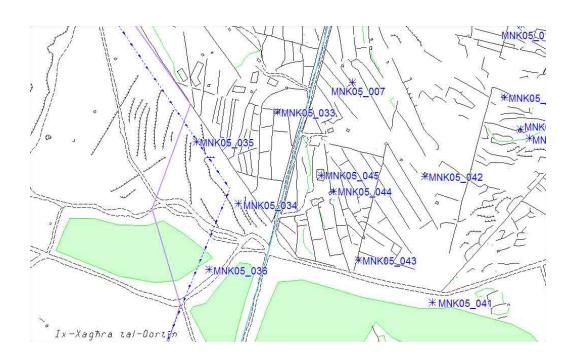
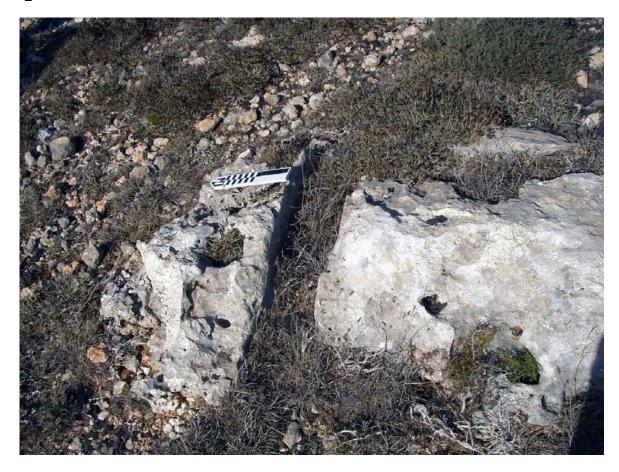
## MNK05\_034

Single rock-cut channel or cart rut running to a length of 0.80m with a width of 0.15m and a depth of 0.15m.

It is not clear whether the channel was used for the drainage of water when the area was put to agricultural use, or if it is the surviving rut of a pair of cart ruts or whether it was linked to a military purpose.

**Condition** Fair

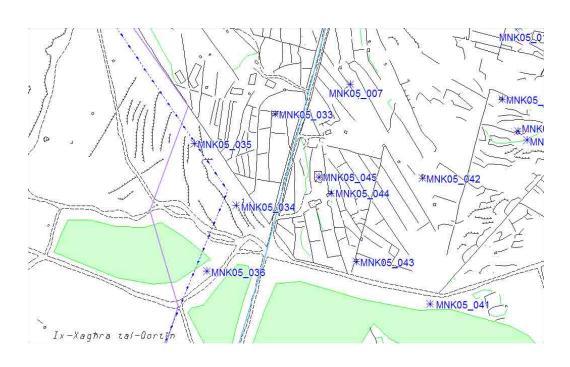
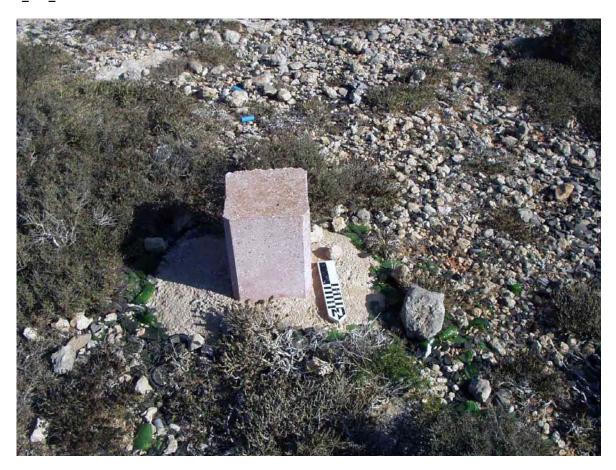
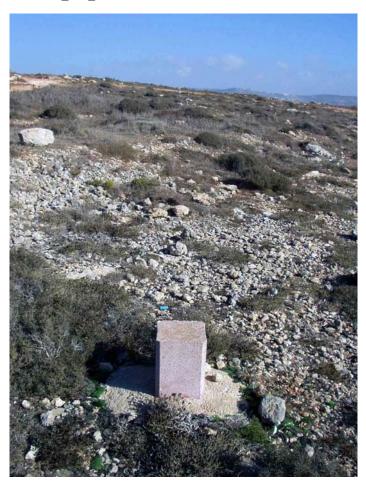
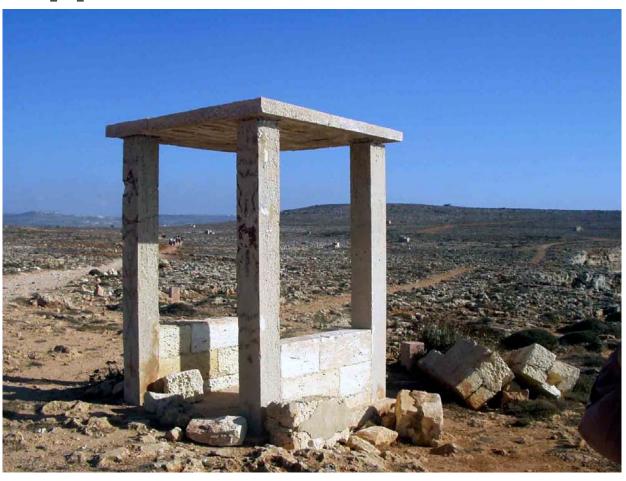
MNK05\_035\_004

A number of equilateral cuboid pink cement posts with chamfered corners. They are 12m apart and run in a straight line from the remains of an open concrete guard post at the edge of the cliffs of

The area beyond the line created by these posts is derelict and the field walls have been abandoned or razed to the ground, possibly resulting from British military operations in the area.

**Condition**Good although a few of the posts are no longer in situ

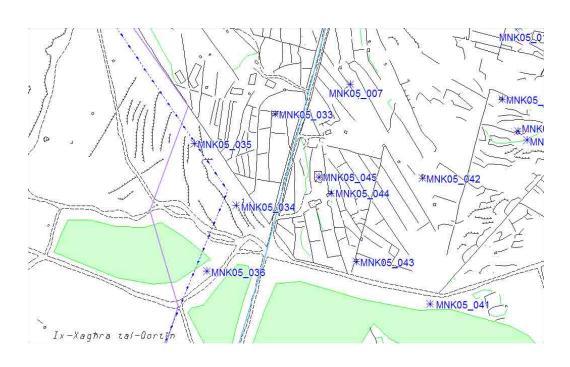
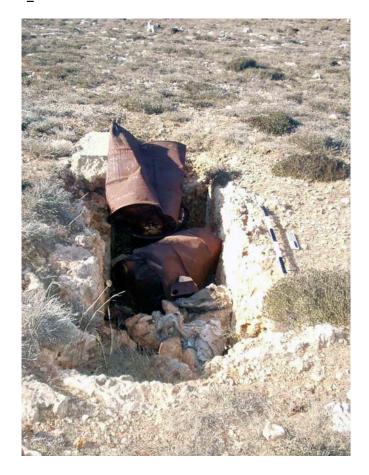
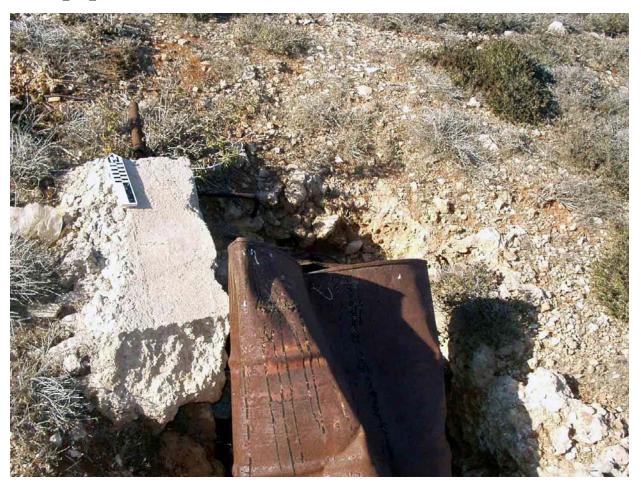
## MNK05\_036

Rock-cut trench measuring 1m by 3.35m. Its depth cannot be determined because it is filled with rubble and other litter. Although resembling a tomb shaft, it is propably British, since part of the ledge is dressed with concrete. Such a trench could have been linked to the British miltary operations in the area. However, one cannot exclude that is was dug in Classical times and reused later

**Condition** Bad **Degree of Protection** None

The trench needs to be cleared to determine its past use.

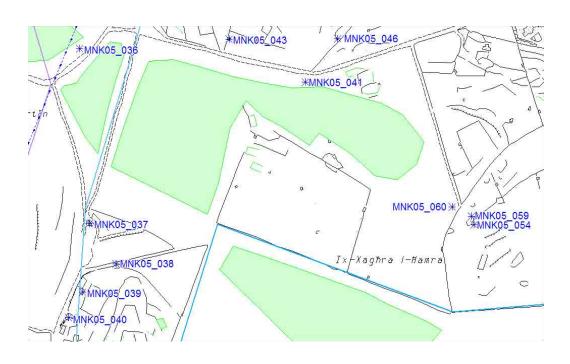
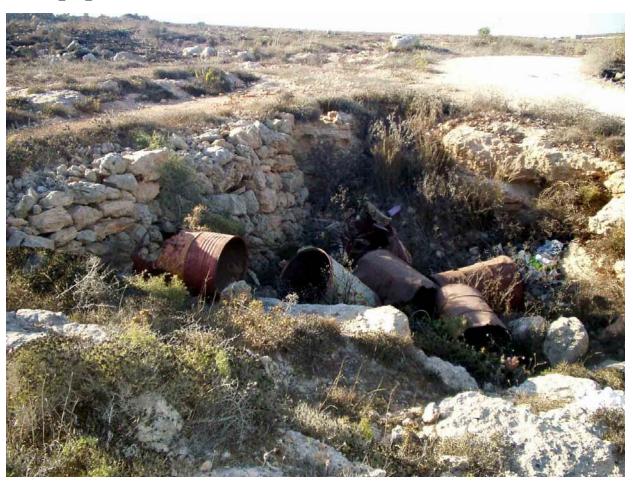
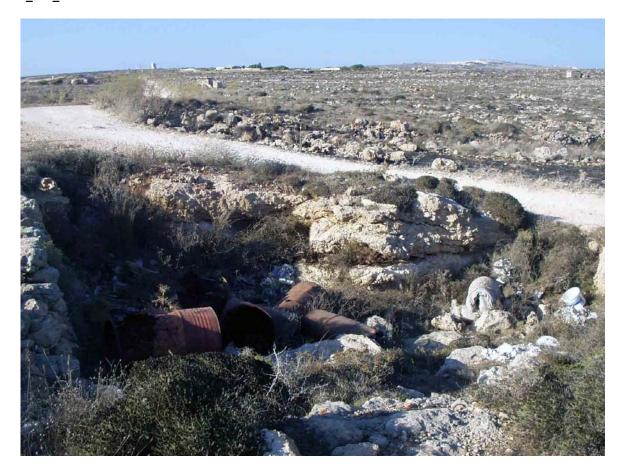
A small quarry located on the road side, porobably used for the extraction of building material for the construction of structures and rubble walls in the vicinity. The quarry is of an irregular shape but its approximate diameter is 6.75m. A rubble wall was built on the

**Condition** Bad **Degree of Protection** None

The quarry needs to be cleared so as to reveal any tool marks, and hence a broad date range

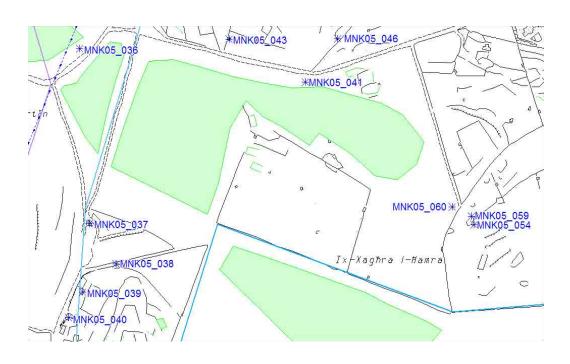
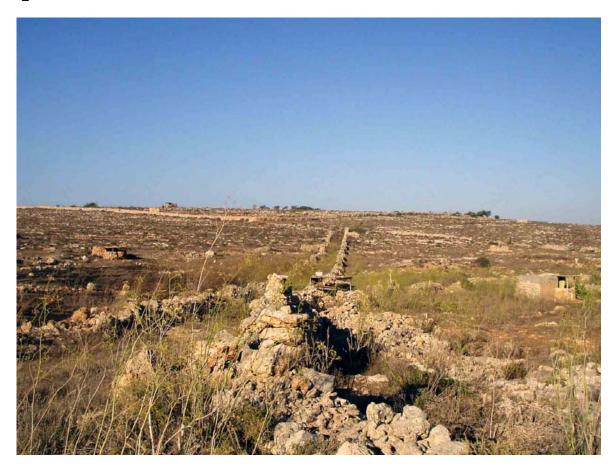
A derelcit country track runnig for a length of approximately 160m. It is bordered by rubble walls that are still extant. The track leads

Probably this track came out of use when fields in this area were abandoned with the start of British military operation. The road surface is not visible due to the overgrown vegetation.

**Condition** Overgrown

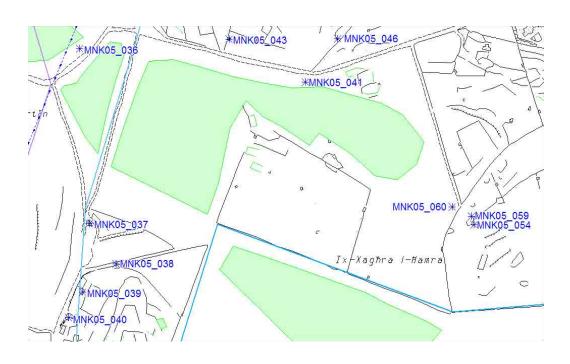
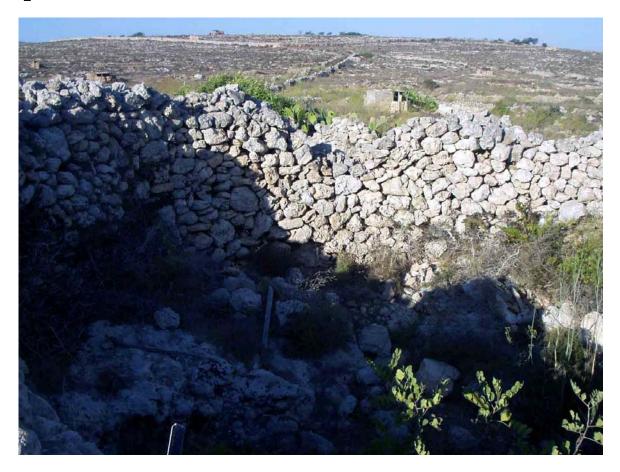
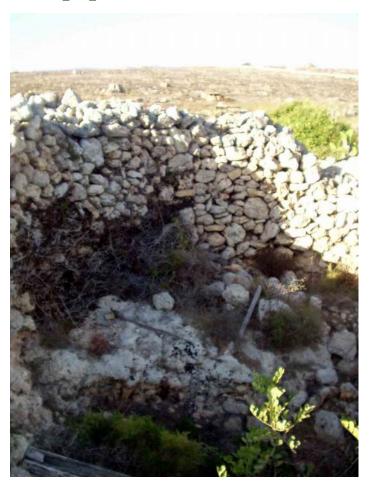
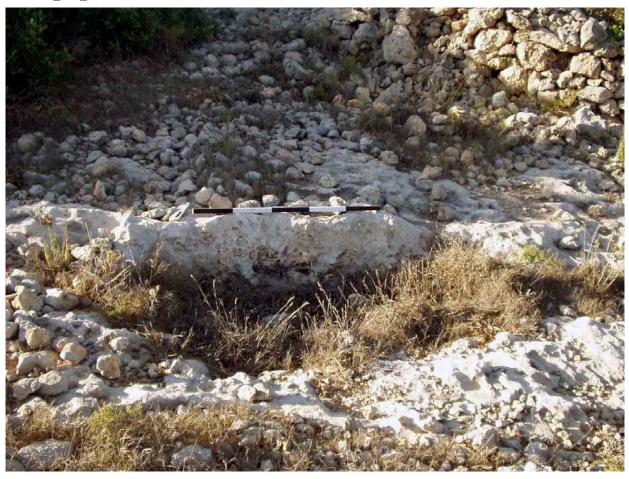
MNK05\_039\_003

A natural hollow of an irregular shape whose perimter has been surrounded by a continuous rubble wall. The wall is 0.80m thick and its diameter is of about 6m. The floor of this hollow is undressed and unworked rock. Since the wall is partially collapsed, the presence of an entrance cannot be determined. In close proximity to this structure there is evidence of rock cutting and relatively large depression in the rock. This is oval in shape and has an average diameter of 2m. A water channel has been dug on its southern face. There is a pottery scatter in the area.

The circular structure could be a destroyed corbelled hut that was abandoned with the building of farmhouse MNK05\_040.

**Condition** Bad **Degree of Protection** None

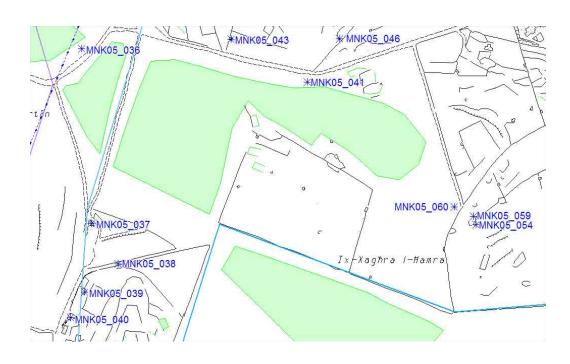
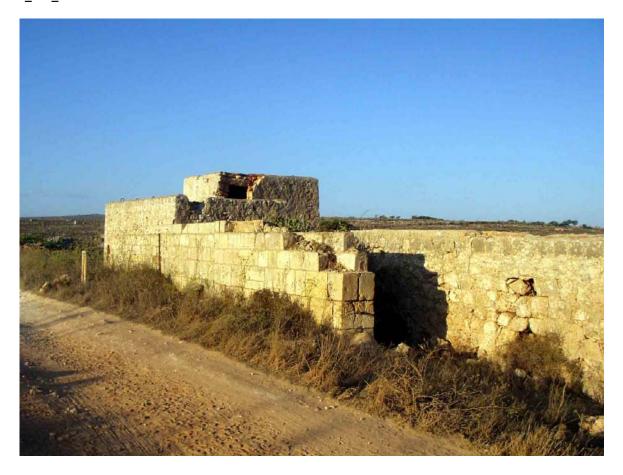
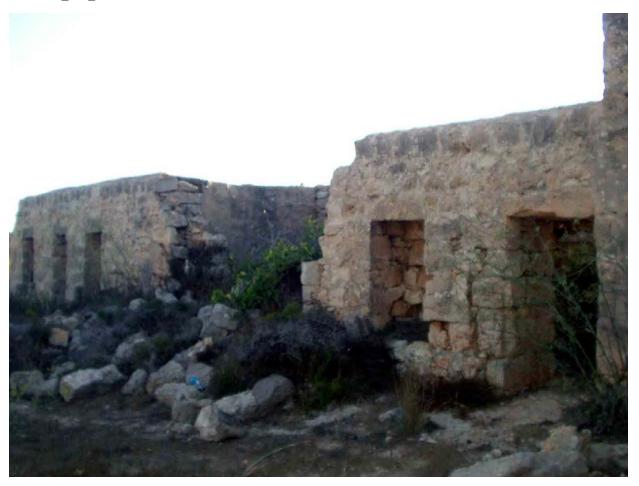
L-Shaped farmhouse consisting of a main building built on 2 floors and 5 outer buildings. Second floor, is reached by an external staricase. Outer building contains 3 mangers on the exterior façade and are separated into 4 chambers each with a distinct entrance and a manger on its western wall. Most of the roofs have collapsed but they have been built using kileb, xorok and wooden beams. All rooms were also closed. Ground floor of the main building has a blocked doorway in its northern wall. 5th room of the outer building, adjacent to main building has a separate entrance into the courtyard. Interior shows signs of plastering, white-washing and a number of niches, some of which have soot. On its SW corner there is a shelf with a cross graffito. External staircase has a small recess beneath it. Walls of main building have been white-washed, plastered and have a number of niches. The roof has collapsed. To the east of the courtyard are a number of collapsed dry stone structures. Courtyard has a bell-shaped cistern and signs of quarrying.

A well-dressed wall dating to the British period is found along its western wall.

**Condition**Bad; in need of reconstruction
