Location Tal-Qortin, Manikata	Category Rural	Site Description (Address) Corbelled Hut at Il-Qortin, Manikata
Eastings 4114	Northings 7816	Period unknown
SS No1 4078	SS No2	Description Circular shaped corbelled hut with its entrance facing south. It has a horizontal lintel, no niche on the doorway and no window.
SS No4	SS No3

Location	Category	Site Description (Address)
Tal-Qortin, Manikata	Rock-cut	Traces of quarrying at Tal-Qortin, Manikata

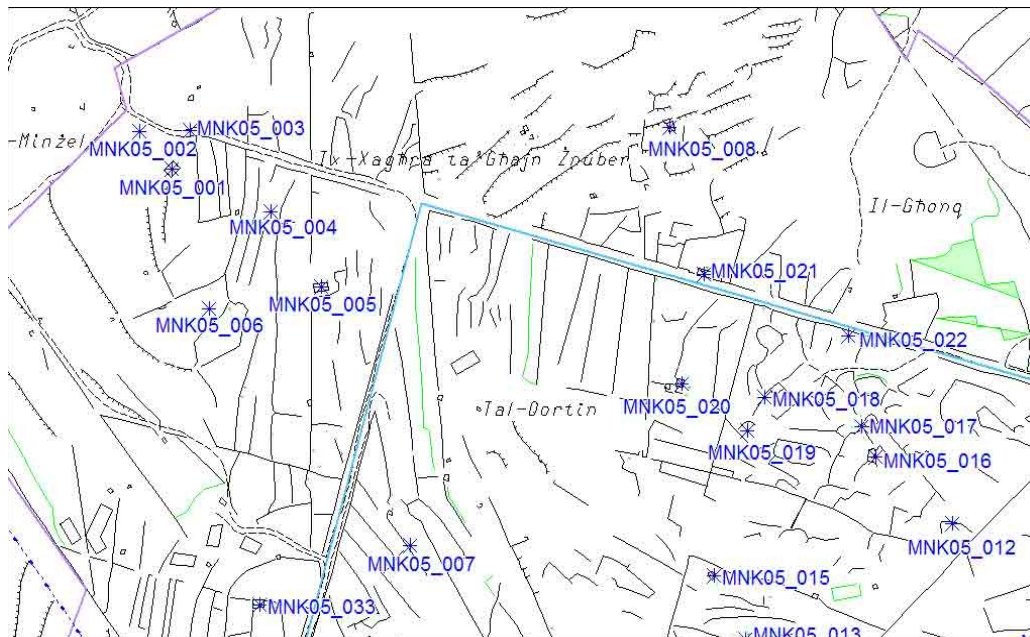
SS No1	SS No2	Description
4078		A small quarry later turned into a field. On the western part of this feature is a pile of small stones indicating quarrying. This small field is enclosed by irregular stones that are about 0.60m thick and 1.00m wide. A small number of pottery sherds was visible in the vicinity of the wall.
SS No4	SS No3

Field

Condition
Fair

Proposed Protection
Grade 3

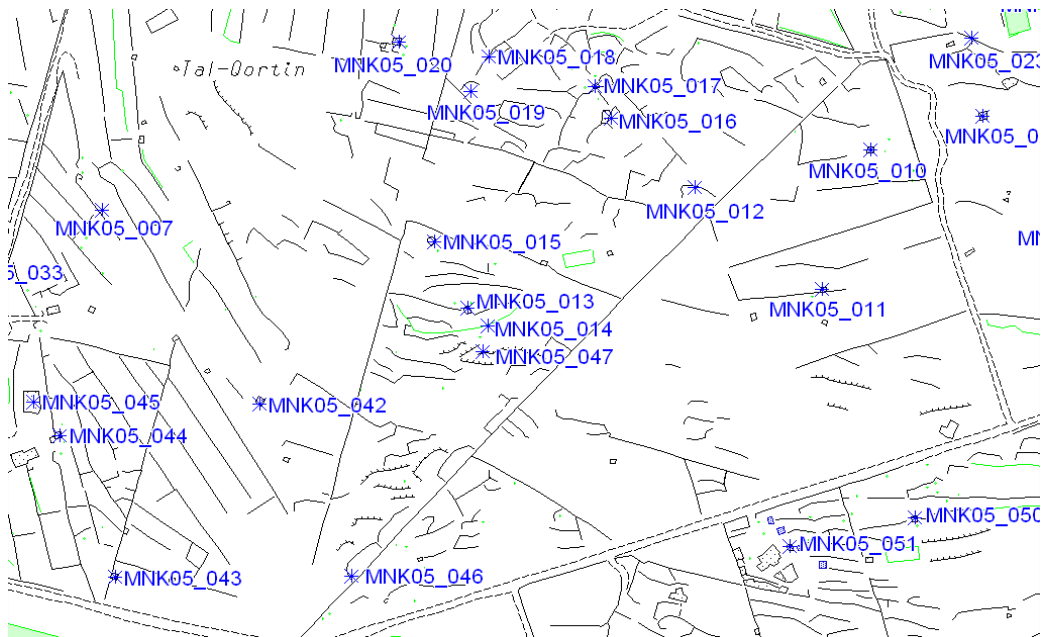
MNK05_013

Elliptical shape corbelled hut with an enclosure. The door, which has a square lintel, faces east. On top of it is a considerably large square niche. The enclosure has a manger on its northern wall. The interior has a triangular window and a rectangular one, as well as a cupboard or manger. On the domed roof is a 'dura' built by bird hunters. The southern wall of the enclosure continues to form a rubble wall, while adjacent to the northern wall is buttressing. The corbelled ceiling is considerably high.

Good

Grade 1

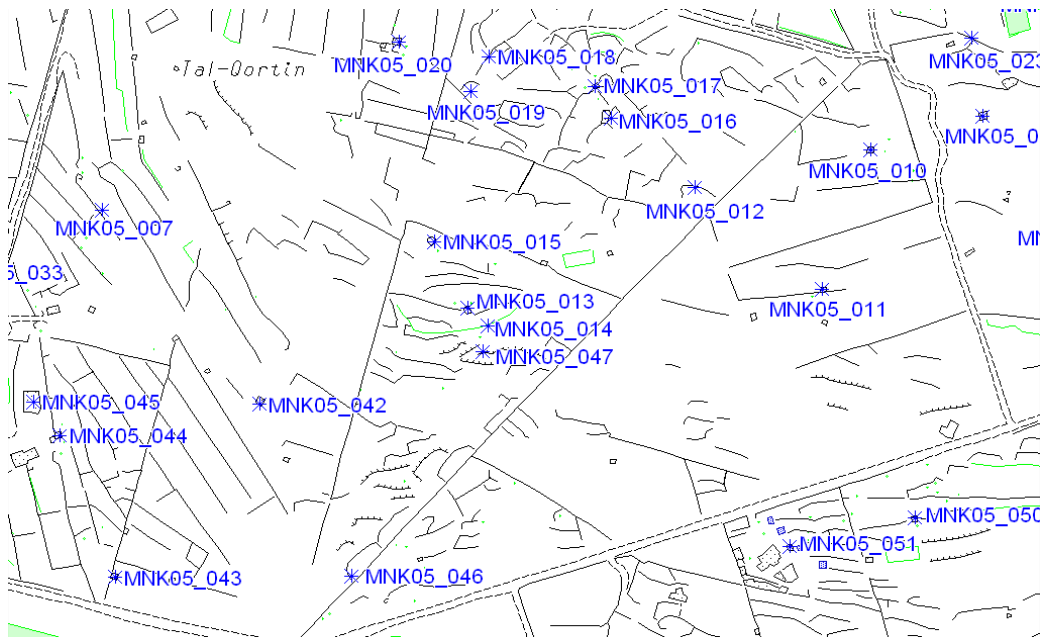
MNK05_014

Location	Category	Site Description (Address)
Tal-Qortin, Manikata	Rock-cut	Exit Holes of a Rain Tunnel at Tal-Qortin, Manikata
Eastings	Northings	Period
4094	7814	unknown
SS No1	SS No2	Description
4078		2 exit holes of a rain tunnel built right through the rubble wall to assist in water drainage. These channels face west and are about 0.50m high and 0.60m wide.
SS No4	SS No3

The channels are partly blocked with soil indicating that they are no longer in use.

Good

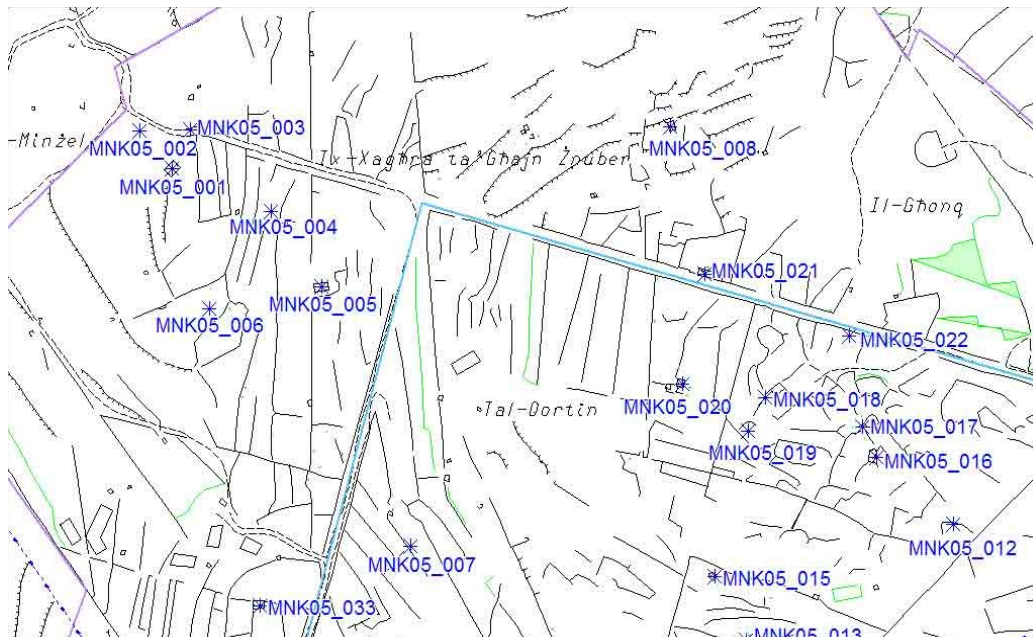
SS No1	SS No2	Description
4078		Circular shaped girna with its entrance facing SE. It has a flat lintel, a square niche on the doorway and two small windows. The interior is a very fine example of corbelling. The exterior walls are buttressed for almost one half of the hut's circumference.
SS No4	SS No3

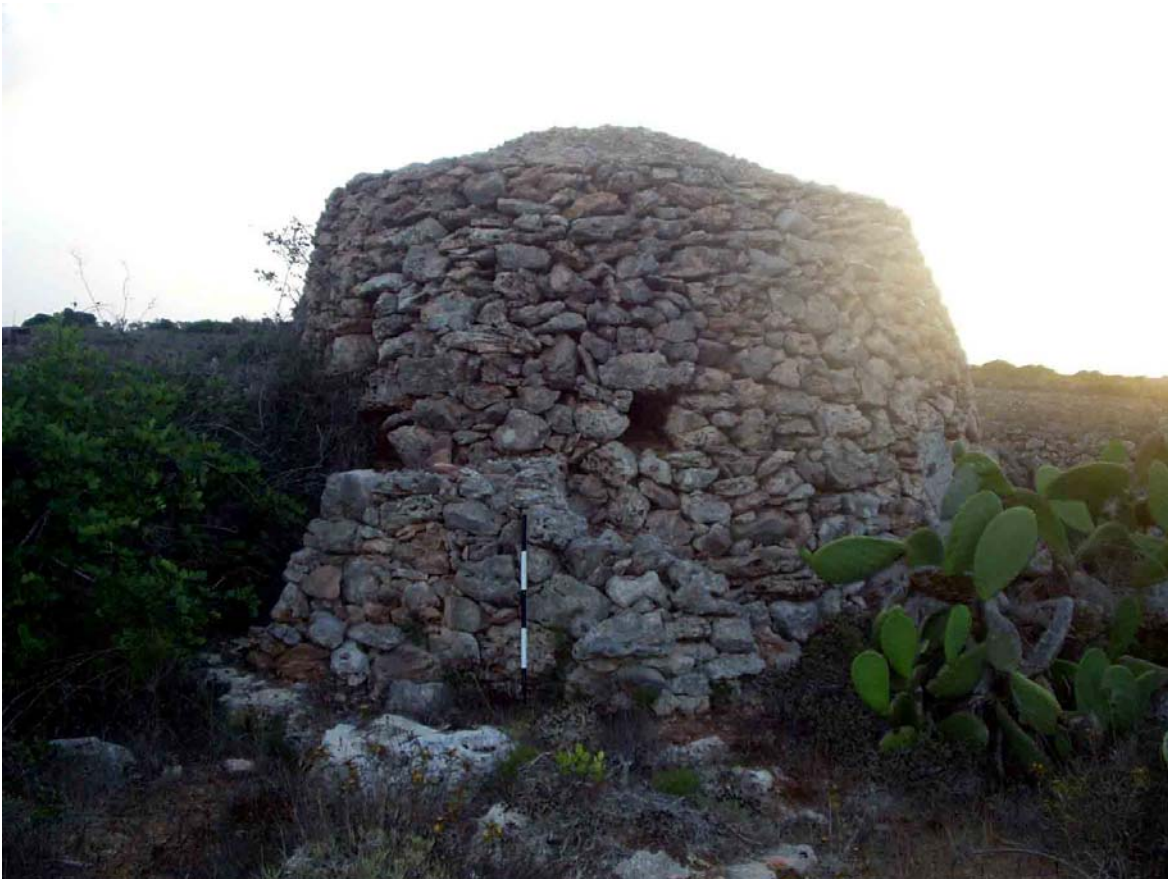
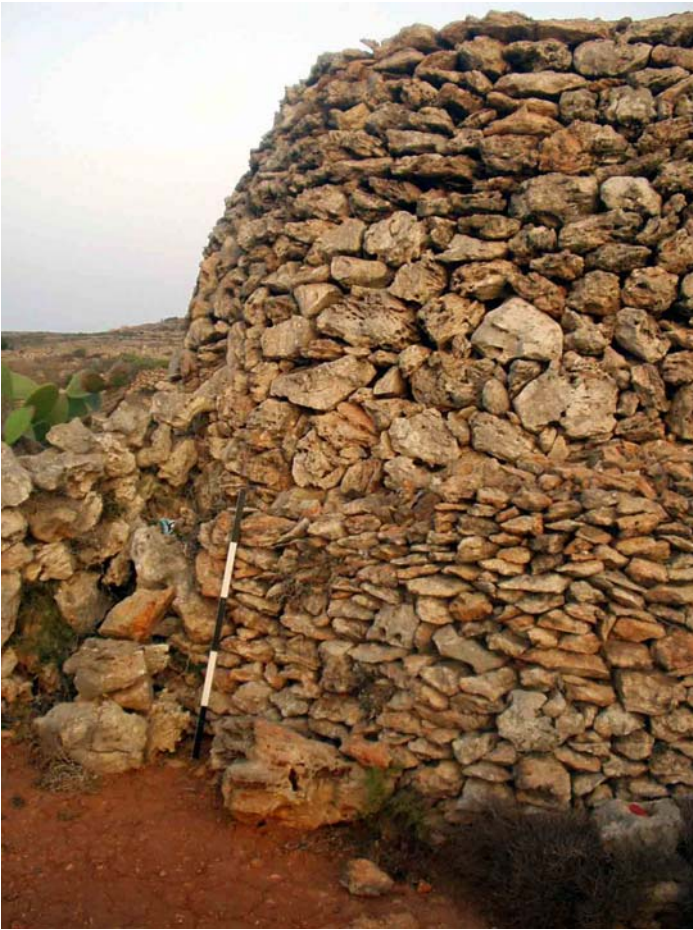
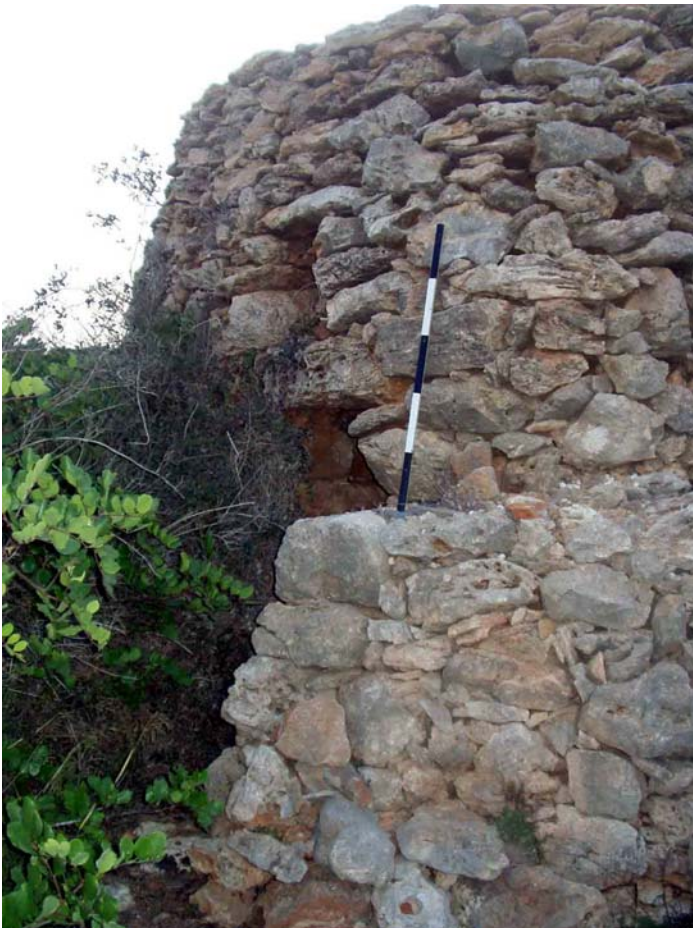
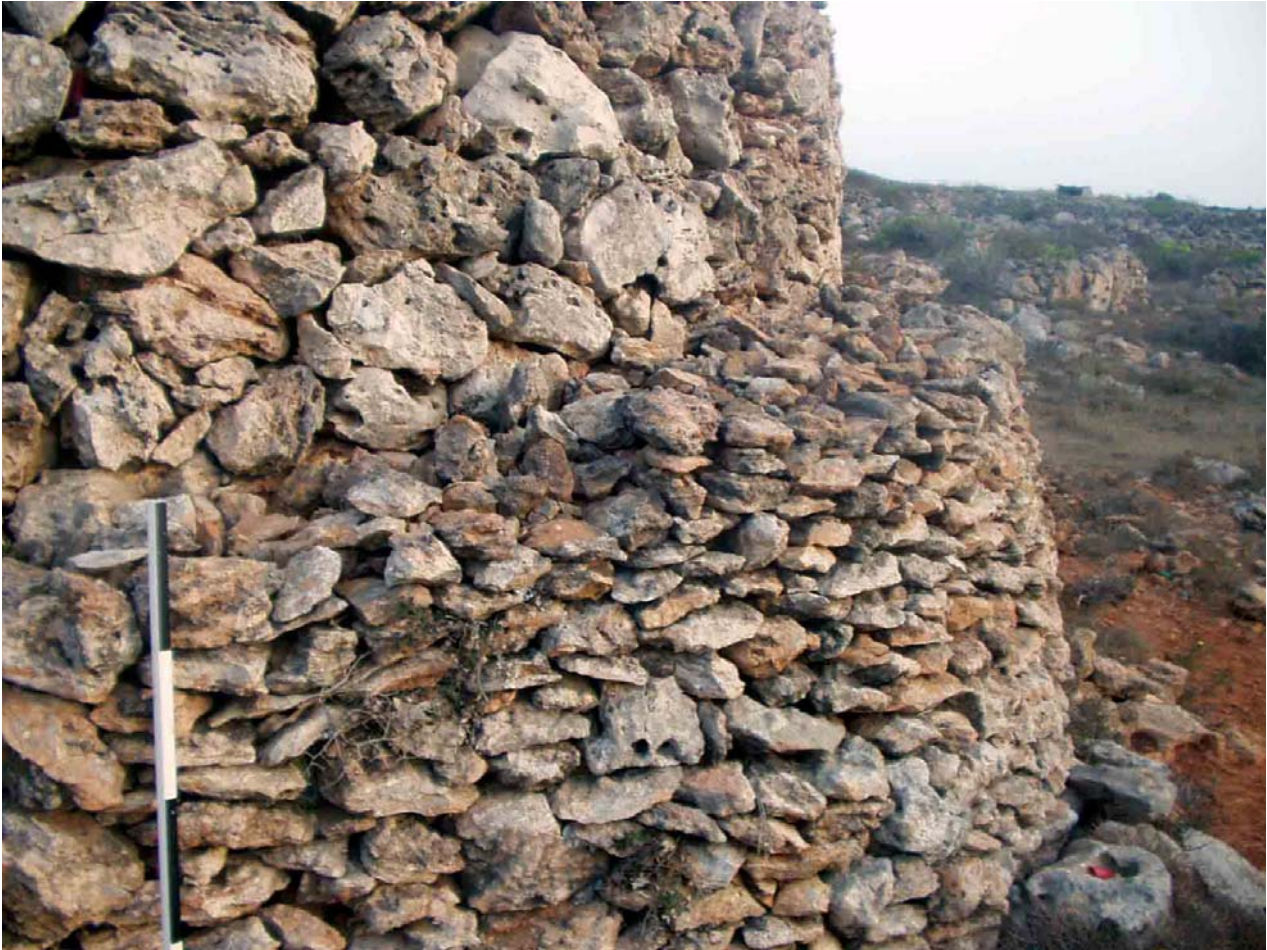
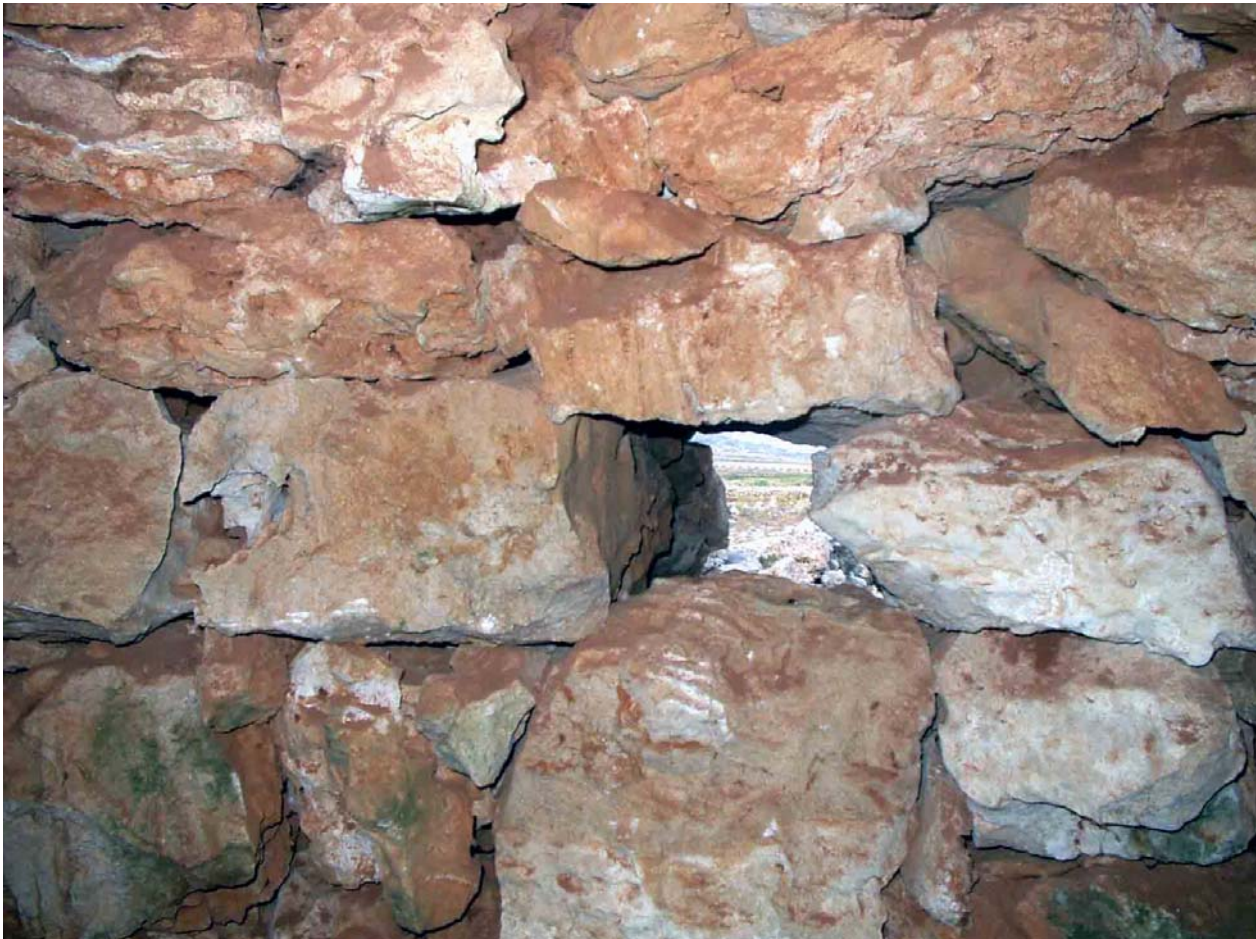
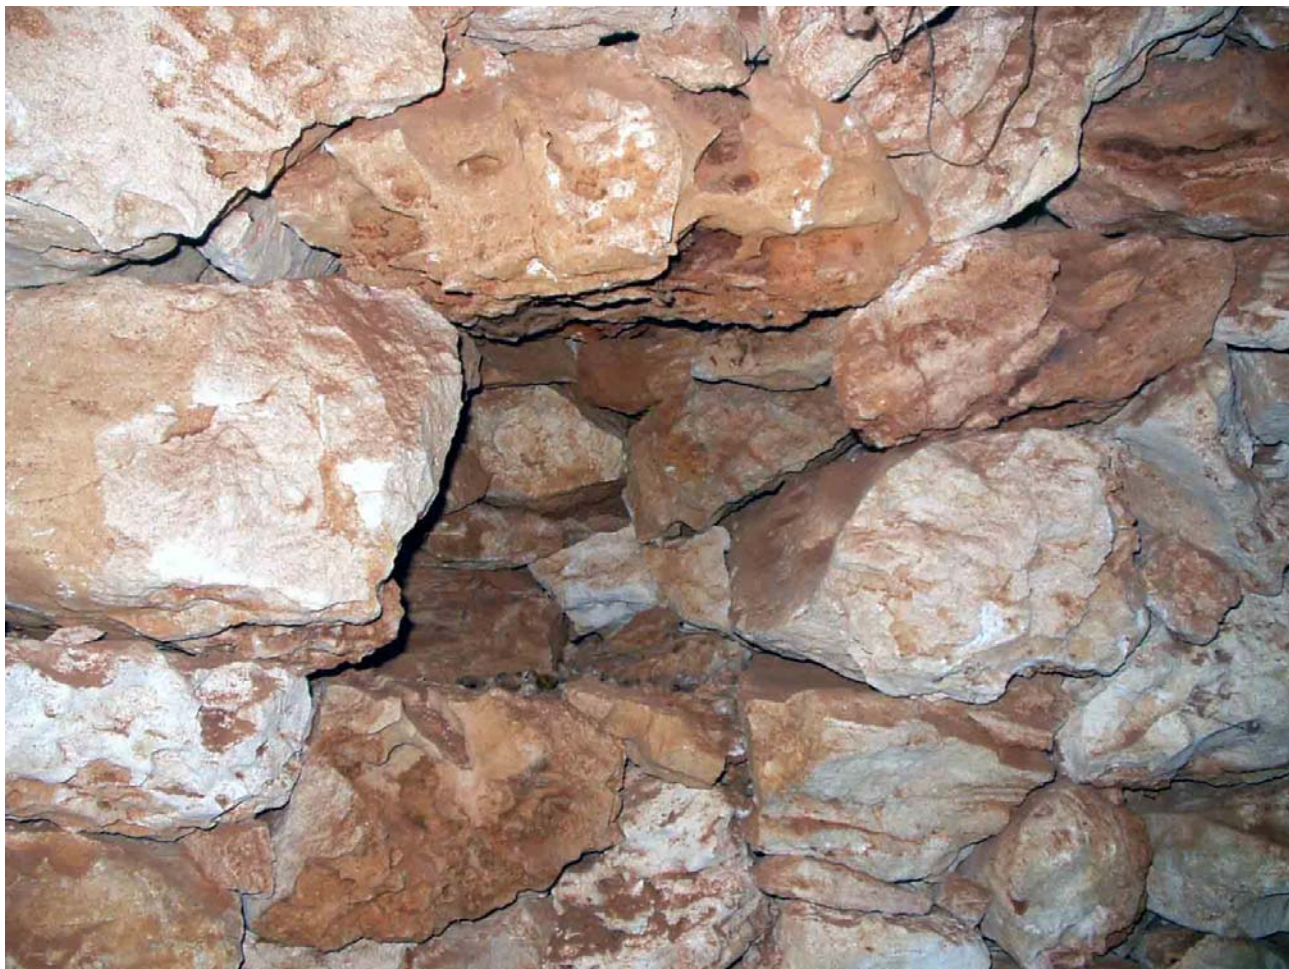
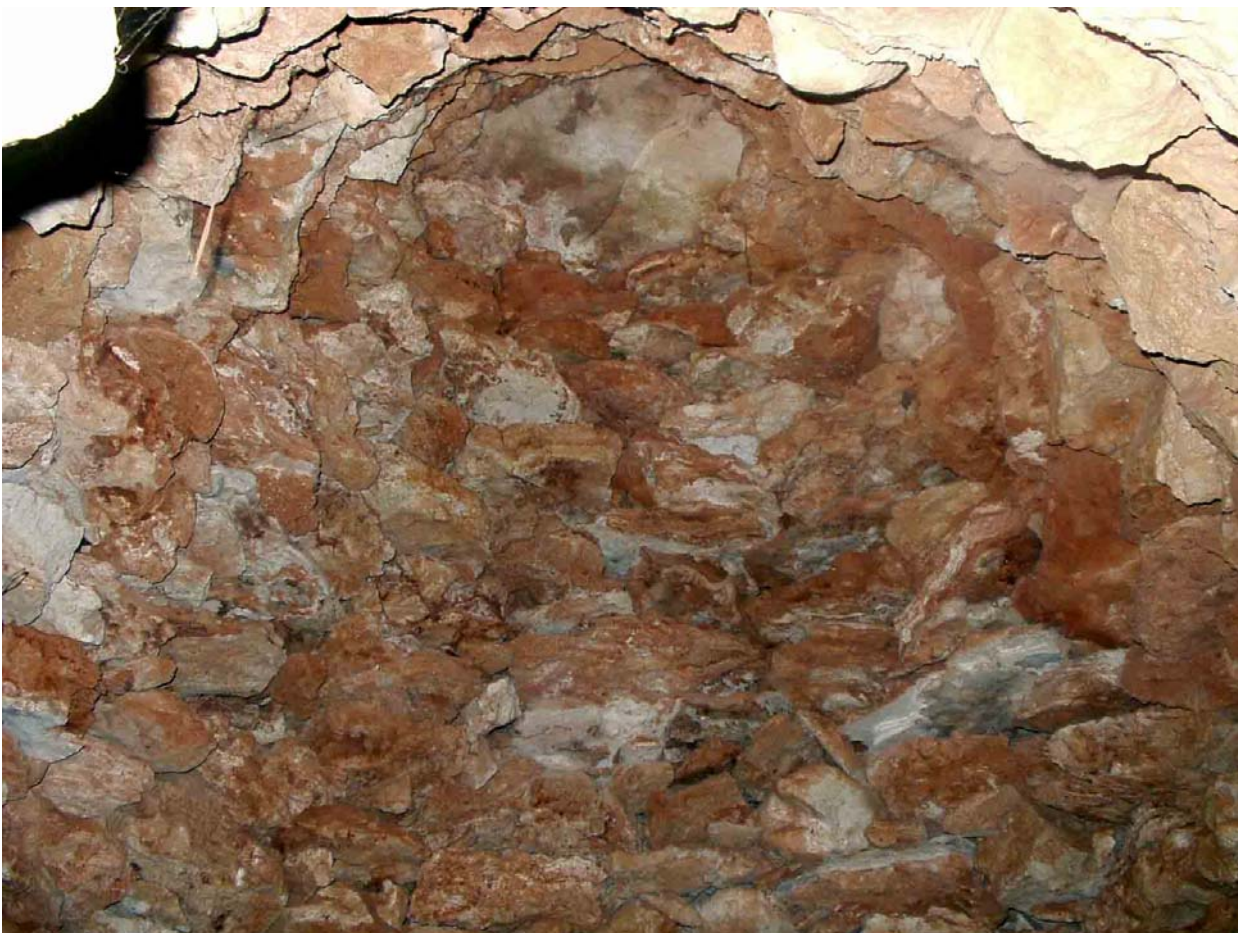
MNK05_015

Good

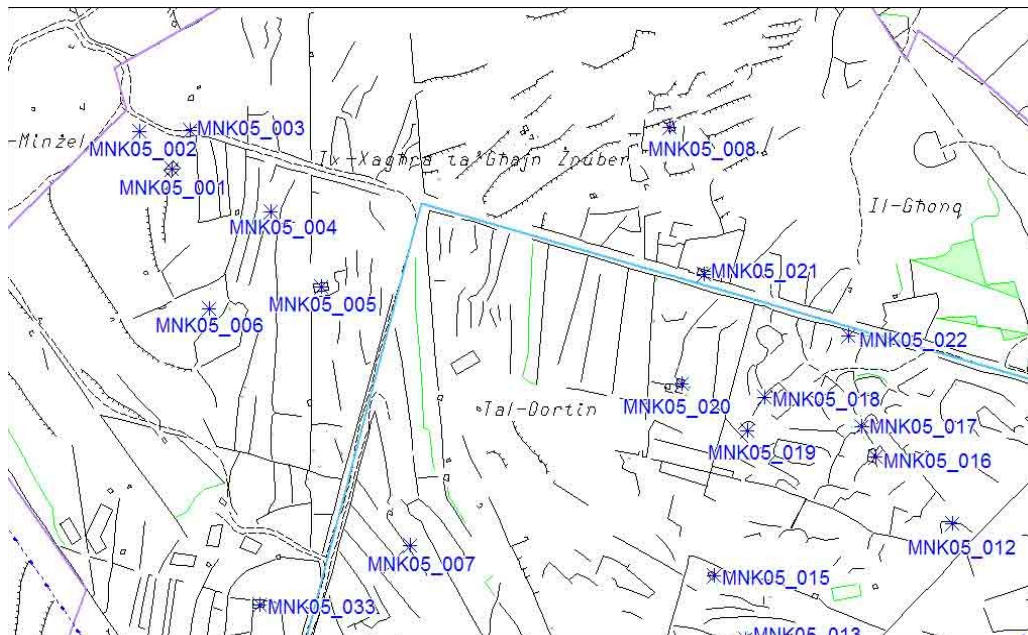
Location Tal-Qortin, Manikata	Category Rural	Site Description (Address) Corbelled Hut at Tal-Qortin, Manikata
Eastings 4101	Northings 7827	Period unknown
SS No1 4078	SS No2	Description Circular shape girna with either a roofed enclosure or a field room built as an extension to it. The hut is currently closed by a wooden door. The entrance faces south and it has a small window on its western wall and another one on its northern wall . The rubble walls in the area are in a very good condition some of which have water channels. In close proximity there is an irregularly shaped depression in the rock surface. Probably it was a natural depression that was enlarged to hold water. British period backs were noticed lying around in the area.
SS No4	SS No3	
Date of survey sheet: 1992

Condition
Good

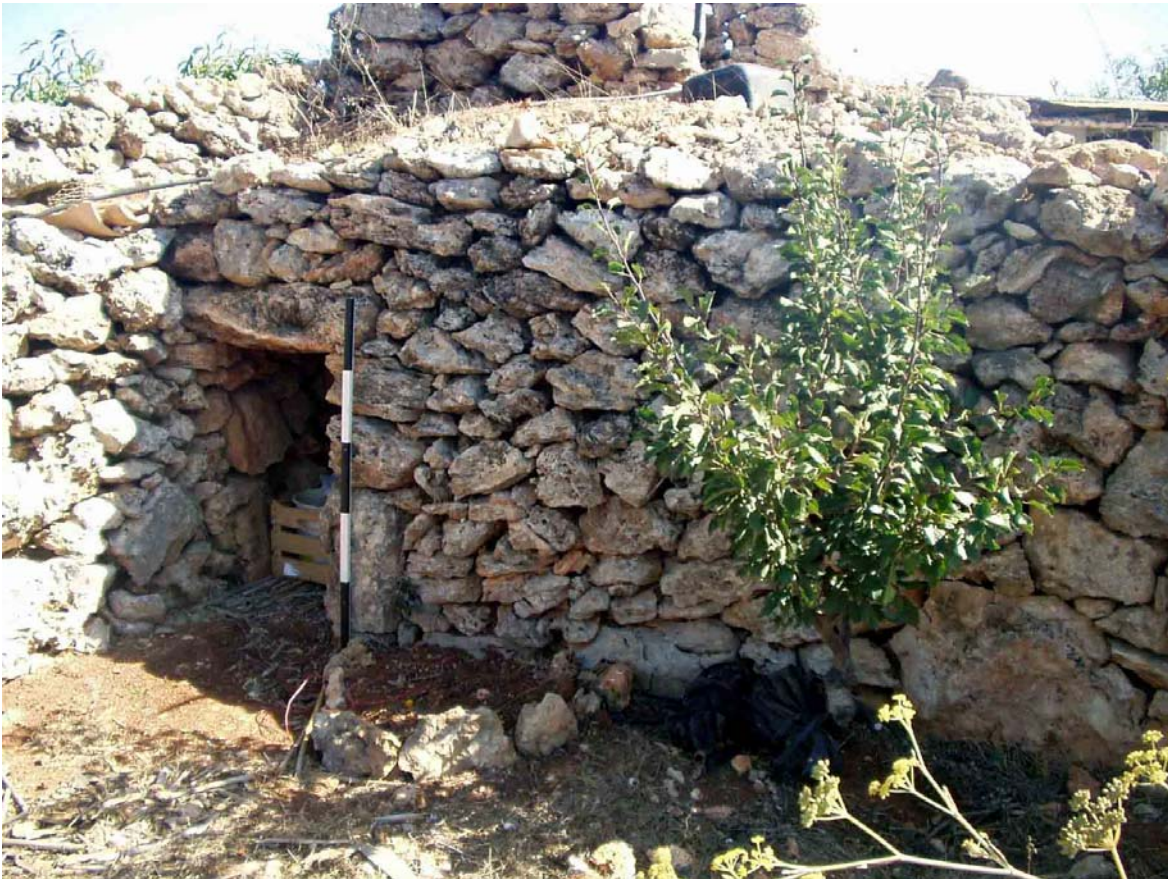
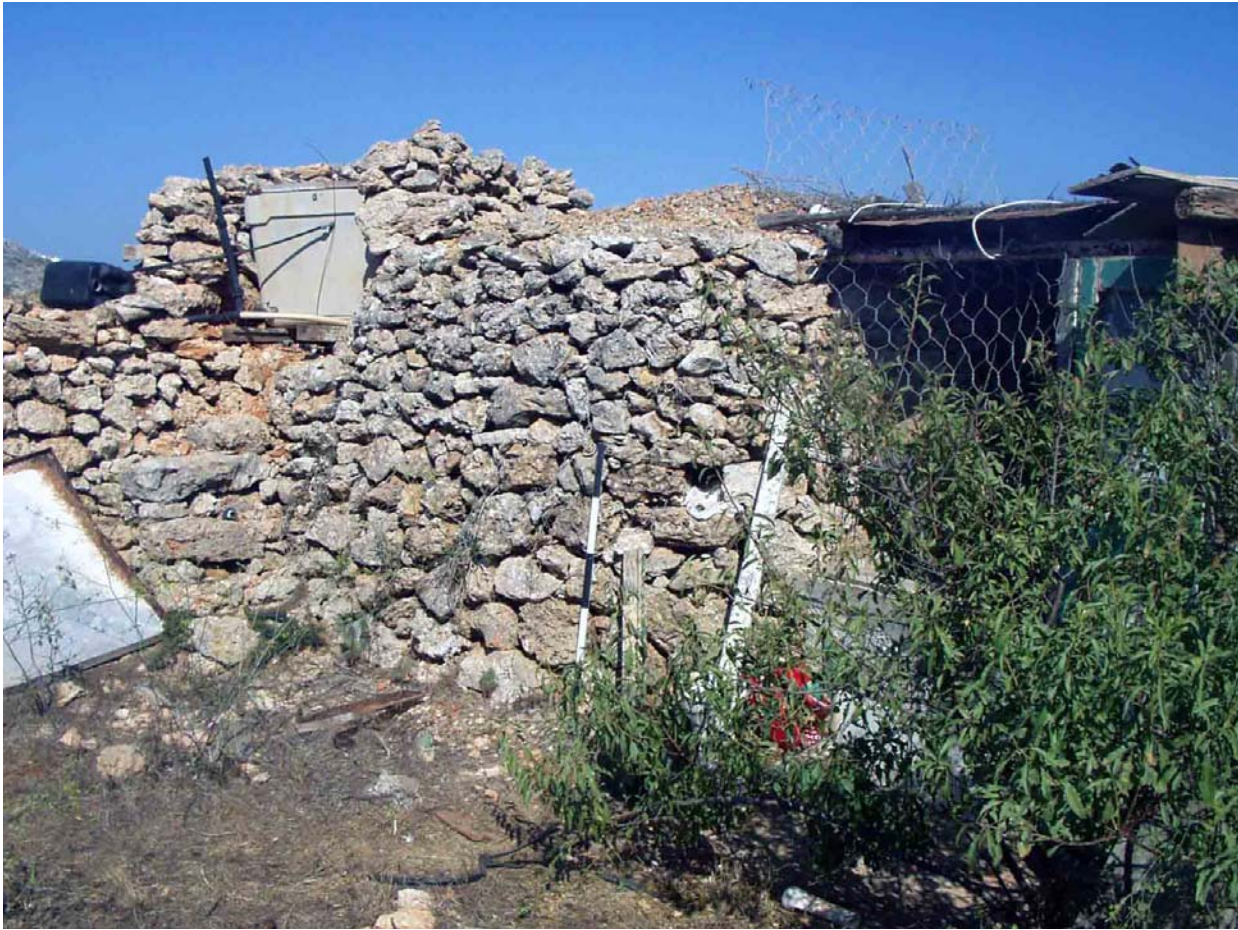
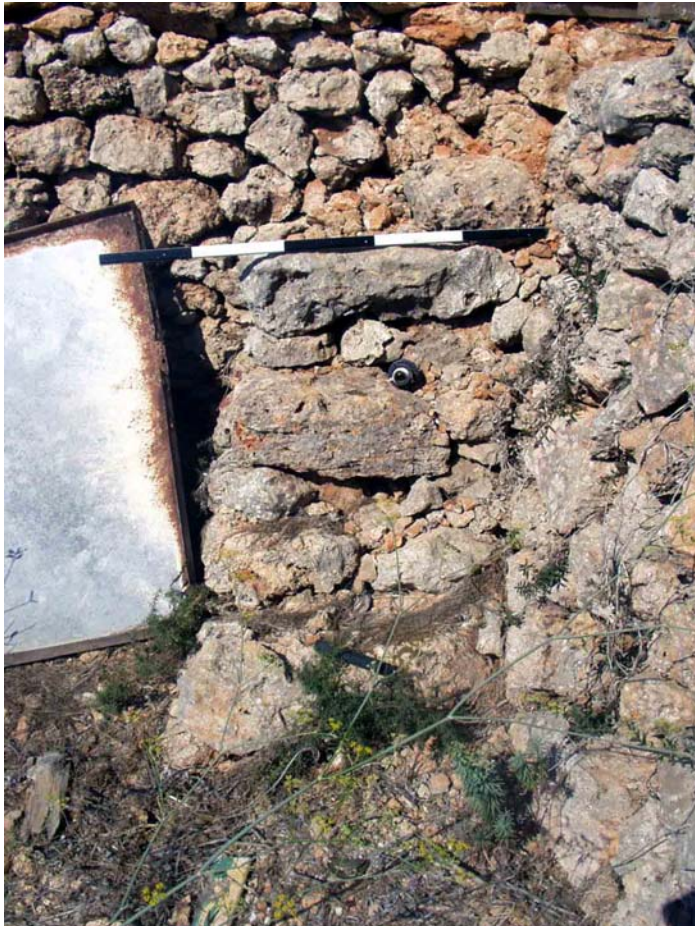
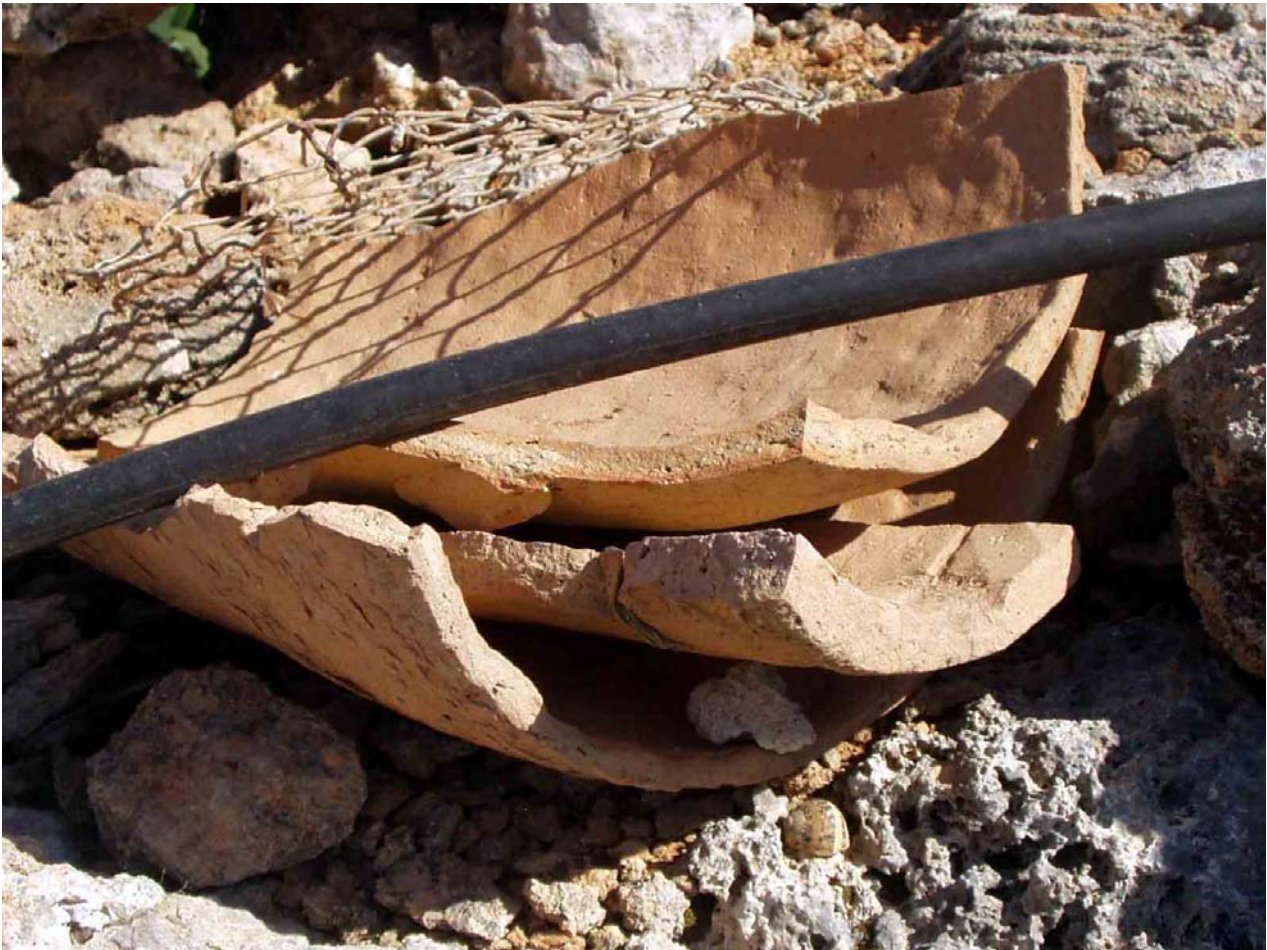
MNK05_017_00

SS No1	SS No2	Description
4078		Small circular shaped girna with its entrance facing south and an abutting field room with a low entrance (0.90m high) facing north. The field room is open and is used as a tool shed. On the hut's western wall there is a small staircase. A makeshift room has been built to the south of the hut to keep a watchdog and quails. Large fragments of a "qolla" (a bee-hive jar) were noticed on the rubble wall near the field room.
SS No4	SS No3

Good; Modern accretions should be removed.

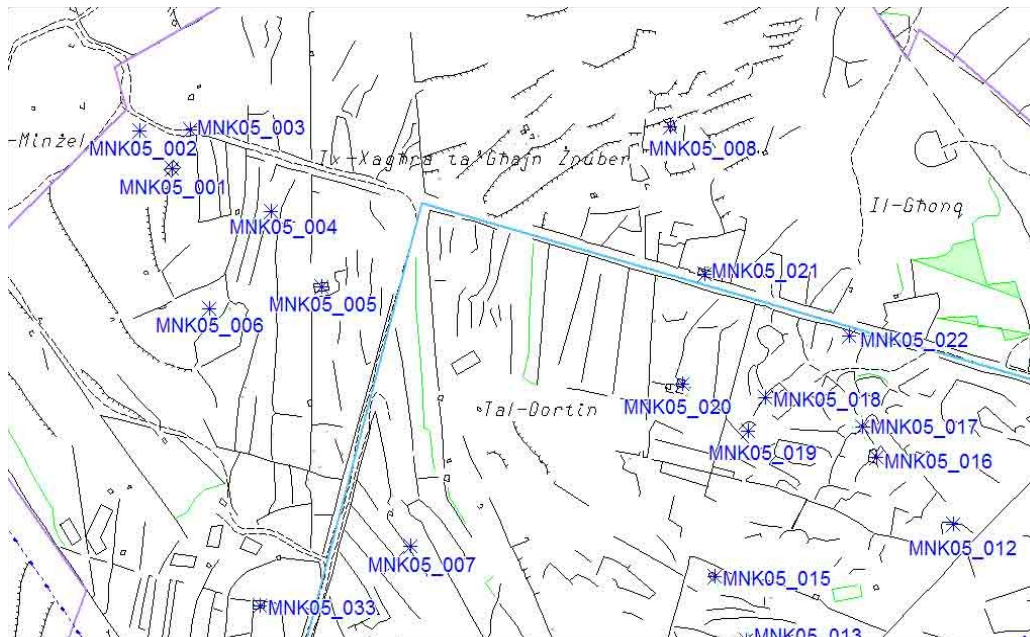
Location Tal-Qortin, Manikata	Category Rural	Site Description (Address) Recessed Bee Hives at Tal-Qortin, Manikata
Eastings 4094	Northings 7830	Period unknown
SS No1 4078	SS No2	Description 5 recessed bee hives built into the rubble wall. They consist of a niche with a lintel supporting the roof. Their average dimensions are 0.65m in width and 0.60m in height. A qolla(bee-hive jar) is still found in 3 of the recesses. However, only 2 are intact. One of the recesses has collapsed.
SS No4	SS No3	
Date of survey sheet: 1992

Condition
Fair

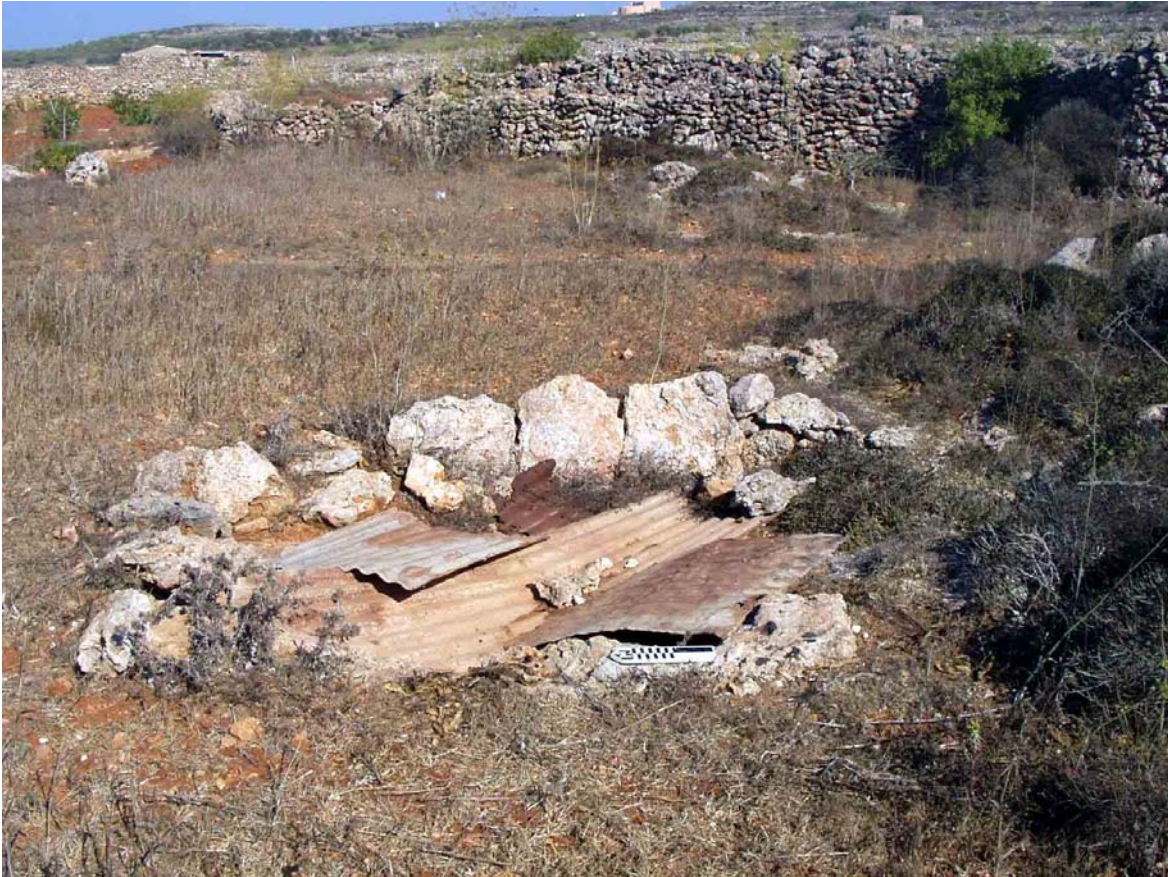
Location Tal-Qortin, Manikata	Category Rock-cut	Site Description (Address) Rock hewn water reservoir at Tal-Qortin, Manikata
Eastings 4093	Northings 7828	Period unknown
SS No1 4078	SS No2	Description Rock-hewn water reservoir of an irregular shape. Its approximate dimensions are 1.12m depth and 1.60m in diameter. Its perimeter is surrounded by a low wall built of irregular stones. It is not clear whether this reservoir was fed by a water channel or if it was solely used to store rain water.
SS No4	SS No3	
Date of survey sheet: 1992

The reservoir is covered with metal sheets to prevent evaporation. Although it was dry at the time of survey, this shows that it is still being used.

Condition
Good

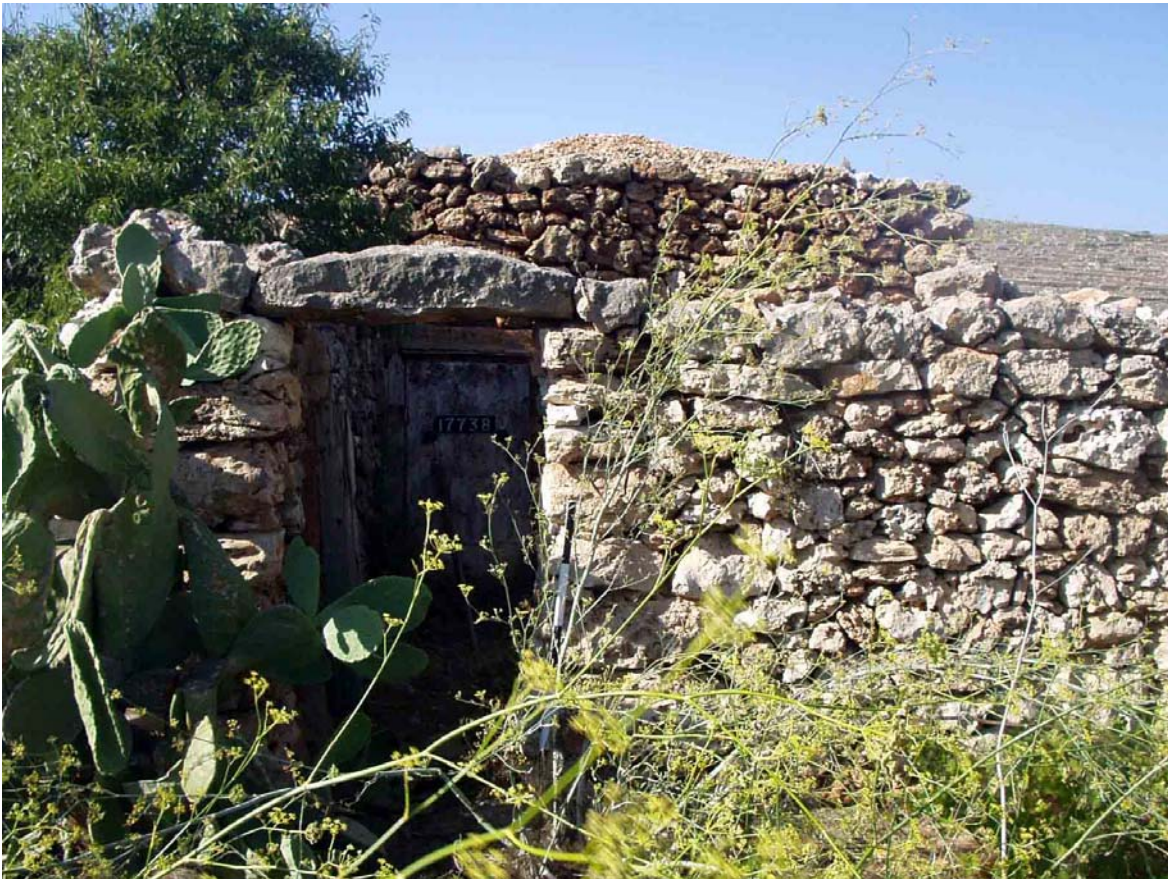
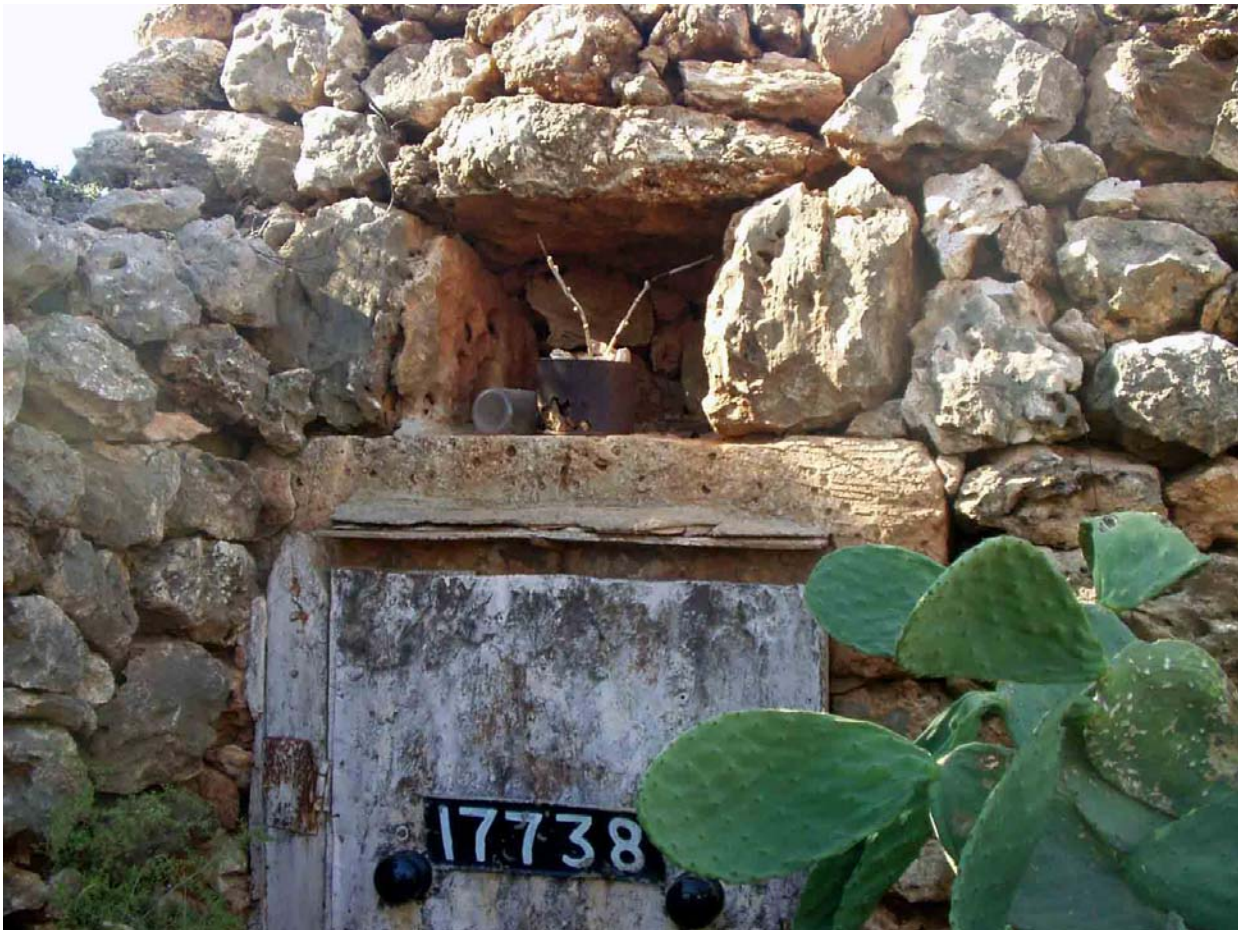
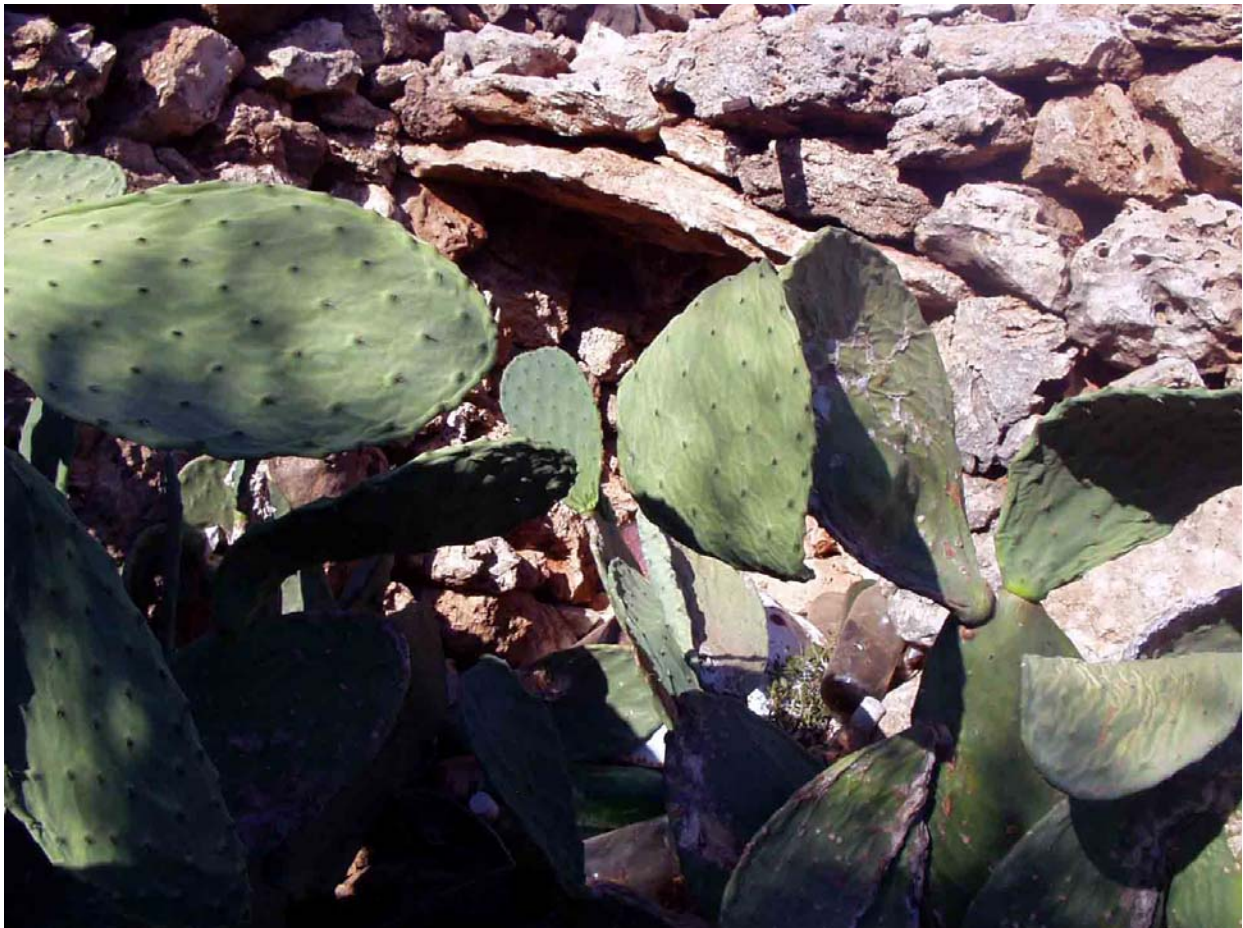
MNK05_020

Location Tal-Qortin, Manikata	Category Rural	Site Description (Address) Corbelled Hut at Tal-Qortin, Manikata
Eastings 4088	Northings 7831	Period unknown
SS No1 4078	SS No2	Description Square plan corbelled hut with the entrance facing south. The walls are slanting and the corner stones are larger than the rest of the rubble used to build the hut. It has 2 enclosures, one to the south and the other to the west. The hut is locked with a wooden door. The south enclosure has a manger with a flat lintel on the eastern wall. The NW corner of the western enclosure was once roofed but it has now collapsed. The hut has a small window on its northern wall.
SS No4	SS No3	
Date of survey sheet: 1992

Although it is locked Fsadni (1999: 87) describes the hut since it was forced open when he was recording the hut. According to him it was inhabited for a long time.

Condition
Good
