Location Ix-Xagħra l-Hamra, Manikata	Category Rural/Rock-Cut	Site Description (Address) Farmhouse complex and tombs at Ix-Xagħra l-Hamra, Manikata
---	-----------------------------------	---

SS No1 4077	SS No2	Description Farmhouse complex with 2 rooms, small separate outbuilding and a central courtyard enclosed with a rubble wall, and a 2nd enclosure at the back. To the S is a small hypogeum, probably Classical, transformed into an animal pen, of which only 3 apses with lamp holes remain. This was later enlarged and roofed over in rubble and 'deffun'. This had 2 entrances, the W one was blocked and the S one was reached by a rock-hewn ramp. The farmhouse is reached through a narrow corridor and the main entrance, facing S, was closed as shown by a horizontal stone ring. The outbuilding lies at the entrance and has a stone bench at the back. Facing it is the entrance to 2 rooms which are roofed with 'xorok' and a wooden beam. The door to the 2nd room lies on the northern wall of the 1st. Both entrances have a flat lintel on the exterior and an arch on the interior. The 2nd room also has an arch supporting the ceiling. The walls are pierced by a number of windows and cupboard in th

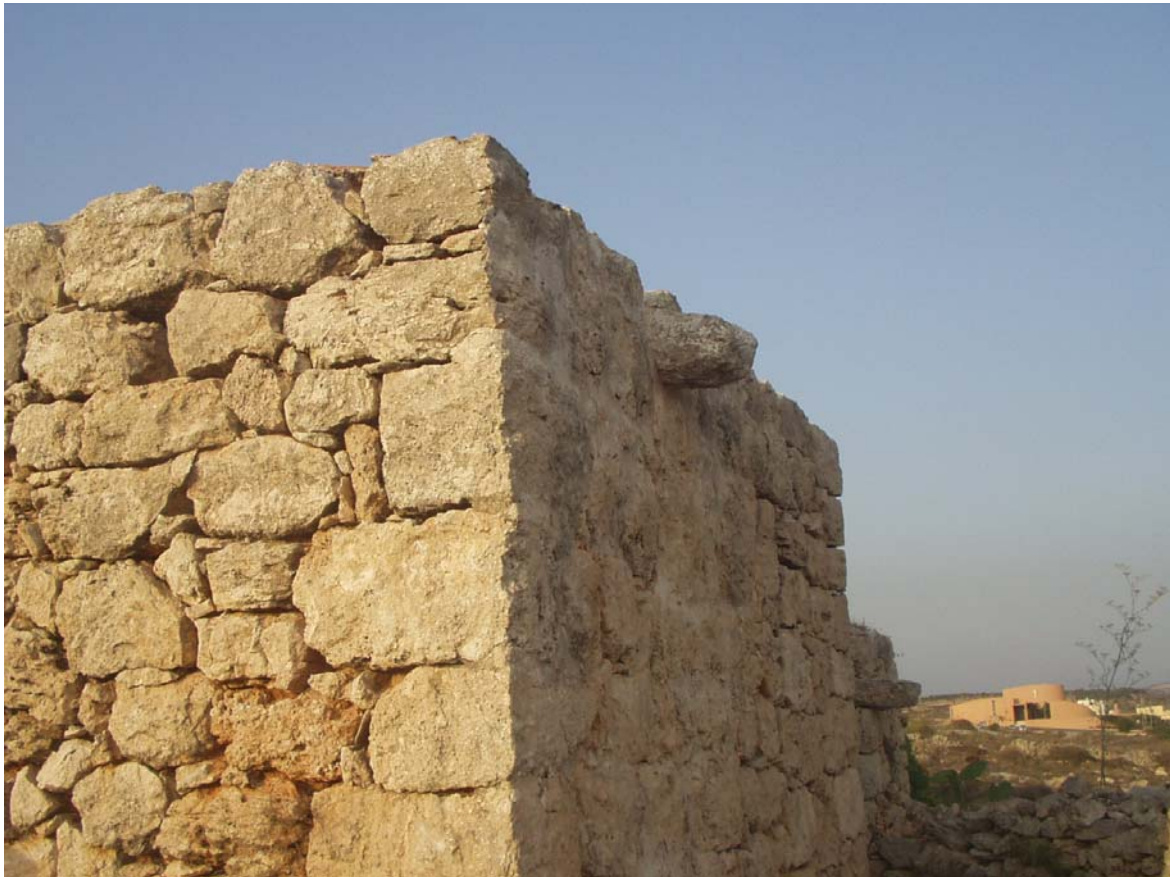
MNK05_071

Good

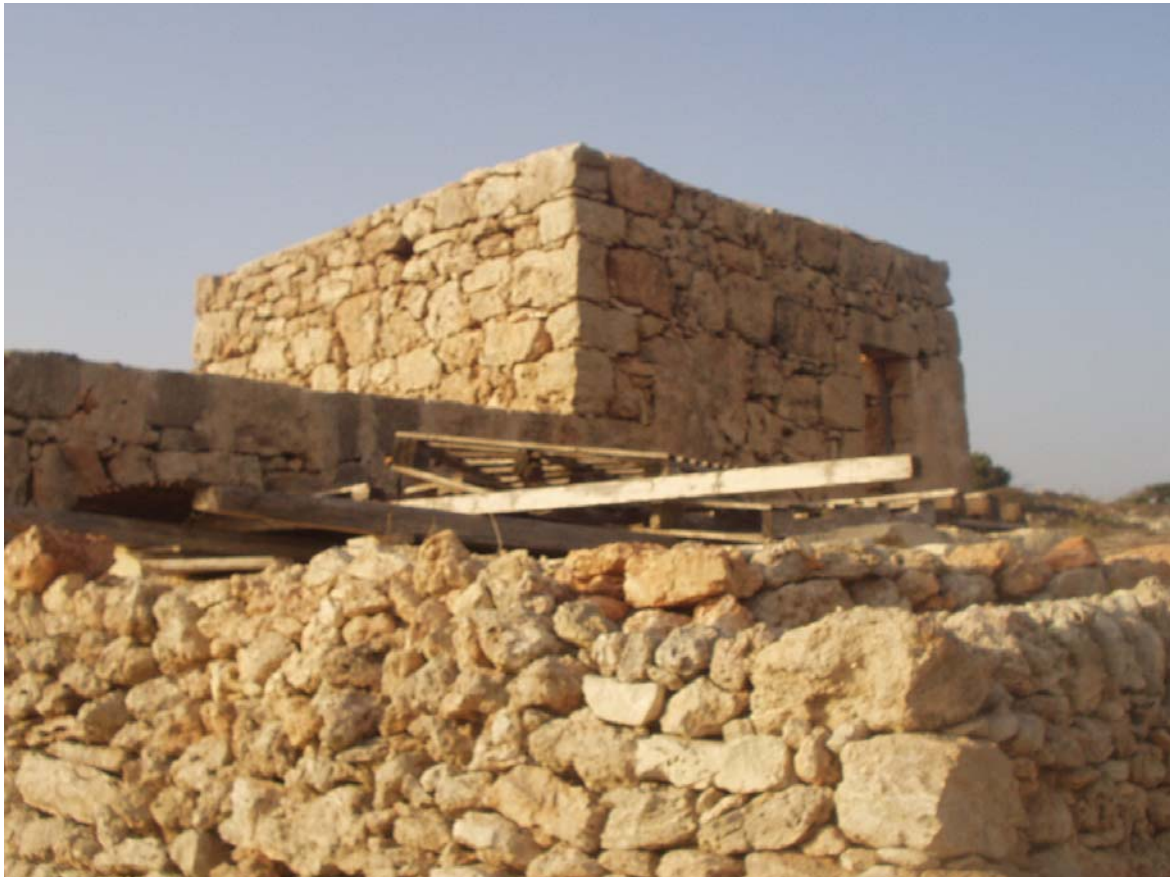
SS No1 4077	SS No2	Description Farmhouse comprising of an 'għorfa' (used for human habitation) on the 1st floor and 2 rooms in the ground floor. The structures are surrounded by an enclosure to form a courtyard. The room beneath the 'għorfa' has a low entrance and has no ceiling. The staircase to this room is no longer extant. Adjacent to its eastern wall is a rock-hewn manger.
SS No4	SS No3

This complex is currently being 'restored' with bricks and concrete beams. Some damages may have been incurred.

Condition
Fair

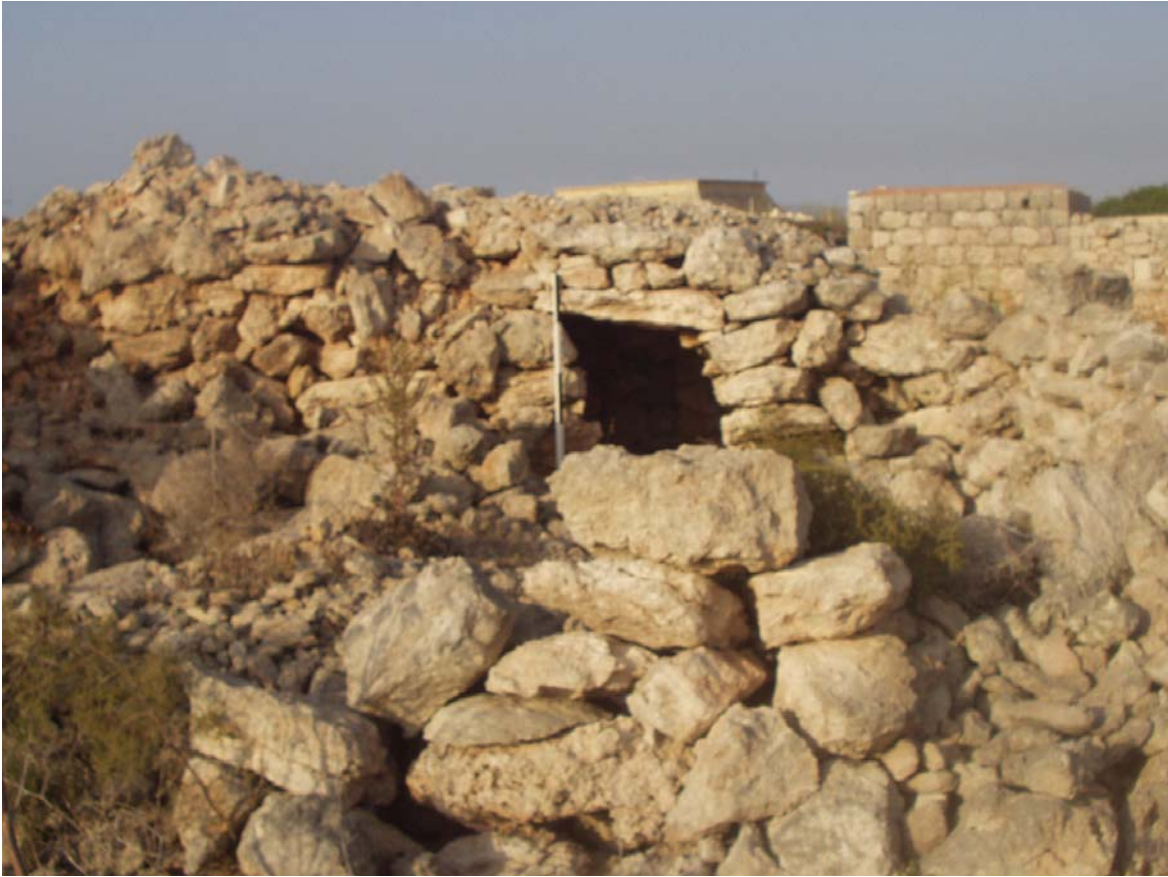
MNK05_072

Location Ix-Xagħra l-Hamra, Manikata	Category Rural	Site Description (Address) Corbelled hut at Ix-Xagħra l-Hamra, Manikata
Eastings 4136	Northings 7783	Period unknown
SS No1 4077	SS No2	Description Small elliptical corbelled hut built within the thickness of a wide rubble wall. It has a very low entrance and an irregular interior shape. It seems that this formed part of a larger structure with a more typical corbelled hut abutting it (now collapsed) and enclosed by a rubble wall. Part of this enclosure has collapsed.
SS No4	SS No3

Possibly this structure was abandoned for one of the nearby farmhouses (MNK05_070, MNK05_072, MNK05_073)

Condition
Bad

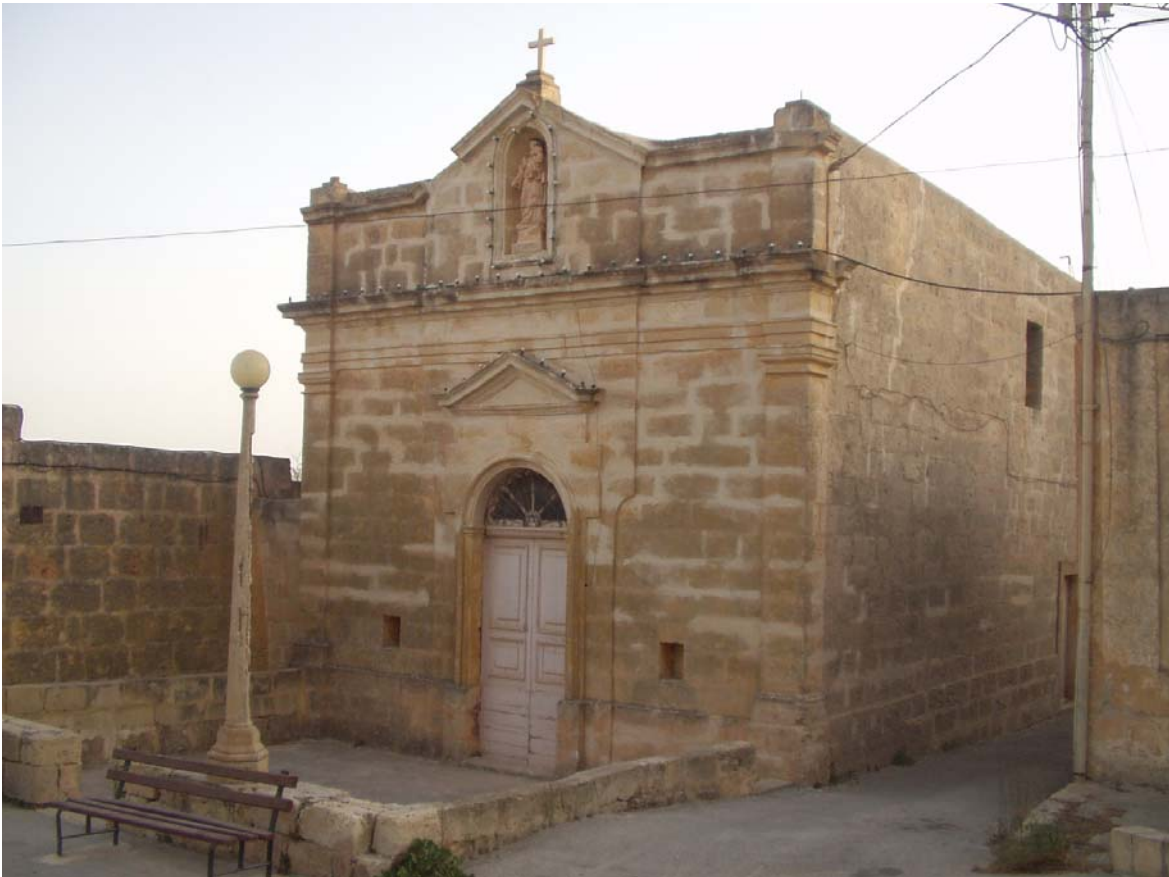
MNK05_074

Location Manikata	Category Chapel	Site Description (Address) St Joseph Chapel at il-Manikata
Eastings 4169	Northings 7774	Period
SS No1 4077	SS No2	Description Chapel dedicated to St Joseph that served the local community before the building of the newer church (MNK05_076). It has the patron saint's statue above the doorway and a small 'zuntier' in front.
SS No4	SS No3

Condition
Good

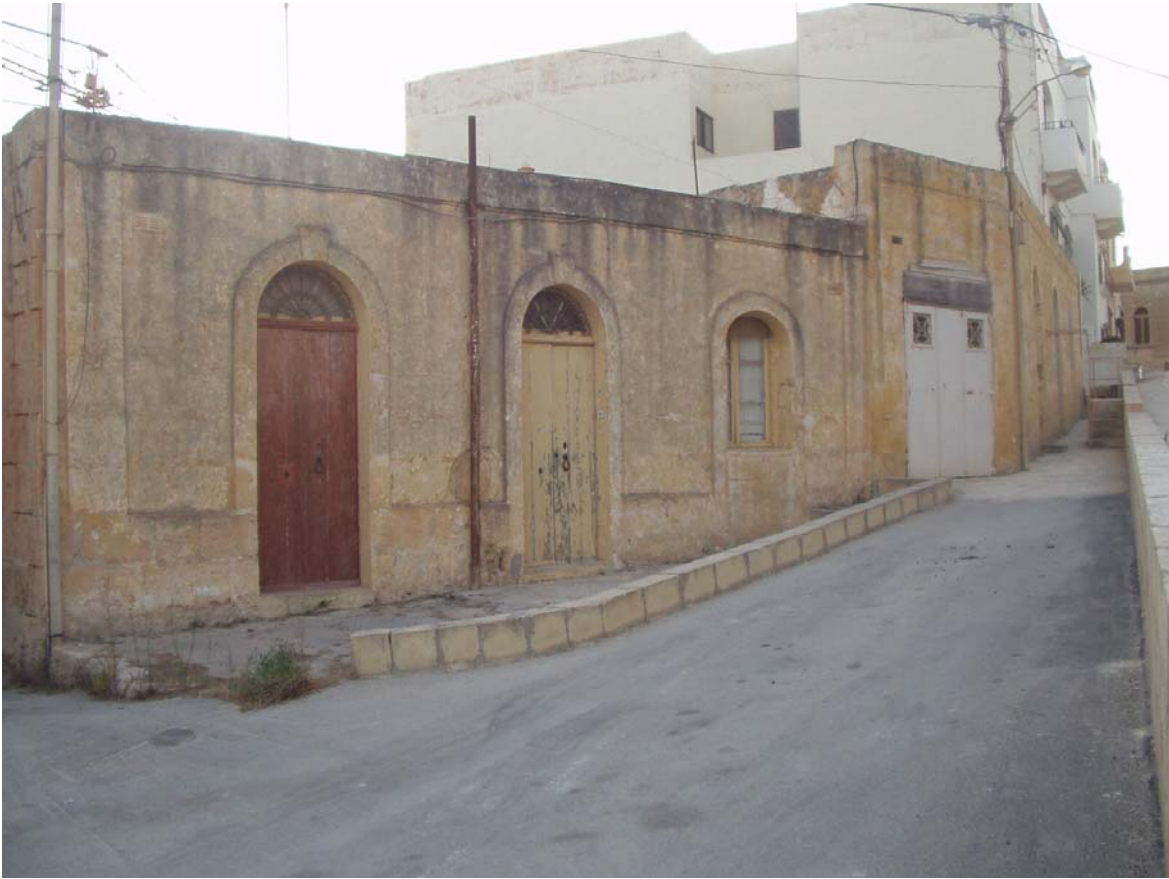
MNK05_075_004

Location Manikata	Category Structure	Site Description (Address) Barrel vaulted building at Manikata
Eastings 4168	Northings 7775	Period
SS No1 4077	SS No2	Description Barrel vaulted building near St Joseph Chapel (MNK05_075). It is not clear whether this was related to the chapel. The building is inhabited and it was not possible to gain access to the interior.
SS No4	SS No3

Condition
Good

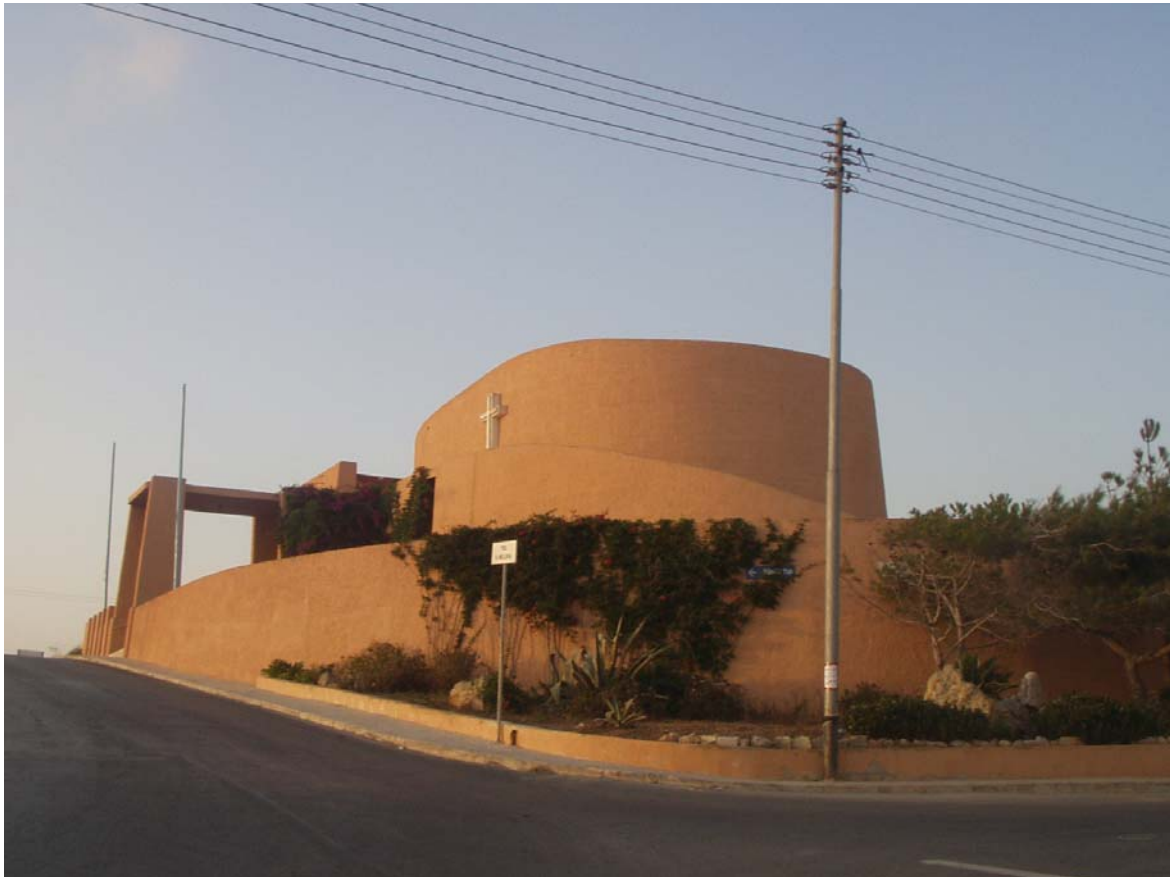
SS No1	SS No2	Description
4077		Parish church dedicated to St Joseph designed by Architect Richard England. It has a very particular architectural style and is one of the first designs for public buildings by this architect.
SS No4	SS No3

Condition
Good

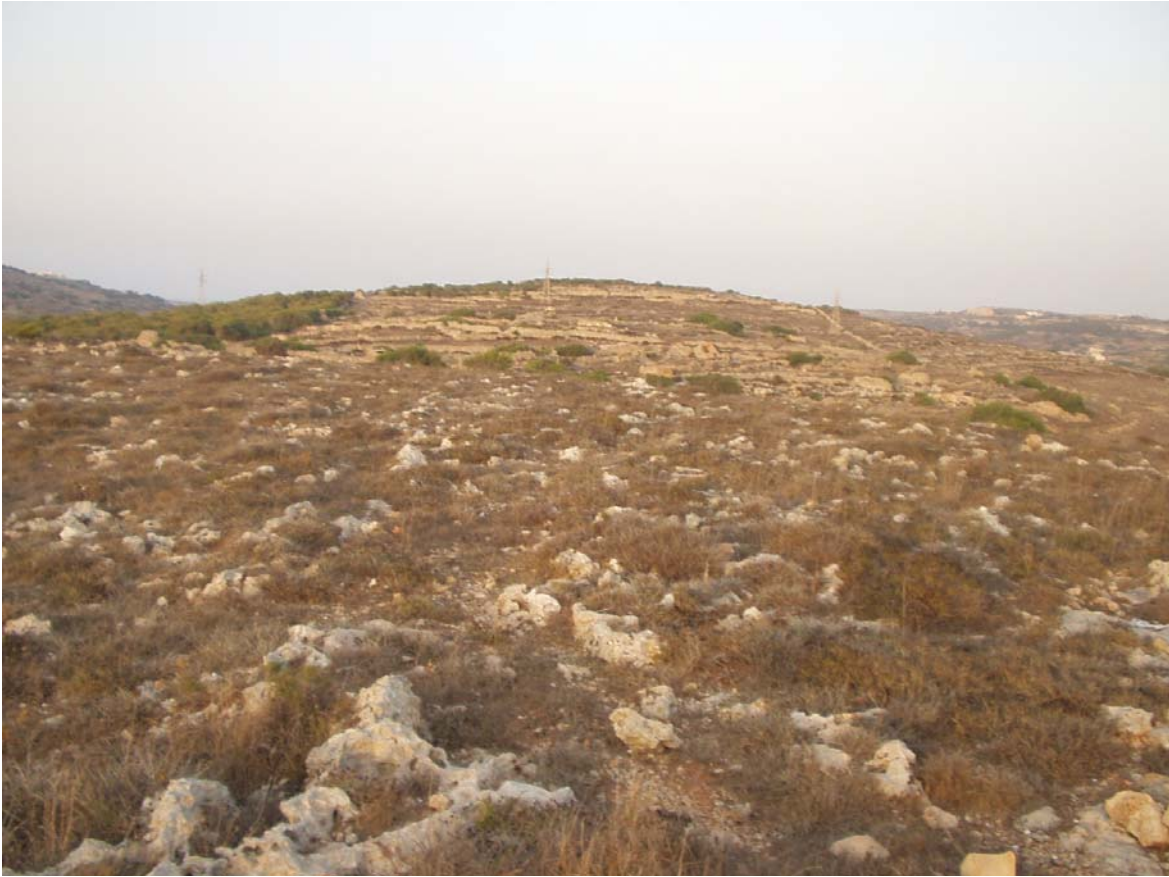
MNK05_077

Location Manikata	Category Rock-Cut	Site Description (Address) Cart Ruts and Qaurries at Manikata
Eastings 4176	Northings 7788	Period unknown
SS No1 4077	SS No2	Description A number of cart ruts and quarries at Manikata.
SS No4	SS No3

Only part of the area lies within the area of study.

Condition
Good

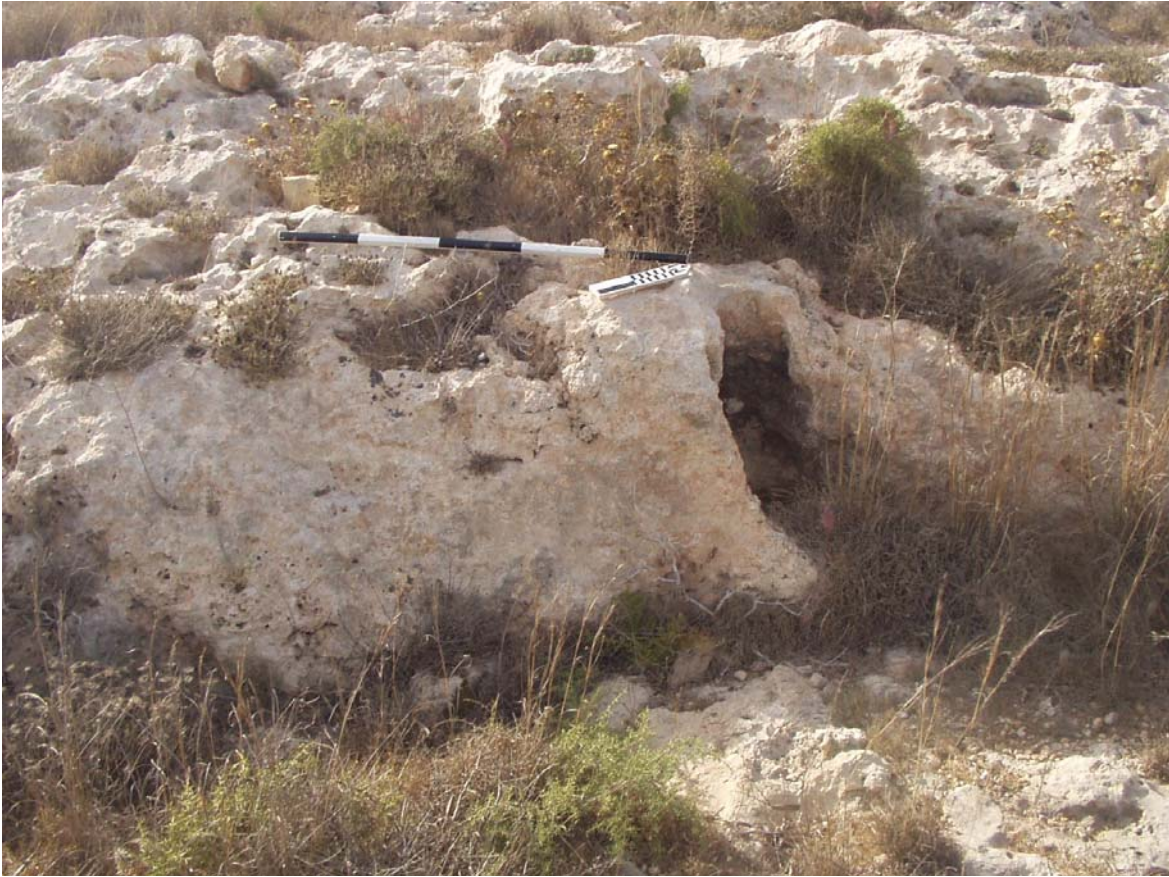
MNK05_078

Location Ix-Xagħra I-Hamra	Category Rock-Cut	Site Description (Address) Quarrying at Ix-Xagħra I-Hamra, Manikata
Eastings 4106	Northings 7755	Period unknown
SS No1 4077	SS No2	Description A straight ledge running along the field track leading off Triq il-Fuħħ ar
SS No4	SS No3	
Date of survey sheet: 1992

Condition
Fair

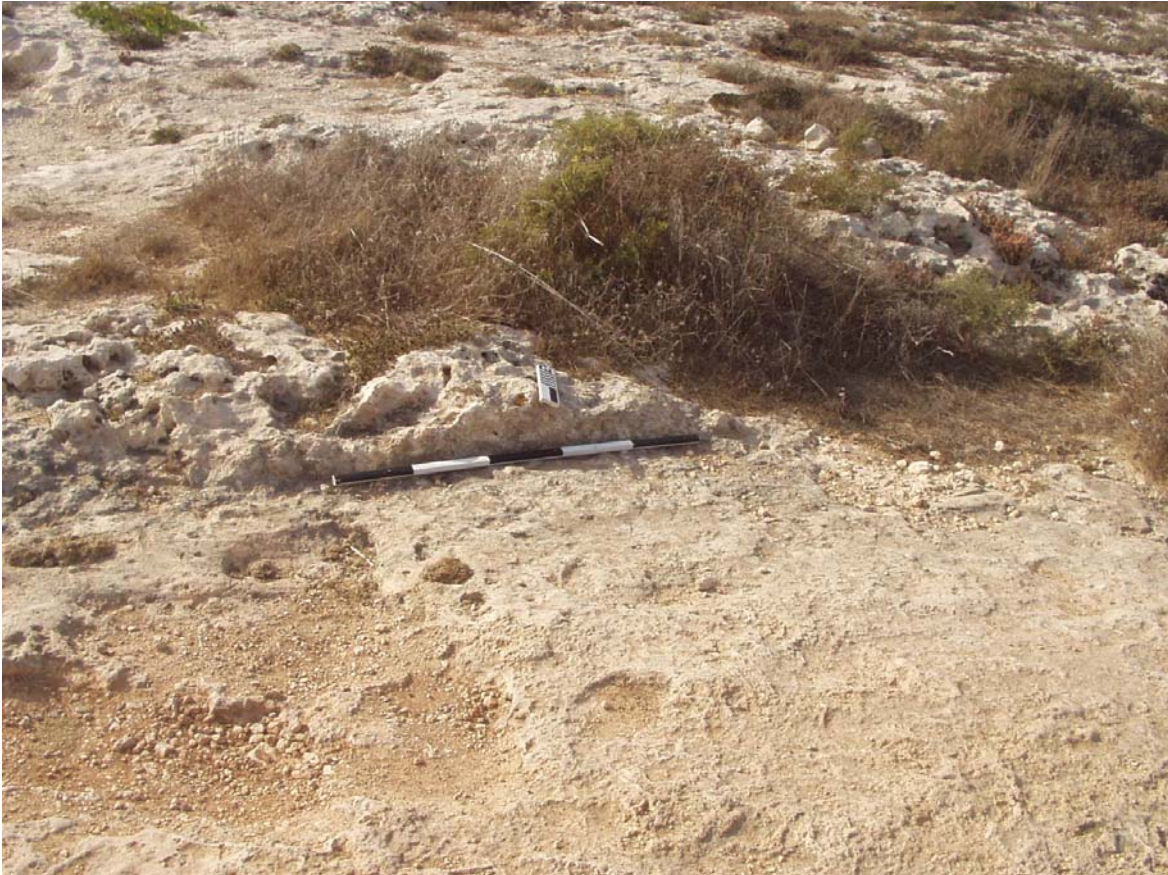
MNK05_079

Location Ix-Xagħra I-Hamra	Category Rock-Cut	Site Description (Address) Rock-hewn track at Ix-Xagħra I-Hamra, Manikata
Eastings 4113	Northings 7758	Period unknown
SS No1 4077	SS No2	Description A country track/road leading off Triq il-Fuħħar hewn out of the rock surface.
SS No4	SS No3

Good

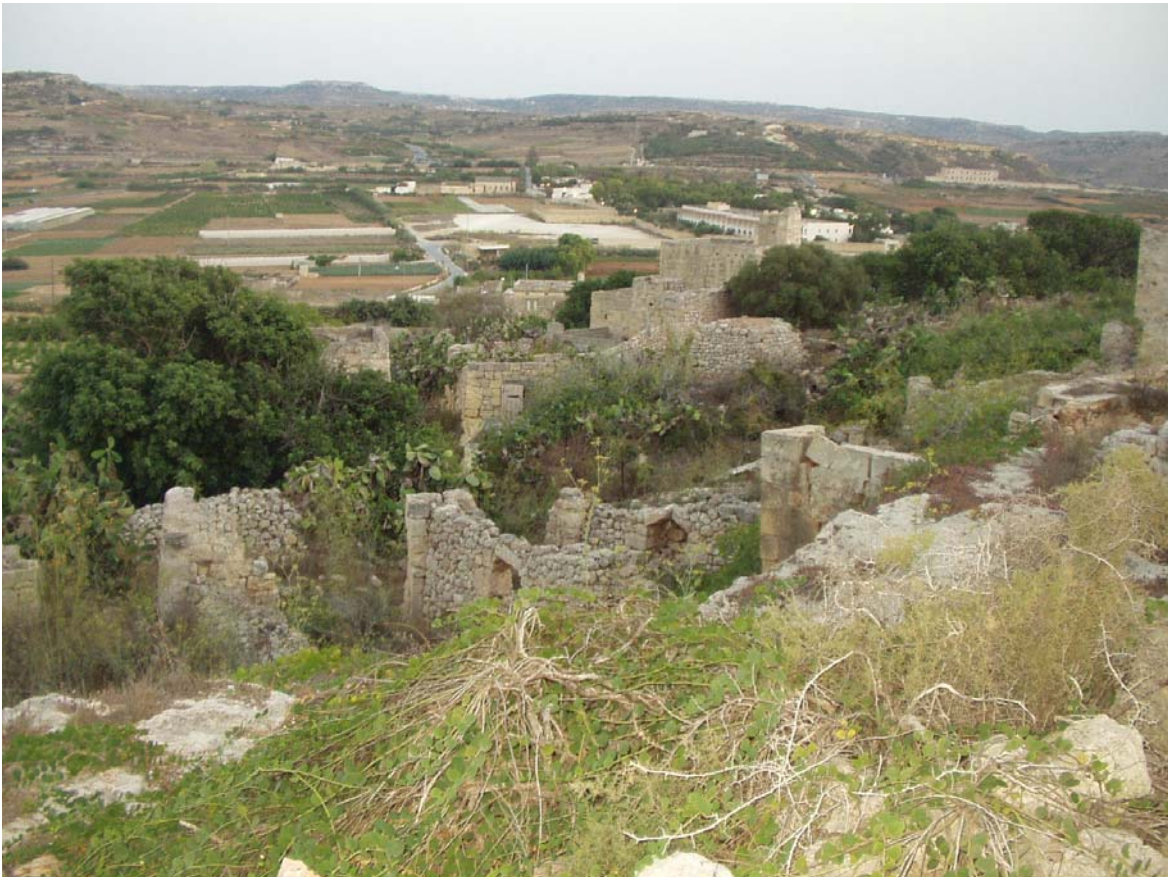
Location Ix-Xagħra I-Hamra	Category Rural	Site Description (Address) Hamlet at Ix-Xagħra I-Hamra, Manikata
Eastings 4118	Northings 7758	Period Unknown
SS No1 4077	SS No2	Description Hamlet consisting of a number of farmhouses, stables, caves and animal pens which have been described individually as features MNK05_080a to MNK05_080f.
SS No4	SS No3

The Hamlet is very interesting in that it is the only such rural featured noted in the immediate area. Other such hamlets are found further inland on the way to Mgarr.

Poor

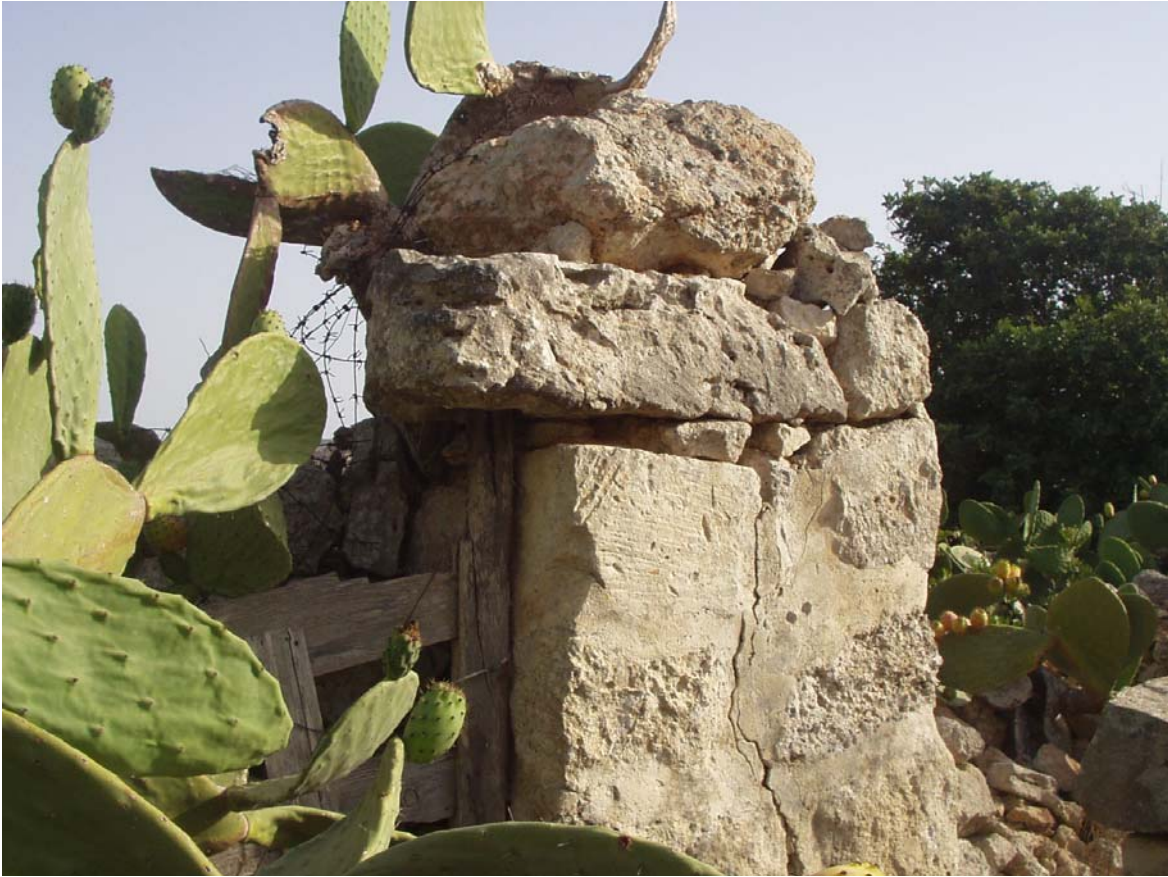
MNK05_080a

SS No1 4077	SS No2	Description 8 caves cut into the cliff face, enlarged by human activity. The caves are situated on one side of a courtyard which was used as an animal pen. The other 3 sides are made up of rubble walls. The walls include post holes for wooden gates, one of which survives in a poor state. 2 mangers are found in two of the surrounding walls, only one of which is in a good state of preservation. The larger cave has numerous recesses typical of troglodytic dwellings. A pottery scatter was also noted within the area.
SS No4	SS No3

The animal pens make part of a larger abandoned hamlet which is in a poor state of preservtion.

Condition
Bad

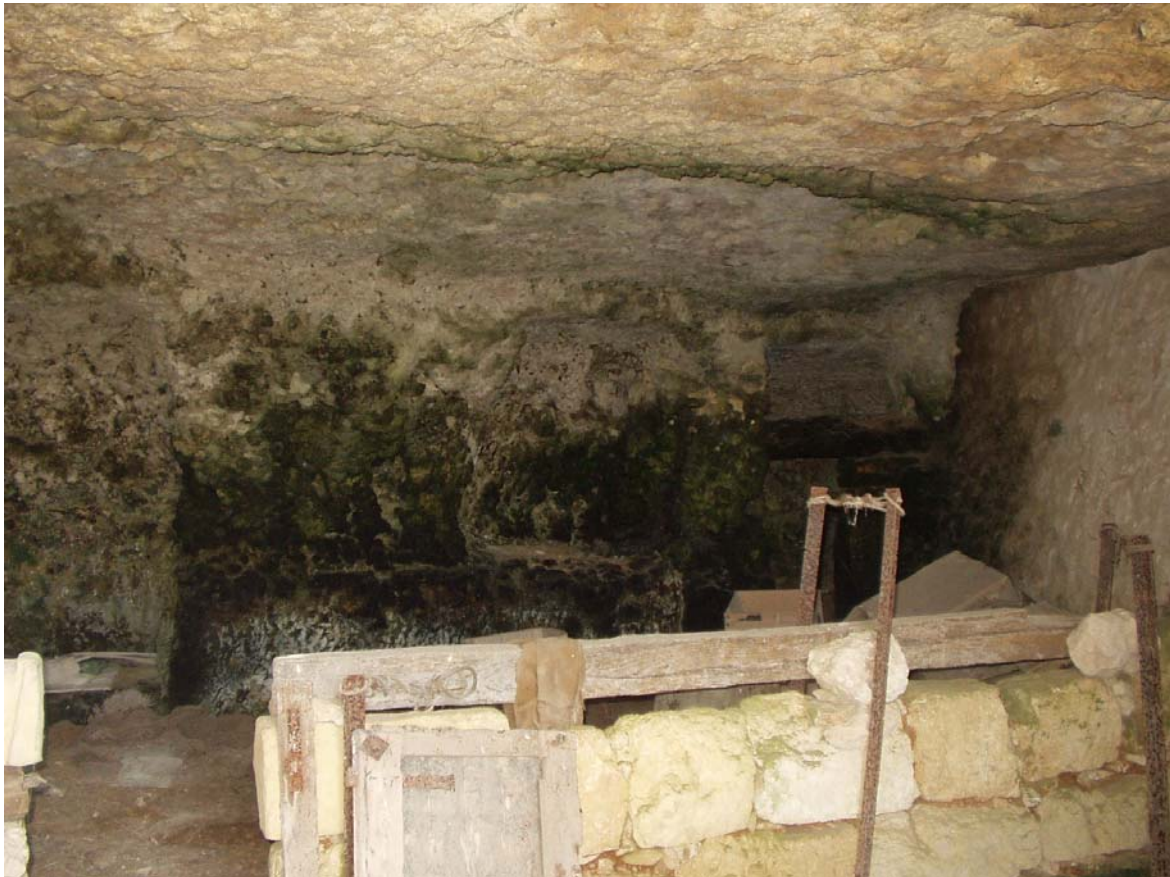
SS No1	SS No2	Description
4077		A room partly dug in the cliff face with its doorway facing south. The roof which consisted of simple corbels, timber beams and stone slabs has collapsed; even though the corbels are still in situ. The room is found next to the animal pens.
SS No4	SS No3

Condition
Bad

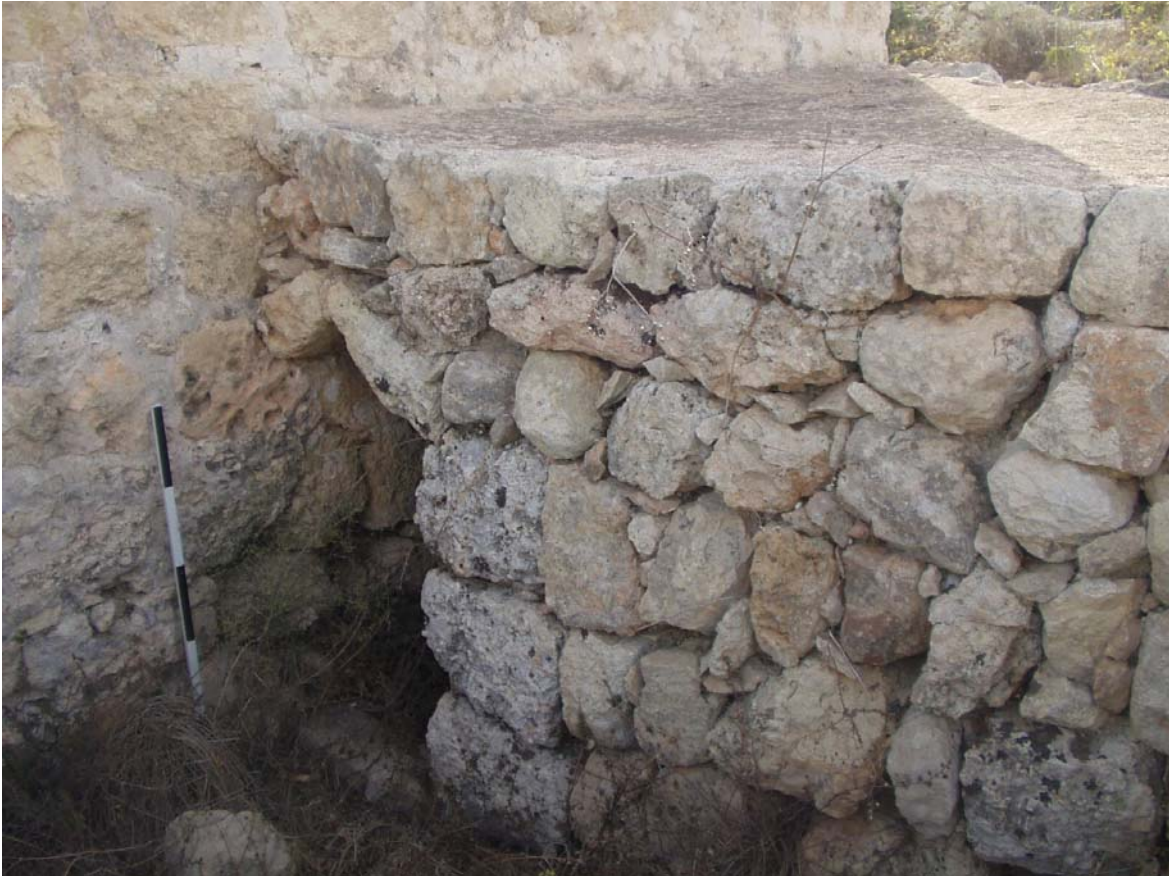
MNK05_080c

SS No1 4077	SS No2	Description A 2 storey farmhouse consisting of a number of rooms. To the east of the building is a small dry-stone room which is partially cut into the rock face, roofed with slabs and covered with deffun. The entrance faces south and the lintel has a triangular shape. A small animal pen is found in front of the room. The larger building consists of 3 adjacent rooms with south facing entrances. The western-most room has partly collapsed. The other rooms were until recently used as storage for fodder. Some wooden apertures are still in place. The doorways have a flat lintel on the outside while on the inside these are arched. The 1st floor was reached via an external staircase. Most of the roofs have collapsed and these consisted of single corbels, wooden beams, stone slabs and deffun. The walls are built of dry-stone and plastered over. Some of the rooms were divided at a later stage using rough upper globigerina limestone blocks. Part of the building is unaccessible.

The building is in a very bad state of preservation.

Condition
Bad

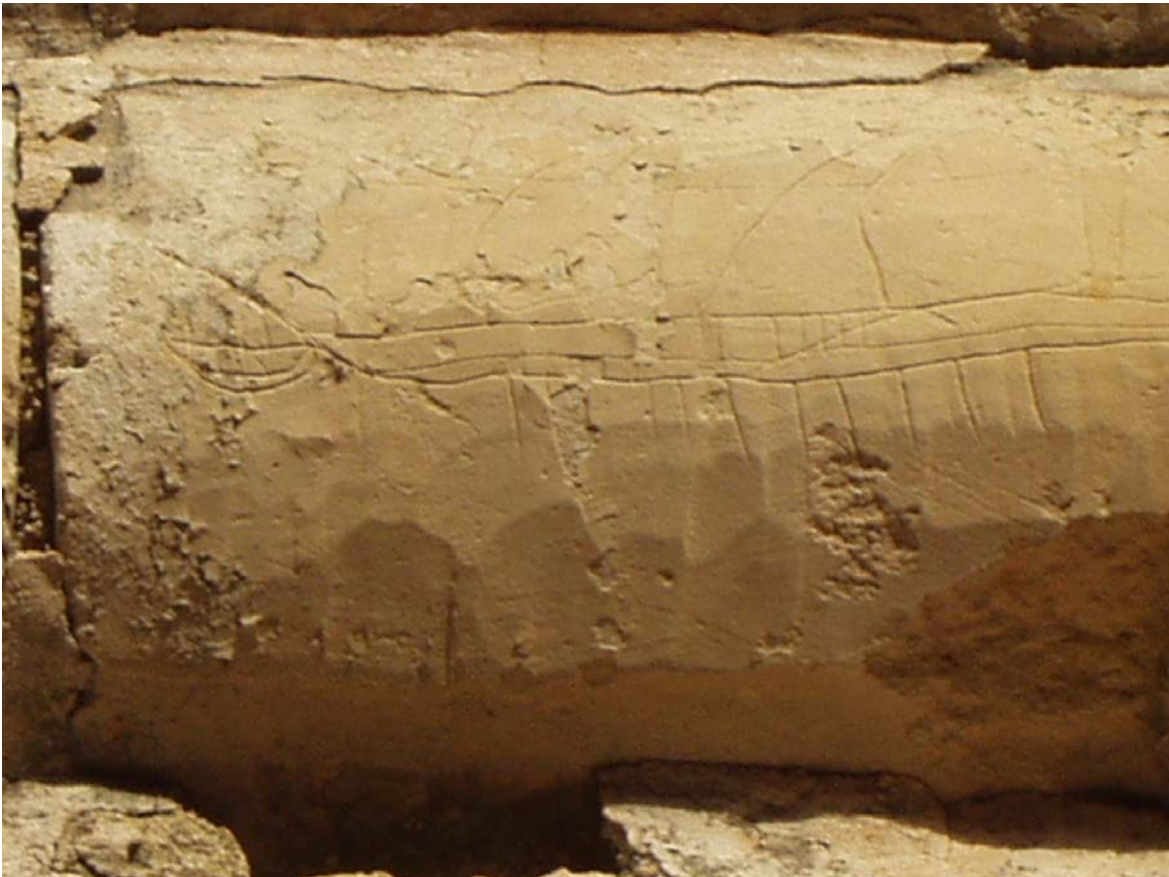
SS No1 4077	SS No2	Description 2 stables adjacent to each other with east facing entrances. A manger is found in the exterior wall, whilst another 2 mangers with loop holes are found inside. 2 enclosed animal pens are located outside each of the stables. In the northern room a graffito carries the date of 19 April 1935, whilst another graffito portrays some type of sailing ship/boat.
SS No4	SS No3	
Date of survey sheet: 1992

This structure is also in a bad state of preservation.

Condition
Bad

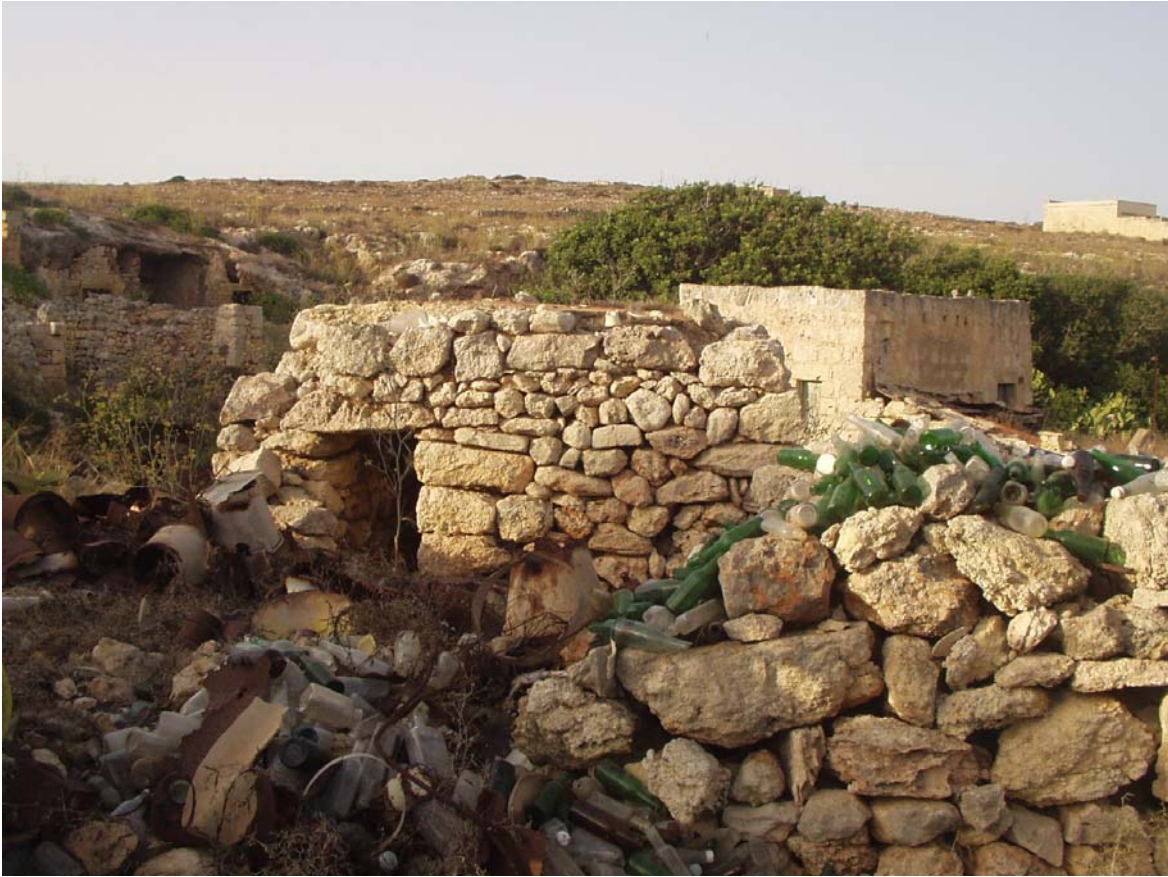
Location Ix-Xagħra I-Hamra	Category Rural	Site Description (Address) Corbelled hut at Ix-Xagħra I-Hamra, Manikata
Eastings 4118	Northings 7758	Period unknown
SS No1 4077	SS No2	Description Corbelled hut built on a rectangular plan with a west facing doorway. The roof is rendered in Deffun.
SS No4	SS No3	
Date of survey sheet: 1992

The corbelled hut is in a fairly good state of preservation.

Condition
Good

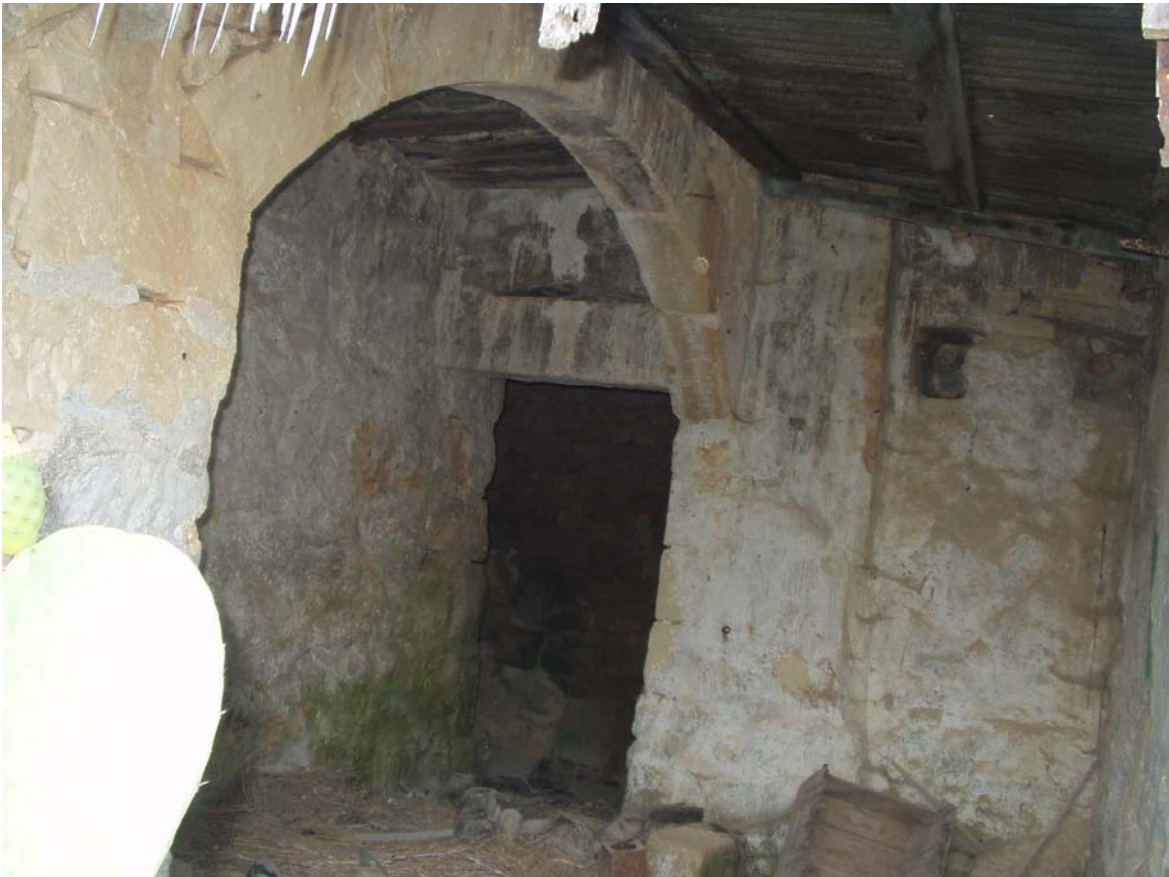
MNK05_080f

Farmhouse complex consisting of 2 large groundfloor stables with south facing entrances and an additional room to the east. Mangers are located inside the stables. An exterior staircase leads up to an open terrace and a 1st floor room utilised for domestic dwelling. The building is roofed in the traditional methods using corbels, wooden beams and roof slabs as well as supporting arches. The 1st floor room contains a number of niches and cupboards built into the thick walls. A gateway divides this structure from another structure located to the south which consists of a 2 storey building similar to the one already described. The second building is inaccessible due to various collapses and overgrowth.

The first building is in a fairly good state of preservation with the roofs still intact.

Condition
Fair
