**ENVIRONMENTAL IMPACT ASSESSMENT FOR
THE PROPOSED GOLF COURSE
AT IX-XAGHRA L-HAMRA AND TAL-QORTIN,
I/o MELLIEHA.**

Technical Appendix 4: Cultural Heritage Baseline Survey

**Prepared by
Kevin Borda
Marlene Borg
Daniel Borg
Joseph Calleja
Clive Vella
Ernest Vella
of
Archaeological Services Co-operative Ltd**

**On behalf of
Malta Tourism Authority**

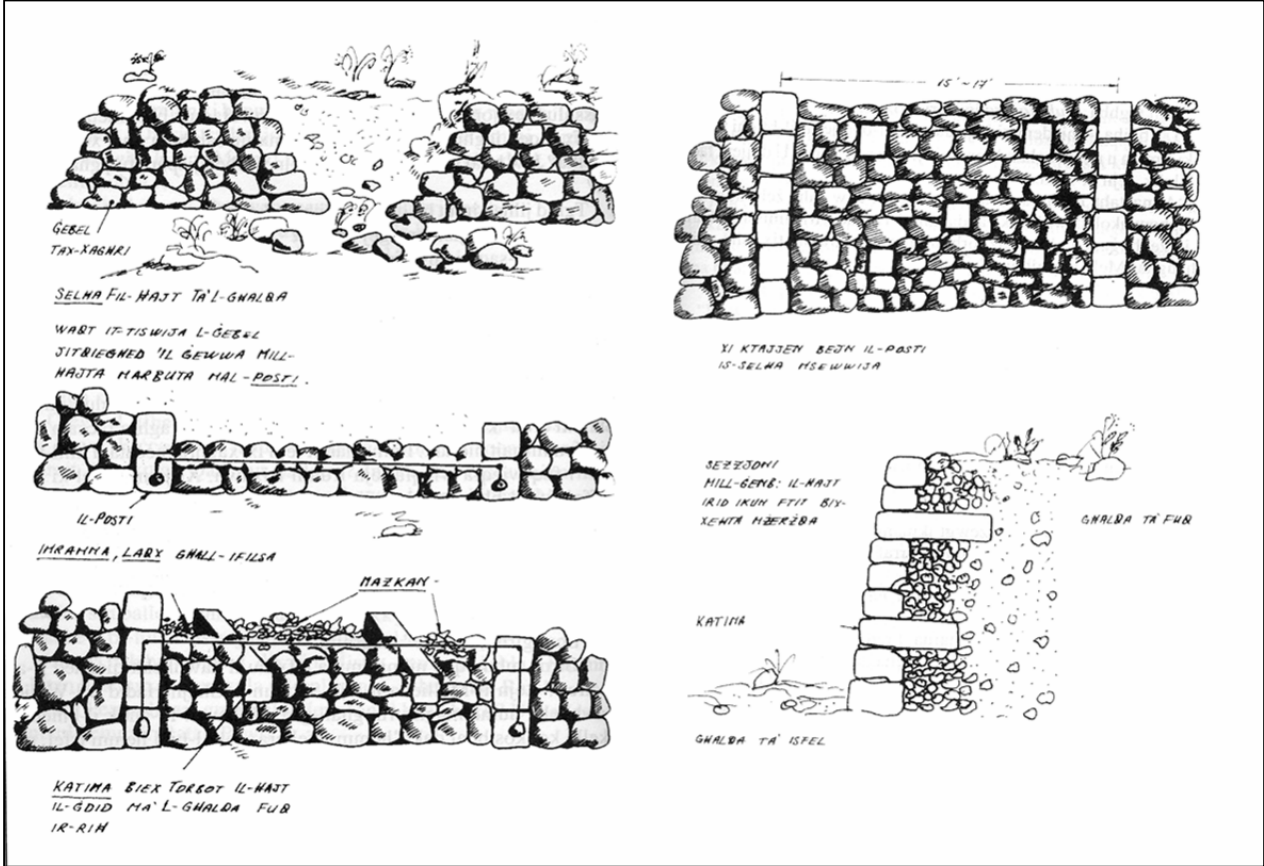
Figure 4: The building and repair of rubble walls (Borg 2000: 122, 123)

- 1.82. Rubble walls were built using irregular shaped blocks of stone packed and locked together without the use of mortar or plaster. These irregular blocks were held together with the use of larger stones inserted into the width of the wall, keeping together the two skins of the wall and the internal filling. This was known as katina. It was inserted every 2 metres and was about 1 metre in length and 0.25 metres wide. It was also important to keep the wall as vertical as possible with no slanting sections. A row of regular stones (posta) was built on top of each other as shown in **Figure 4**. These columns were placed 5 m apart (Borg 2000: 128). The rubble walls in the area under study were built using these techniques. **Figure 5** shows the rubble walls in the Area including their classification, which is described in the subsequent section.

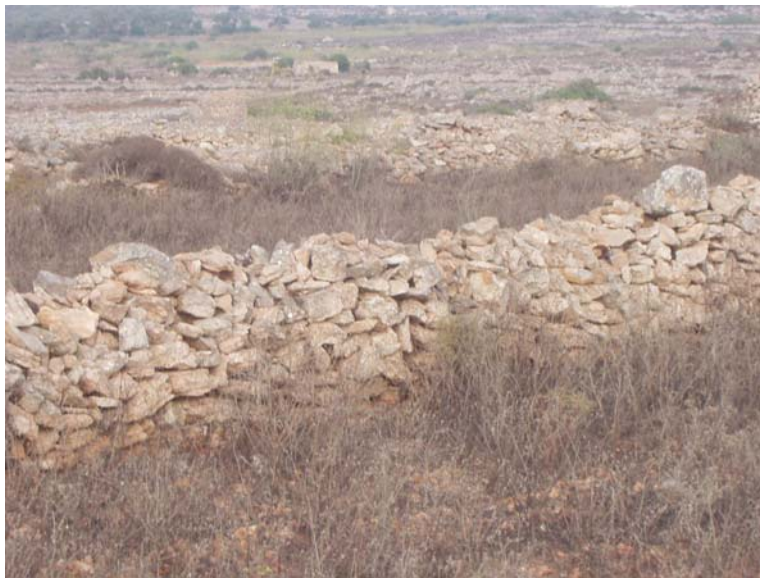
Figure 6: Grade A rubble wall

- I.85. The state of preservation of the rubble walls indicated as Grade A, ranges from good to fair condition. These walls still retain a large percentage of the original stonework, which may vary from 85% to 65% of the whole (See **Figure 6**).

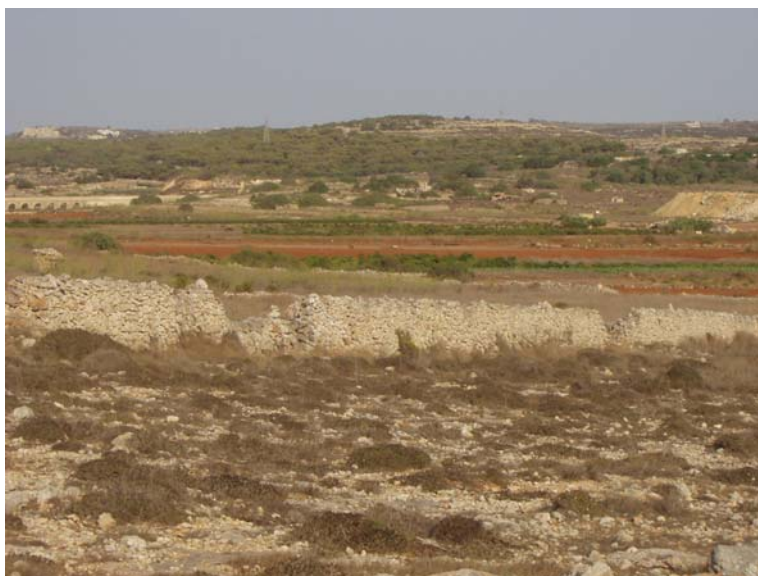
Figure 7: Grade B rubble wall

- I.86. Grade B walls range from fair to poor condition. These walls still contain part of the original stonework but have parts either restored with new blocks of stone or are still in a partly demolished state. The amount of original stonework varies from 64% to 35% of the whole (See **Figure 7**).

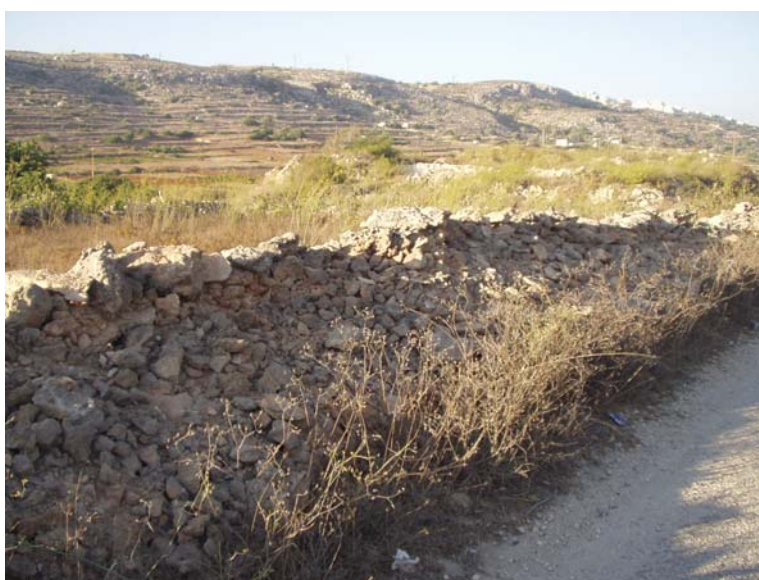
Figure 8: Grade C rubble wall

- I.87. These walls are in a bad state of repair and in some cases they consist of slight traces of wall only. The amount of original stonework varies from 34% to 10% of the whole (See **Figure 8**).

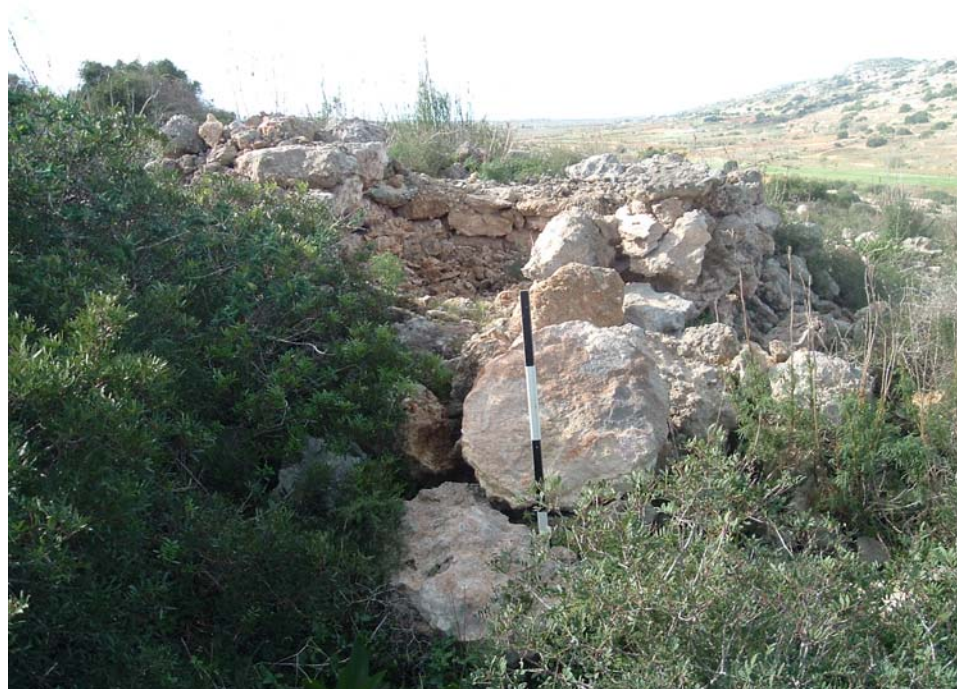
Figure 11: Scheduled Corbelled Hut at Xemxija (now collapsed)

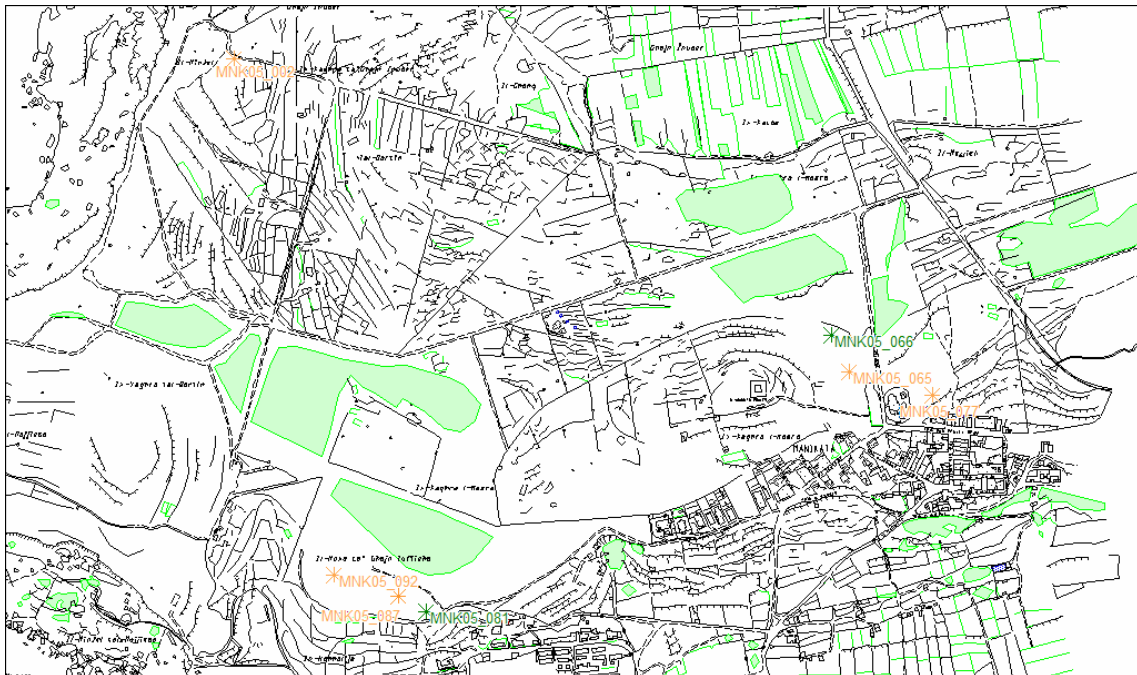
Figure 17: Cartruts

- I.131. It should also be noted that these cart ruts are occasionally associated with other features (for example feature **MNK05_077**) that are related to the quarrying activity and include a number of large boulders. Other ruts are associated with quarrying marks in the same area, such as features **MNK05_006** and **MNK05_053**; feature **MNK05_65** has been interrupting by quarrying (**MNK05_066**). Quarrying at **MNK05_078** is close to cart ruts **MNK05_081** and **MNK05_087**. The quarrying marks at **MNK05_091** are nearby cart ruts **MNK05_092**. These location relationships further strengthen the idea that the cart rut phenomenon is strongly associated with quarrying. The exact relationship remains unclear: it could be either part of the technique to extract stone or the effect on the landscape of transporting heavy loads over the same area.

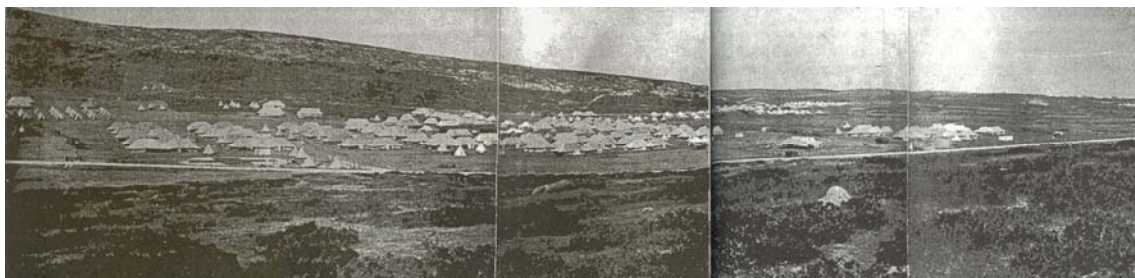
The convalescent camp at Ghajn Tuffieha (Mizzi 1991: 132-133)

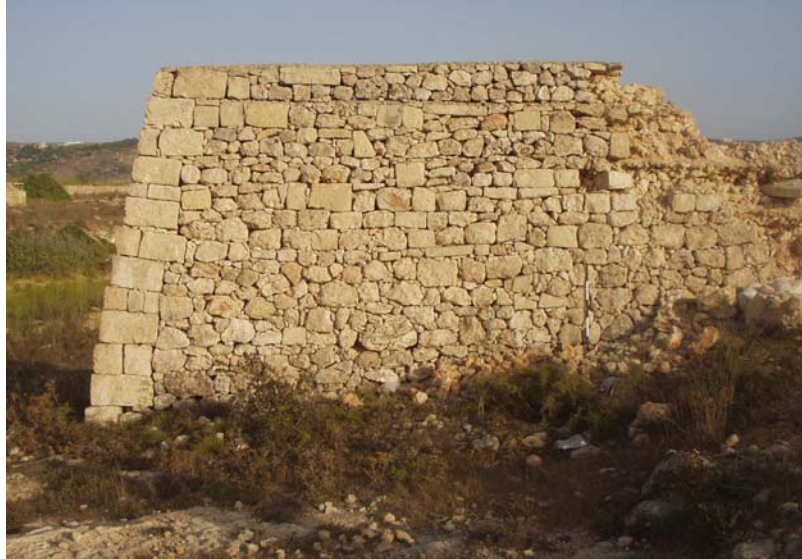
Figure 21: Entrenchment MNK05_094 similar in construction to the technique shown in Figure 12

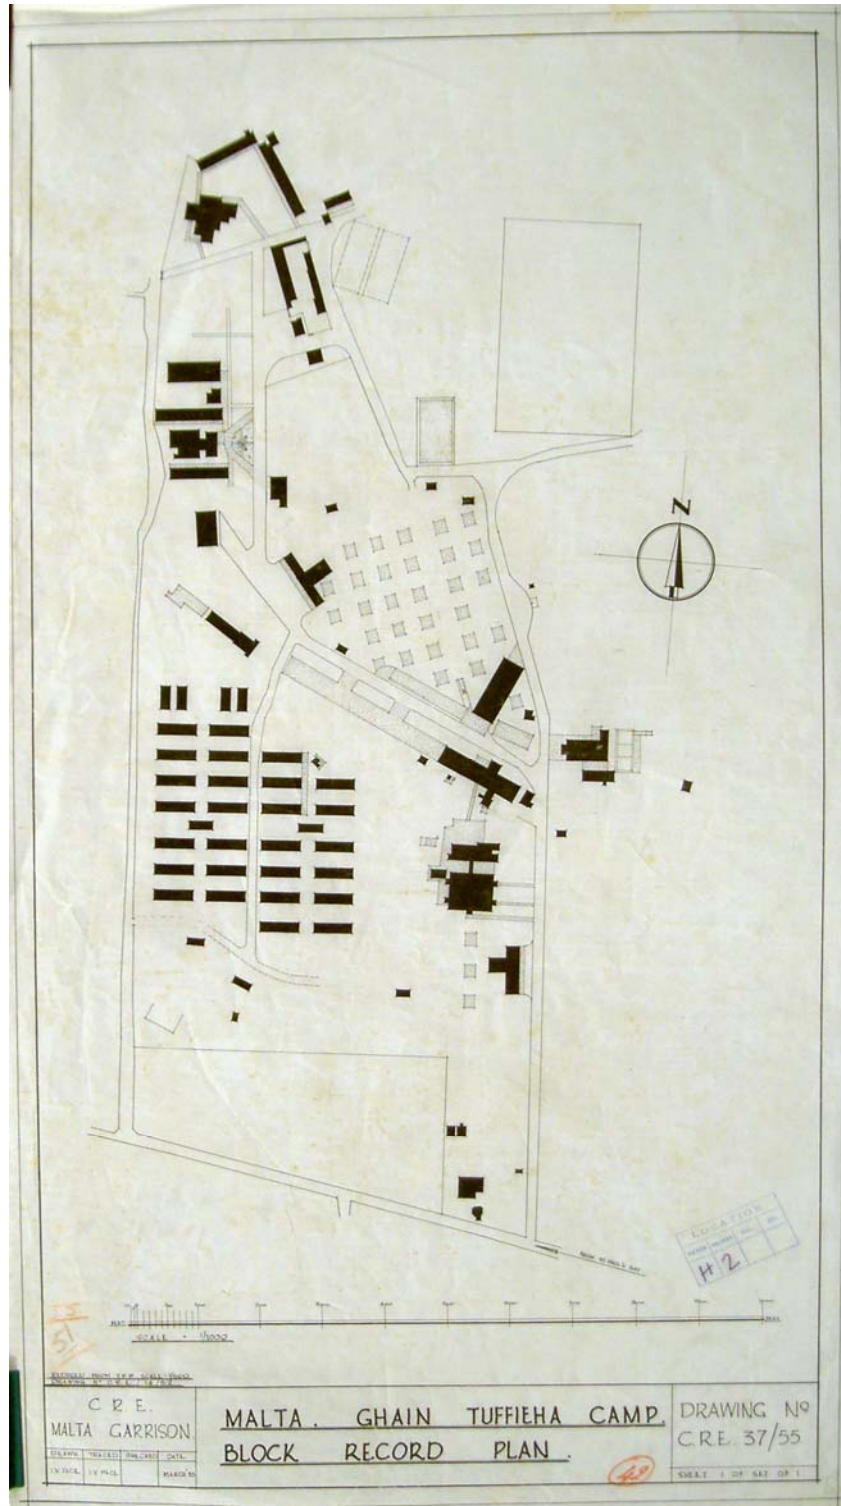
Figure 23: Drawings for the construction of Barracks at il-Kamp ta' Ghajn Tuffieha (Hal Ferh tourist complex)

- I.148. The barracks **MNK05_085** and **MNK05_099** dating to the British Period are similar in style to other barrack blocks located elsewhere on the island. However, these are the only example of this type of architecture in the area - other barracks are found south of the Great Fault. The barracks, particularly **MNK05_085**, contain a number of architectural features typical of the neo-classical style adopted by the British during their occupation of the islands. This barrack complex (MNK05_085) probably retains all of the buildings constituting the original layout: the communal sleeping quarters, officers' quarters, main barrack blocks and a probable parade ground. It is noted that most of the barracks in the Pembroke area and those in the Cottonera have been protected under the Development Planning Act and graded Level 1 or 2.
