Location Ix-Xagħra I-Ħamra, Manikata	Category Rural	Site Description (Address) Corbelled hut at Ix-Xagħra I-Ħamra, Manikata
Eastings 4112	Northings 7800	Period unknown
SS No1 4078	SS No2	Description Circular corbelled hut with its entrance facing east. It has a flat lintel on the doorway. The roof has been cemented over. It is inaccessible so it was not possible to examine the hut closely.
SS No4	SS No3

Date of survey sheet: 1992

Date of Survey

08.08.2005

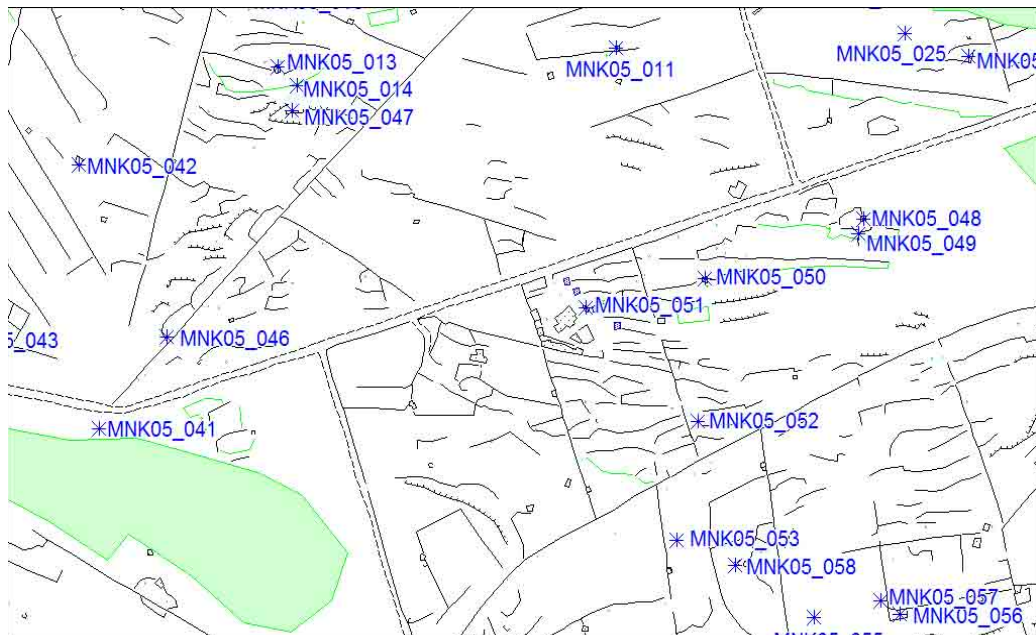
Good and well kept

Grade 1

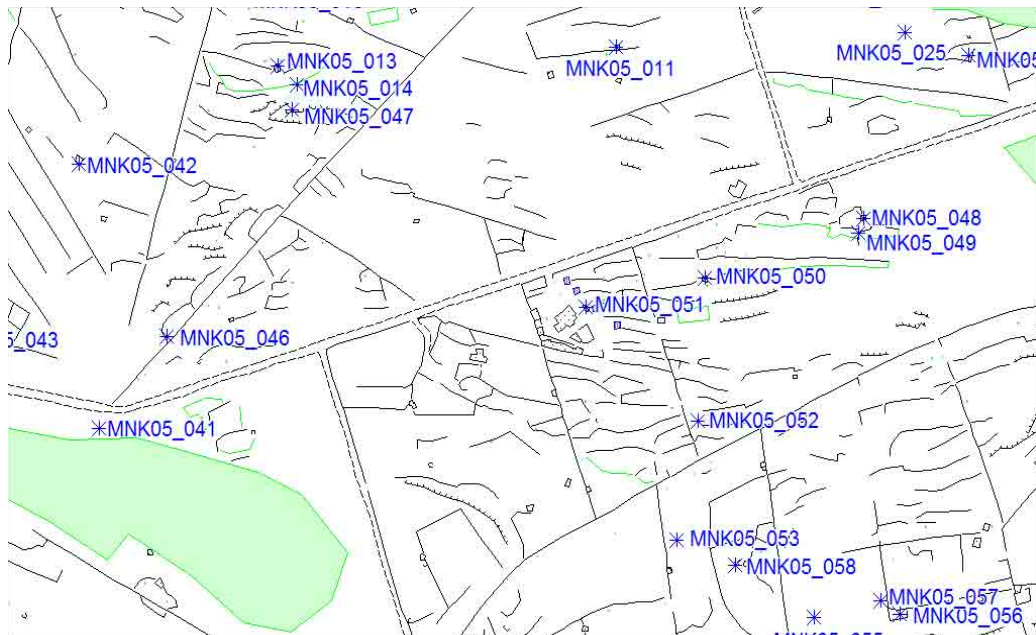
SS No1 4077	SS No2	Description Traces of surface quarrying consisting of straight ledges of rock and heaps of stone chippings typical of surface quarrying in the late early modern period. One of the two stone heaps is covering a channel cut in the rock. The quarried area has been covered in soil and transformed into terraced fields. These have been abandoned.
SS No4	SS No3

Condition
Fair

Proposed Protection
Grade 3

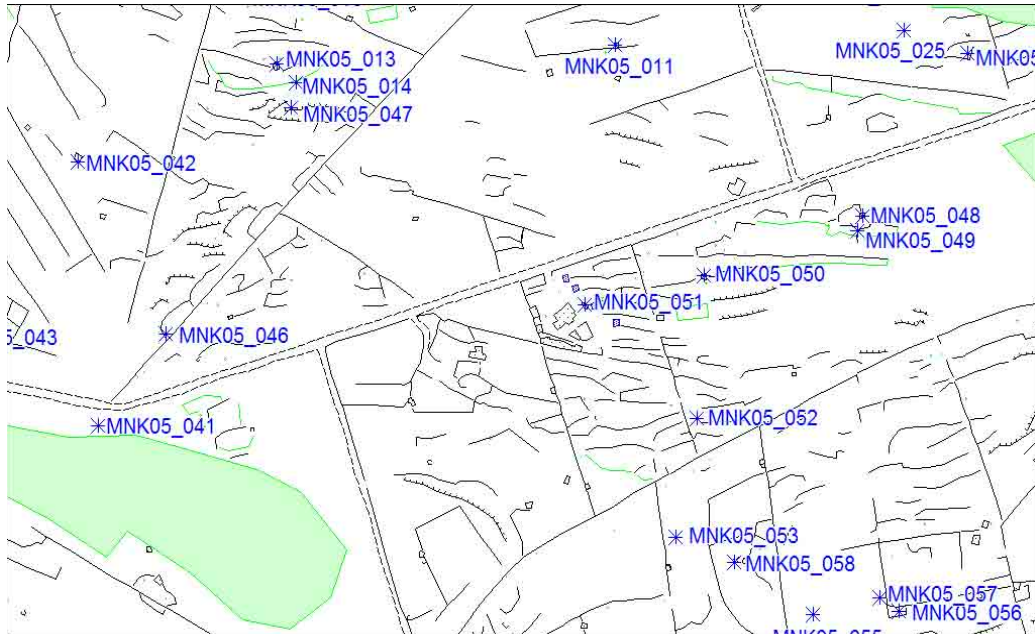
MNK05_053

SS No1	SS No2	Description
4077		A garrigue area enclosed by rubble walls showing signs of quarrying and a pair of intermittent cart ruts. There are also stone heaps similar to MNK05_052. The cart ruts run in a north-south direction. To the south of these ruts is an artificial ledge in the rock surface that is bordered by an irregular wall built of large boulders.
SS No4	SS No3

Fair

Grade 2

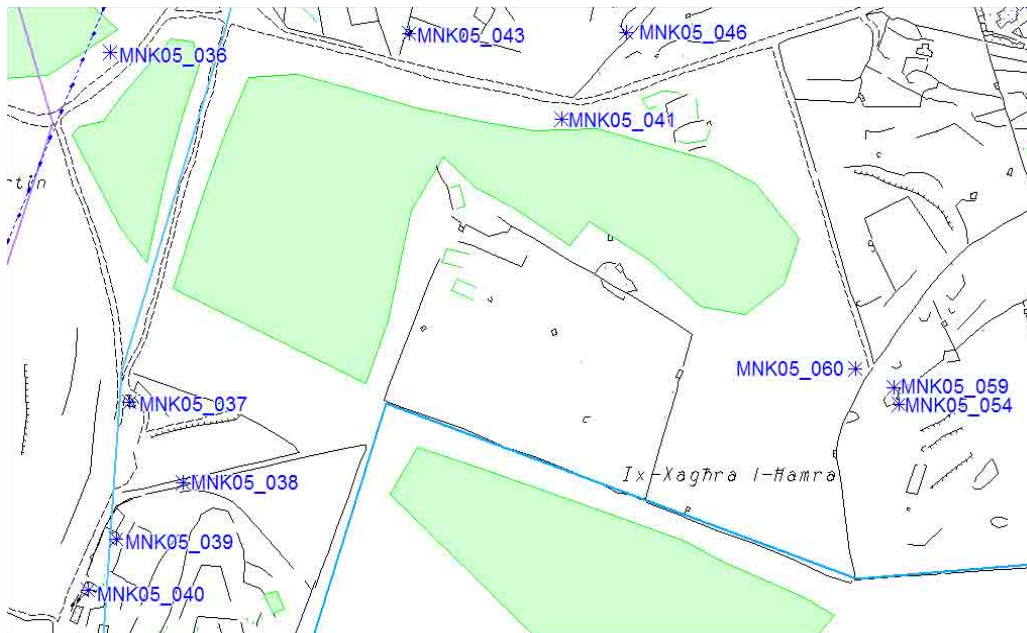
MNK05_054

Location Ix-Xagħra I-Hamra, Manikata	Category Rural	Site Description (Address) Corbelled hut at Ix-Xagħra I-Hamra, Manikata
Eastings 4104	Northings 7775	Period unknown
SS No1 4077	SS No2	Description A circular corbelled hut with its entrance facing south. The doorway has a triangular lintel and there is a window in the eastern wall. There are a number of irregularly shaped depressions in the rock surface similar to those noted near other huts in the area under study. On the northern part of the hut is an unclear overgrown depression.
SS No4	SS No3	
Date of survey sheet: 1992

Good

Grade 1

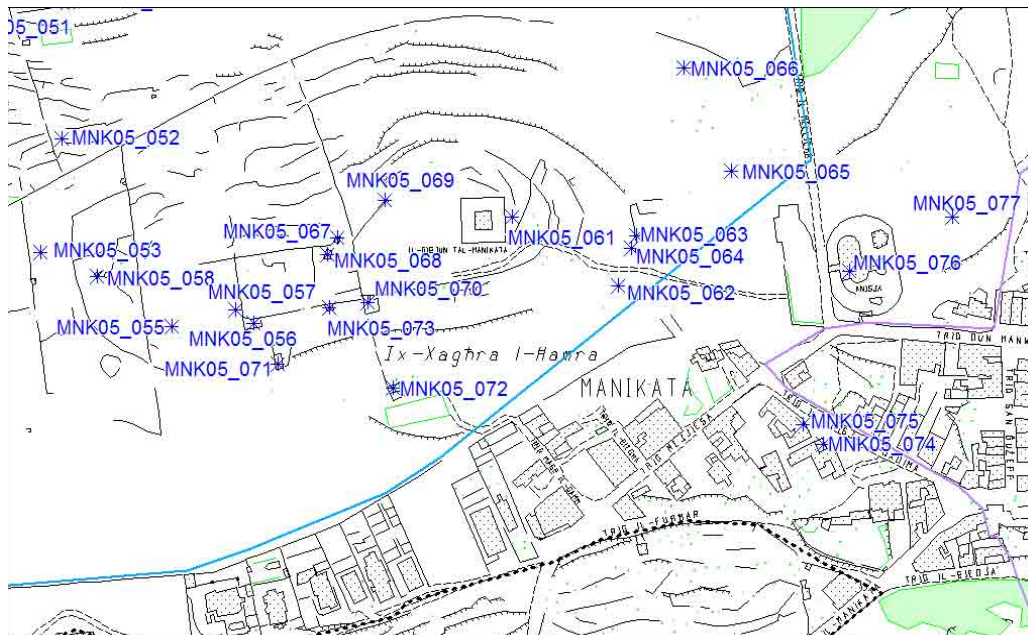
MNK05_055

Location Ix-Xaghra l-Hamra, Manikata	Category Structure	Site Description (Address) 4 possible cairns at Ix-Xaghra l-Hamra, Manikata
Eastings 4126	Northings 7781	Period Bronze Age (?)
SS No1 4077	SS No2	Description 4 possible cairns, one of which is in a better condition than the rest. The latter, which is the largest, has a thriliton entrance facing east.
SS No4	SS No3

Condition
Fair

Proposed Protection
Grade 1

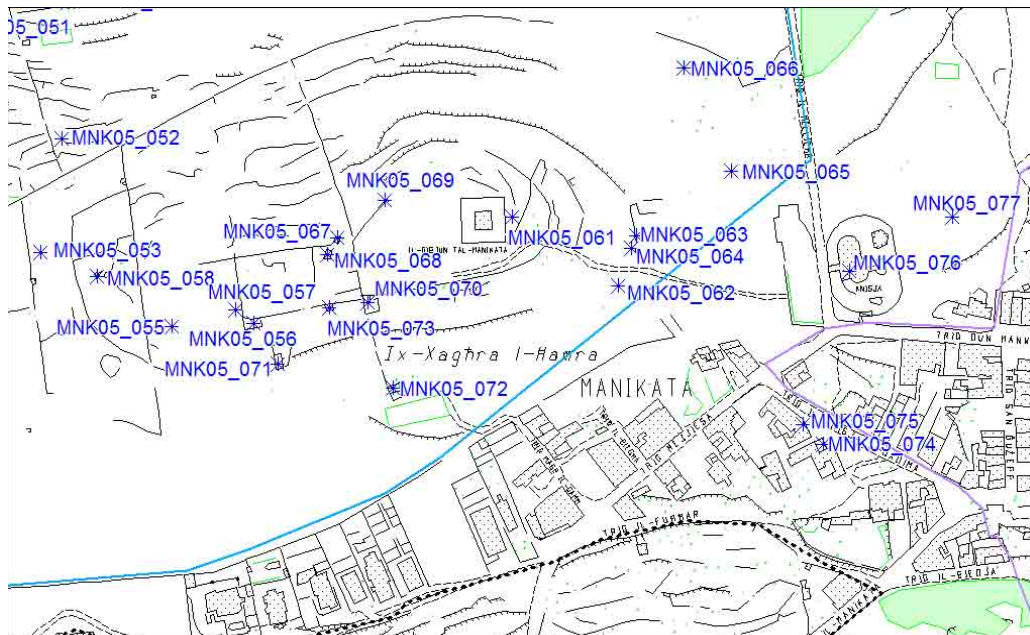
Location Ix-Xagħra l-Hamra, Manikata	Category Rock-cut	Site Description (Address) A small shallow quarry at Ix-Xagħra l-Hamra, Manikata
Eastings 4138	Northings 7782	Period unknown
SS No1 4077	SS No2	Description A small shallow quarry, later transformed into a terraced field or orchard. Quarrying reaches a depth of about 1m.
SS No4	SS No3

Condition
Good

Proposed Protection
Grade 3

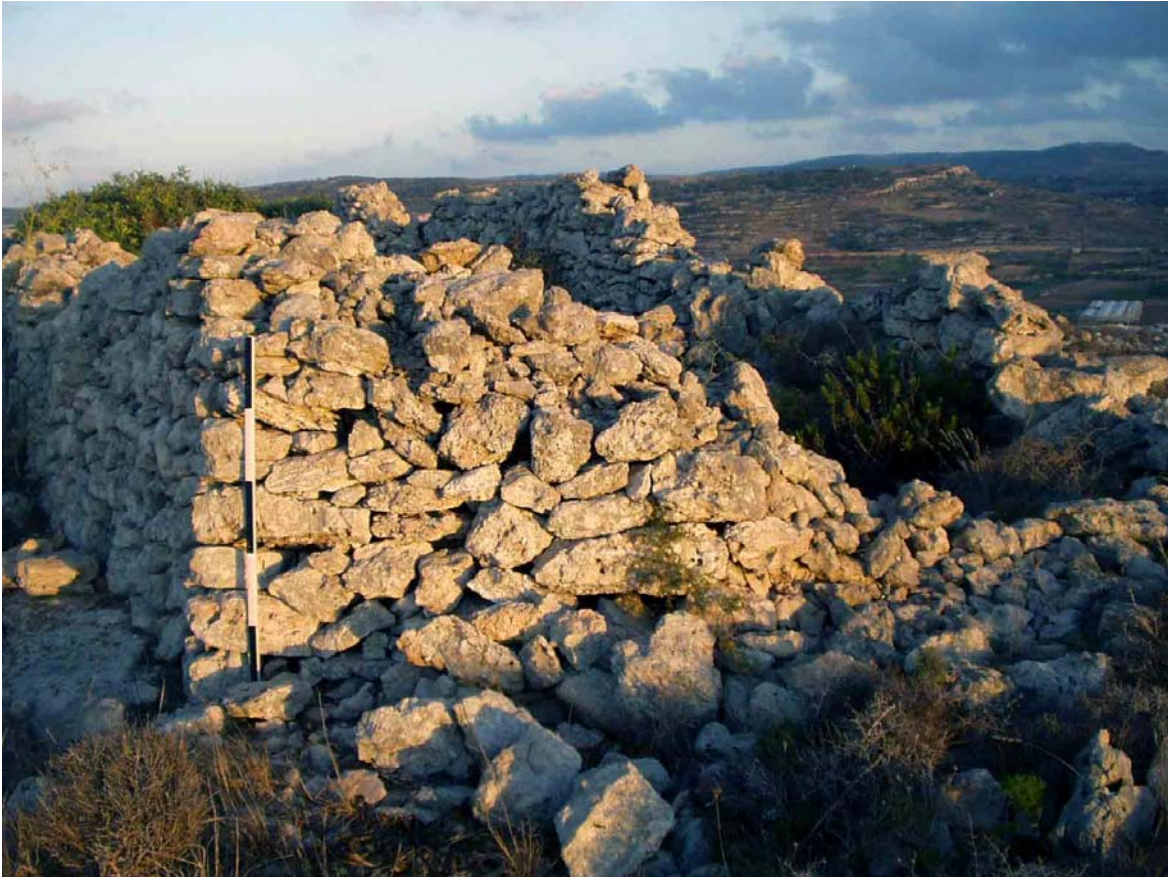
MNK05_057

Location Ix-Xagħra I-Hamra, Manikata	Category Rural	Site Description (Address) Remains of an Animal Pen at Ix-Xagħra I-Hamra, Manikata
Eastings 4131	Northings 7783	Period unknown
SS No1 4077	SS No2	Description Remains of an animal pen consisting of a single structure divided into 3 segments by a wall. The pen was built in the dry stone technique and only a few courses remain. Hence, the roofing method cannot be determined, as well the presence or absence of a manger. There are a number of small tunnels/air vents on the lowest course both sides of the structure.
SS No4	SS No3	
Date of survey sheet: 1992

Condition
Bad

Proposed Protection
Grade 3

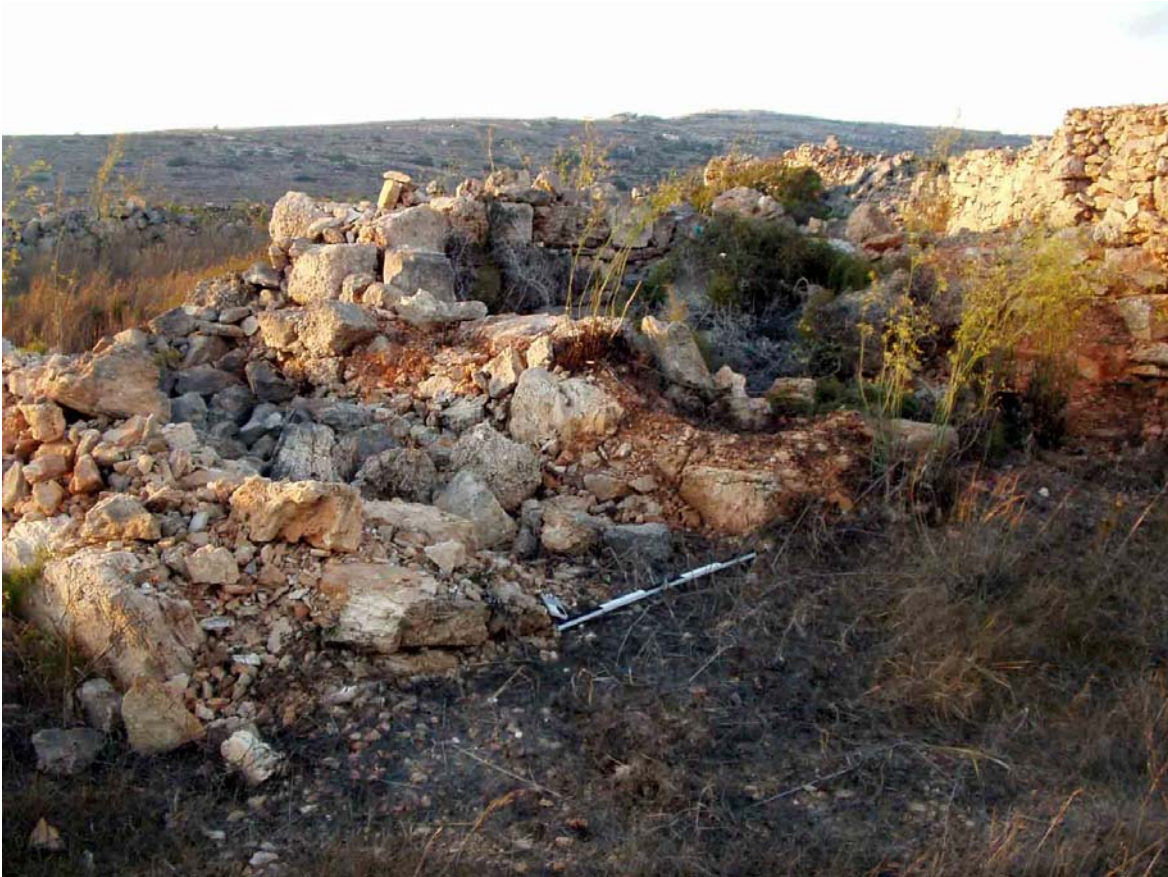
MNK05_058

Location Ix-Xaghra l-Hamra, Manikata	Category Rural	Site Description (Address) Two adjacent collapsed field rooms at Ix-Xaghra l-Hamra, Manikata
Eastings 4121	Northings 7785	Period unknown
SS No1 4077	SS No2	Description Two collapsed field rooms adjacent to each other. The entrance faced south. The stones from the collapse have been reused to built a trapping hut nearby.
SS No4	SS No3

Condition
Bad

Proposed Protection
Grade 3

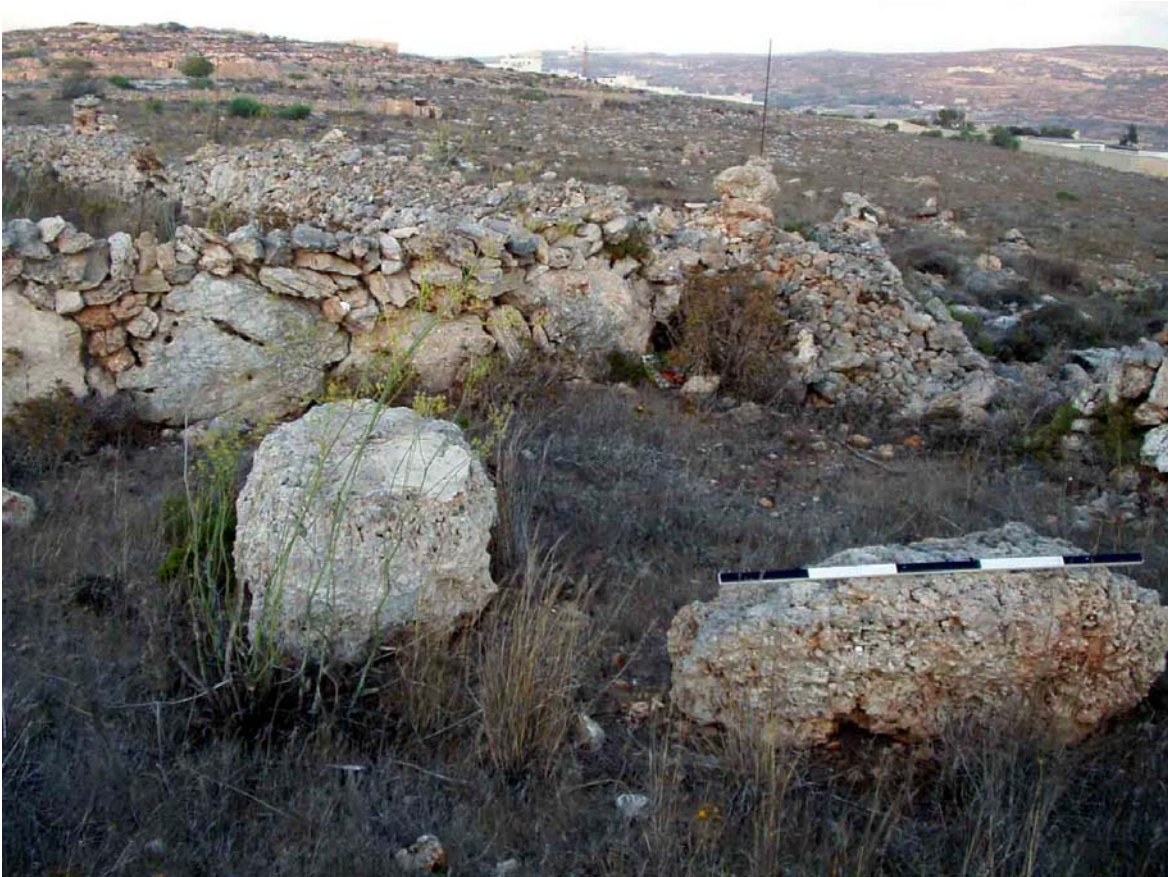
MNK05_059

SS No1	SS No2	Description
4077		Undressed boulders forming part of a rubble wall north east of corbelled hut MNK05_054. There are another three boulders in the field bordered by the same wall.
SS No4	SS No3

Condition
Fair

Proposed Protection
Grade 2

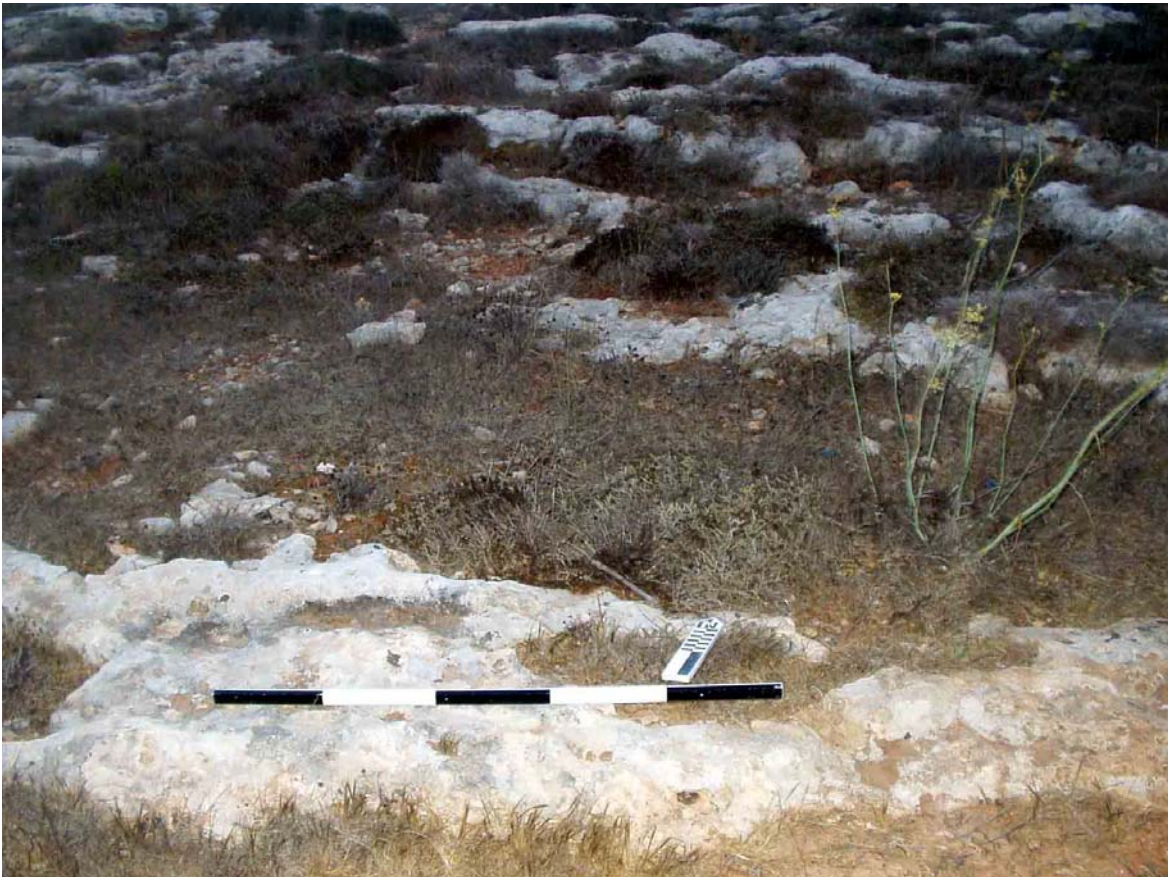
MNK05_060

Location Ix-Xagħra l-Hamra, Manikata	Category Rock-cut	Site Description (Address) Quarrying at Ix-Xagħra l-Hamra, Manikata
Eastings 4101	Northings 7777	Period unknown
SS No1 4077	SS No2	Description Traces of quarrying with tool marks, small holes and relatively straight-edged rocks.
SS No4	SS No3	
Date of survey sheet: 1992

Good

Grade 3
