Location	Category	Site Description (Address)
Tal-Qortin, Manikata	Rural	Corbelled Hut at Tal-Qortin, Manikata
Eastings	Northings	Period
4090	7838	unknown
SS No1	SS No2	Description
4078		Square plan corbelled hut with two entrances. The entrance to the south on road (MNK05_003) has been blocked while the second, which faces east has an enclosure in front of it. The hut is not accessible since this second entrance is closed by a wooden door. The door has two triangular lintels with a keystone in between, while the manger in the northern wall of the enclosure has two triangular lintels. The hut is exceptionally large and in fact is buttressed by a low wall. The hut has a second enclosure to the right of the first one. This was once roofed by some perishable material, of which only one wooden beam survives.
SS No4	SS No3	
Date of survey sheet:	1992

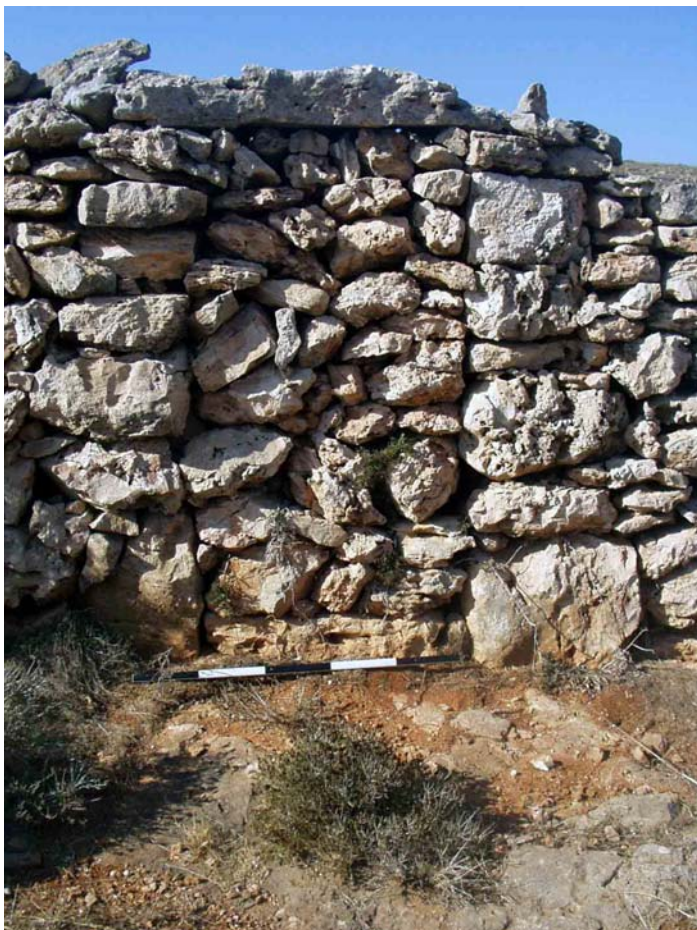
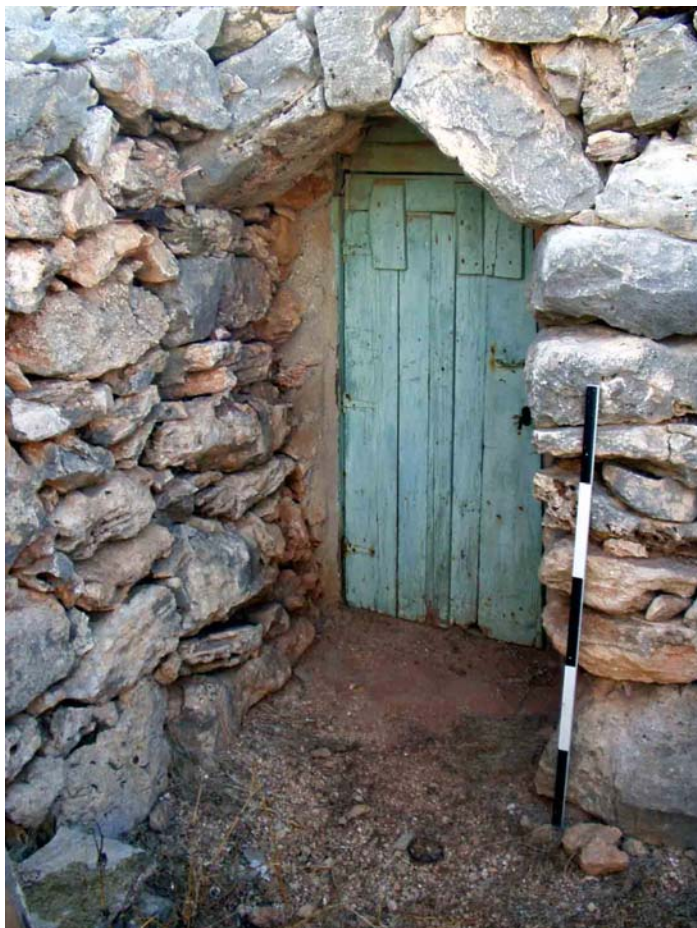
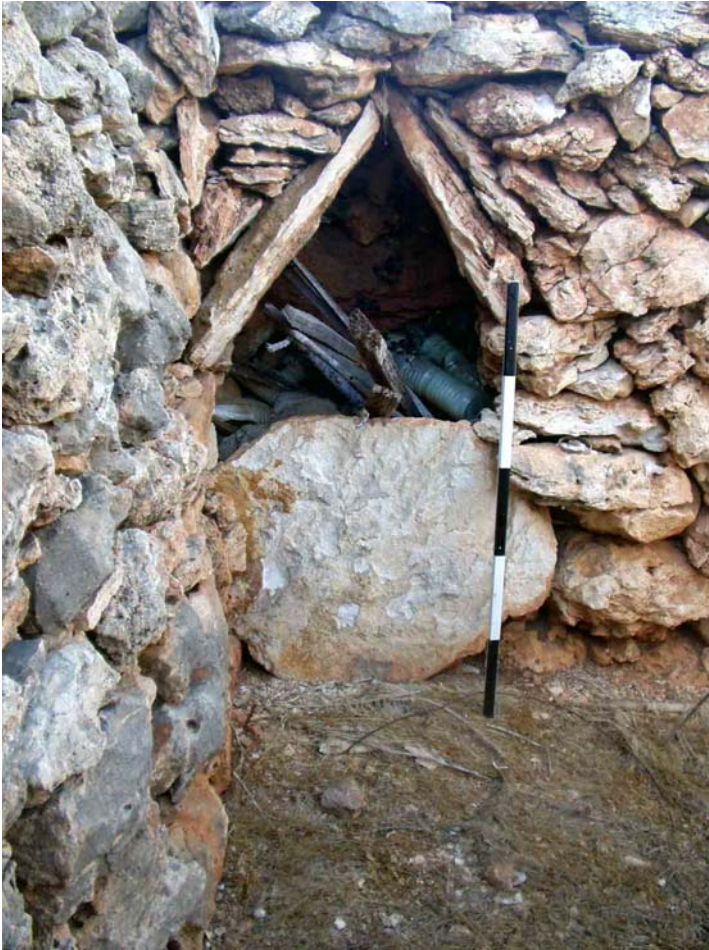
Condition
Good

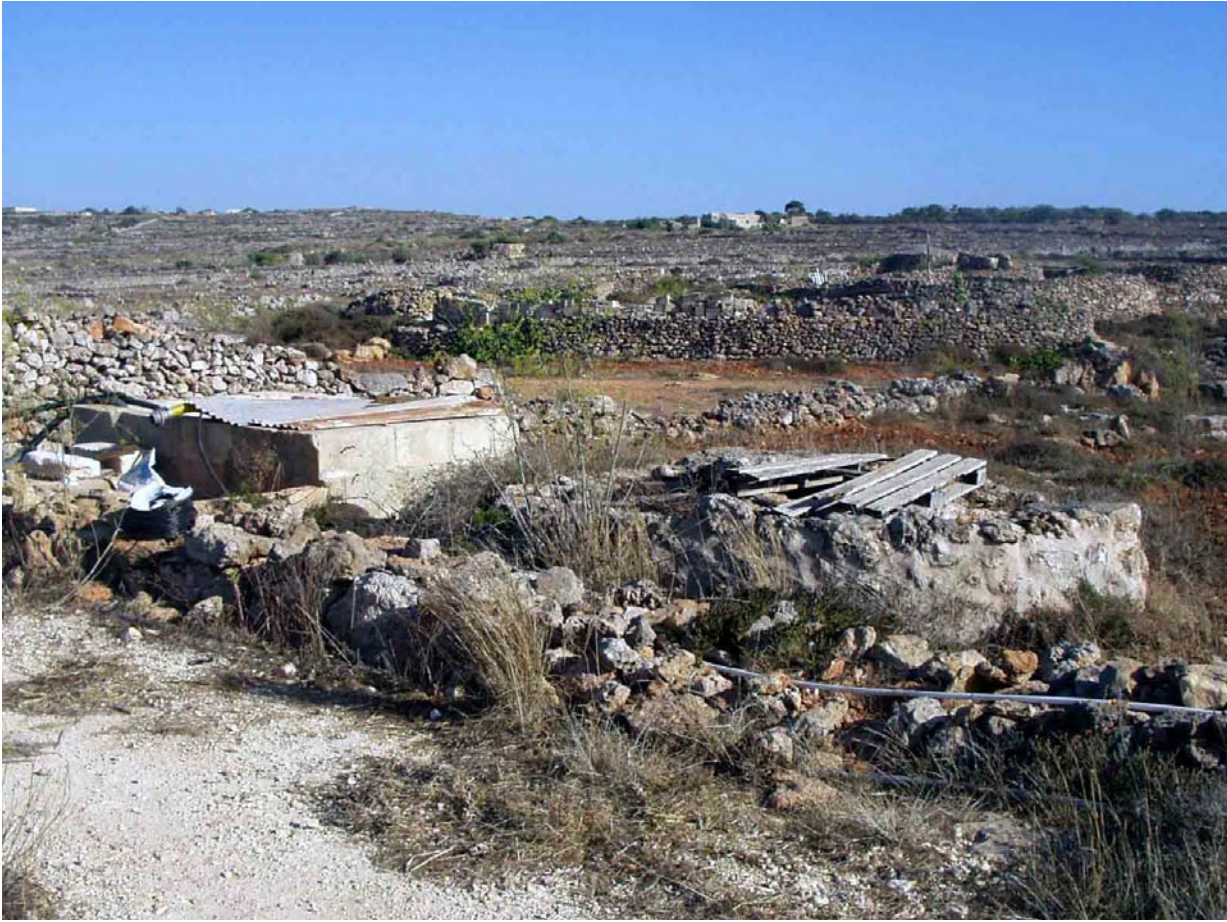
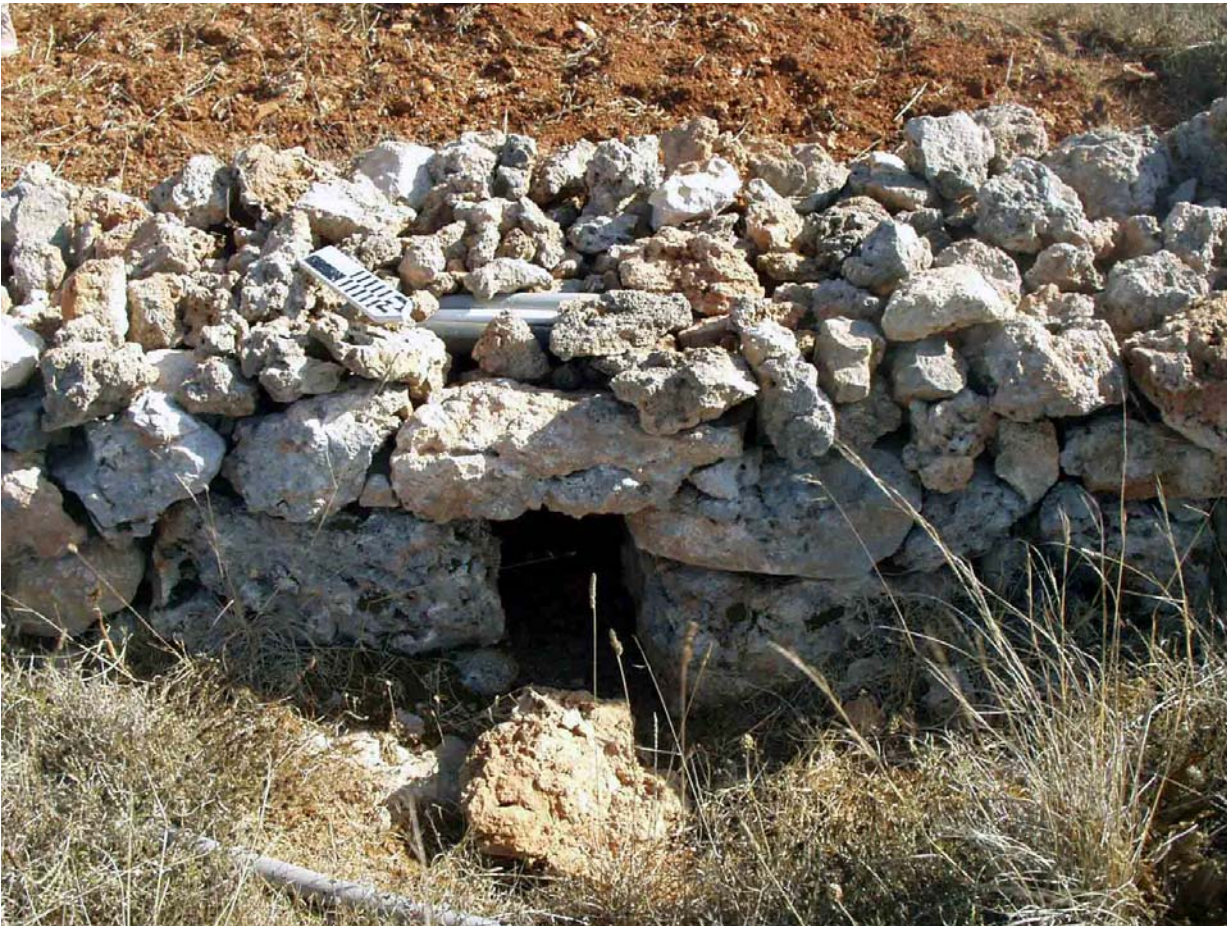
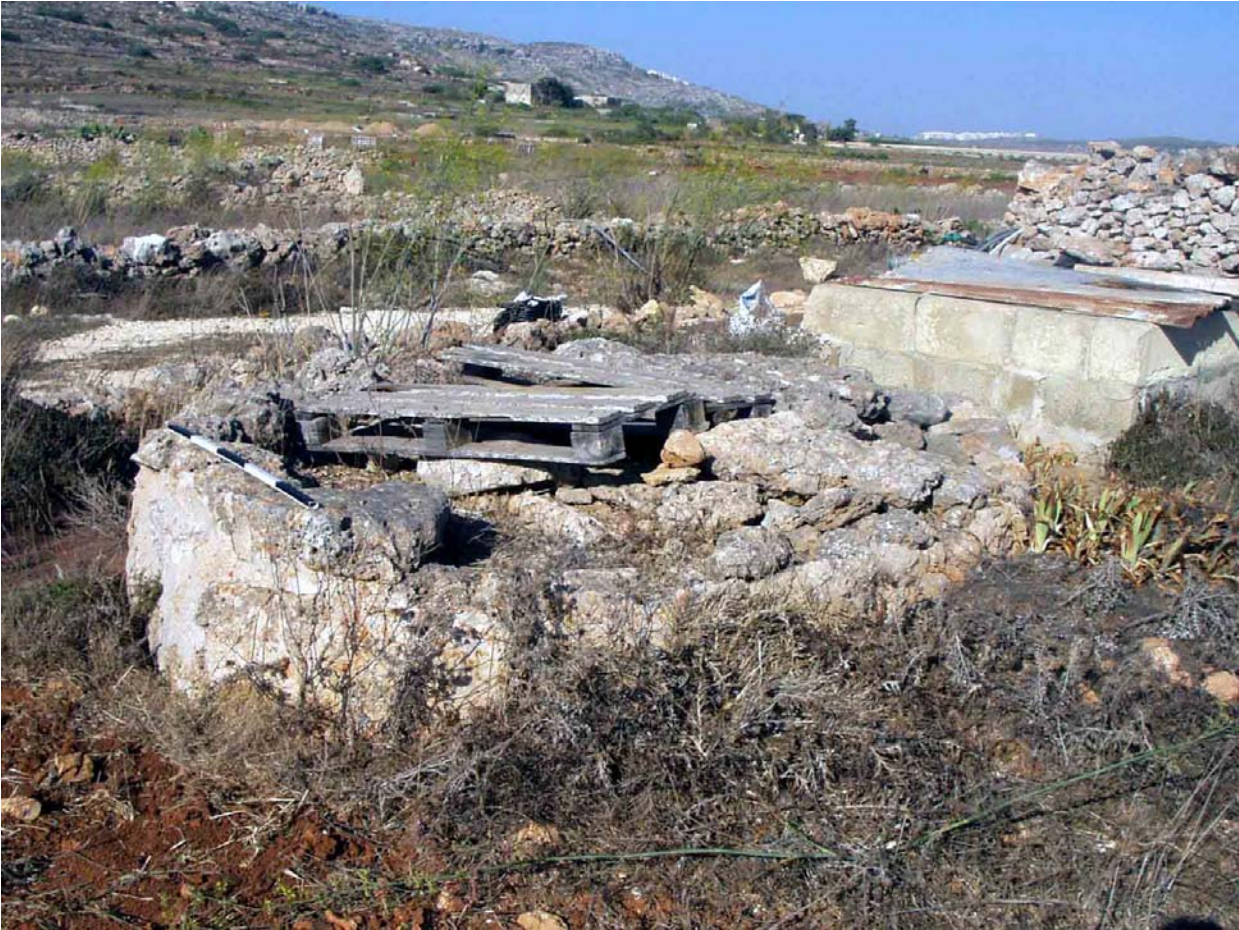
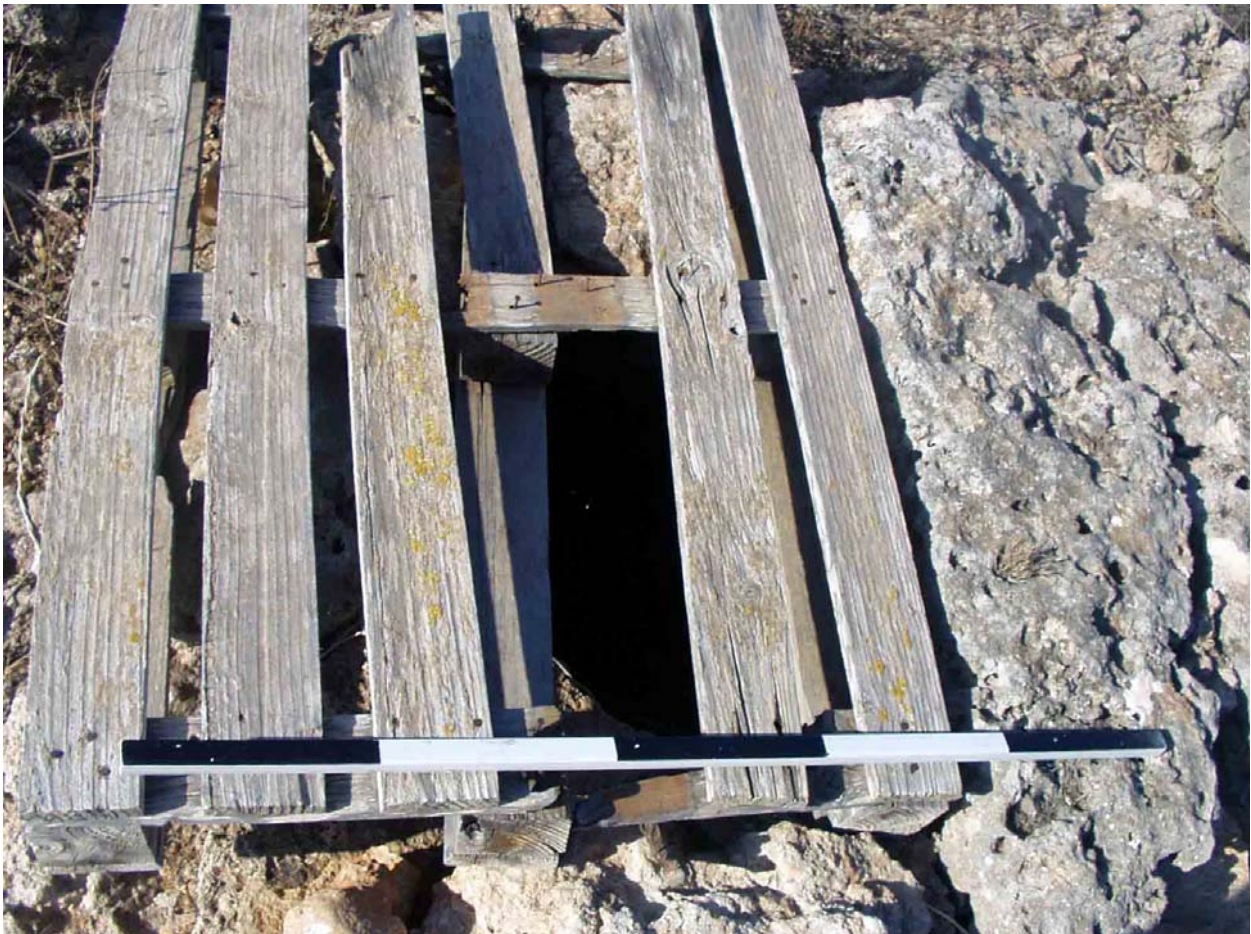
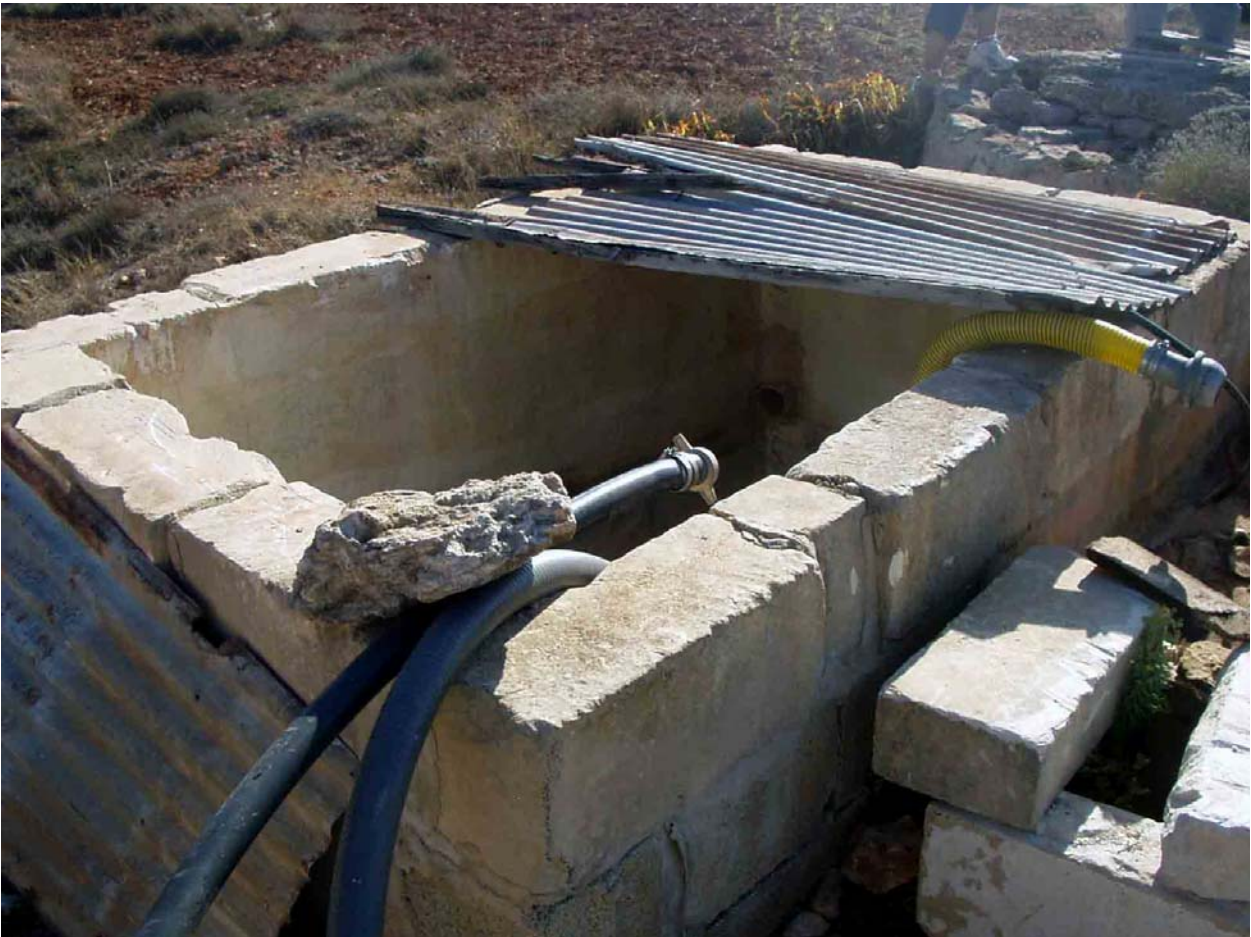
Location	Category	Site Description (Address)
Tal-Qortin, Manikata	Rock-cut	Bore Hole at Tal-Qortin, Manikata
Eastings	Northings	Period
4100	7834	unknown
SS No1	SS No2	Description
4078		Bore hole along road MNK05_003. It has a circular well-head, built of rubble which was plastered with deffun, and later cement. The opening of the well-head was covered with stone slabs, 2 of which are still extant. In the rubble wall, beside the well head is a channel to collect water from surface runoff. A modern bell-shaped well has been dug beside it to collect the water overflowing from the bore hole. This is shown by a connecting channel dug in the walls of the bell-shaped cistern in the direction of the borehole. Contemporary pipes leading to different fields show that this is still in use.
SS No4	SS No3	
Date of survey sheet: 1992

The bore hole was full of water at the time of survey

Condition
Good

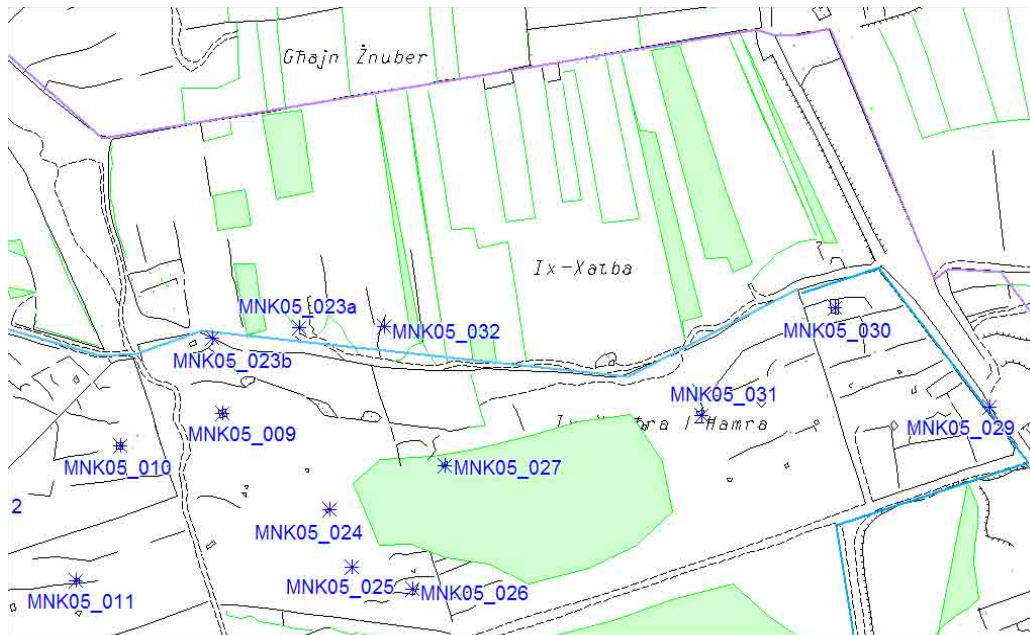
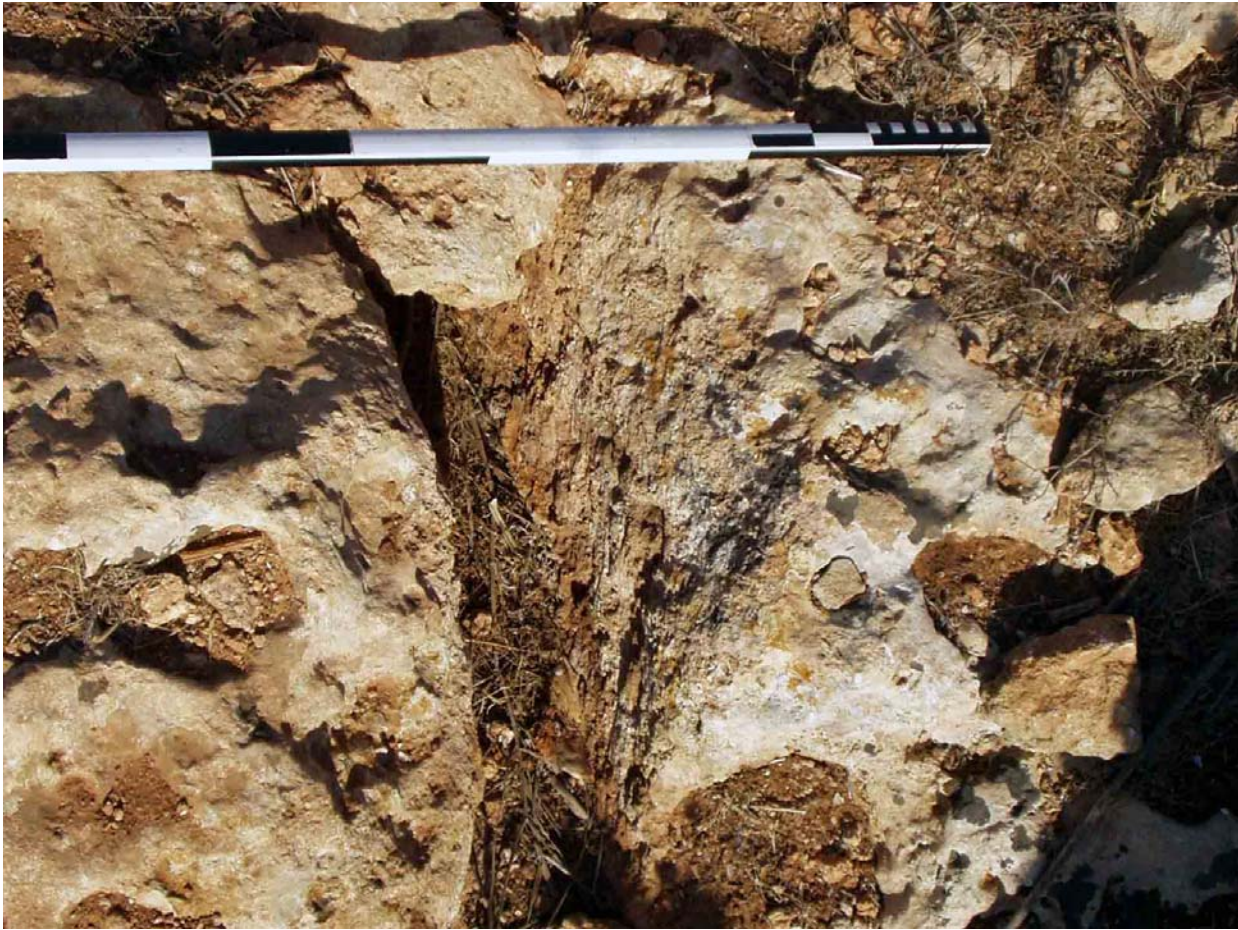
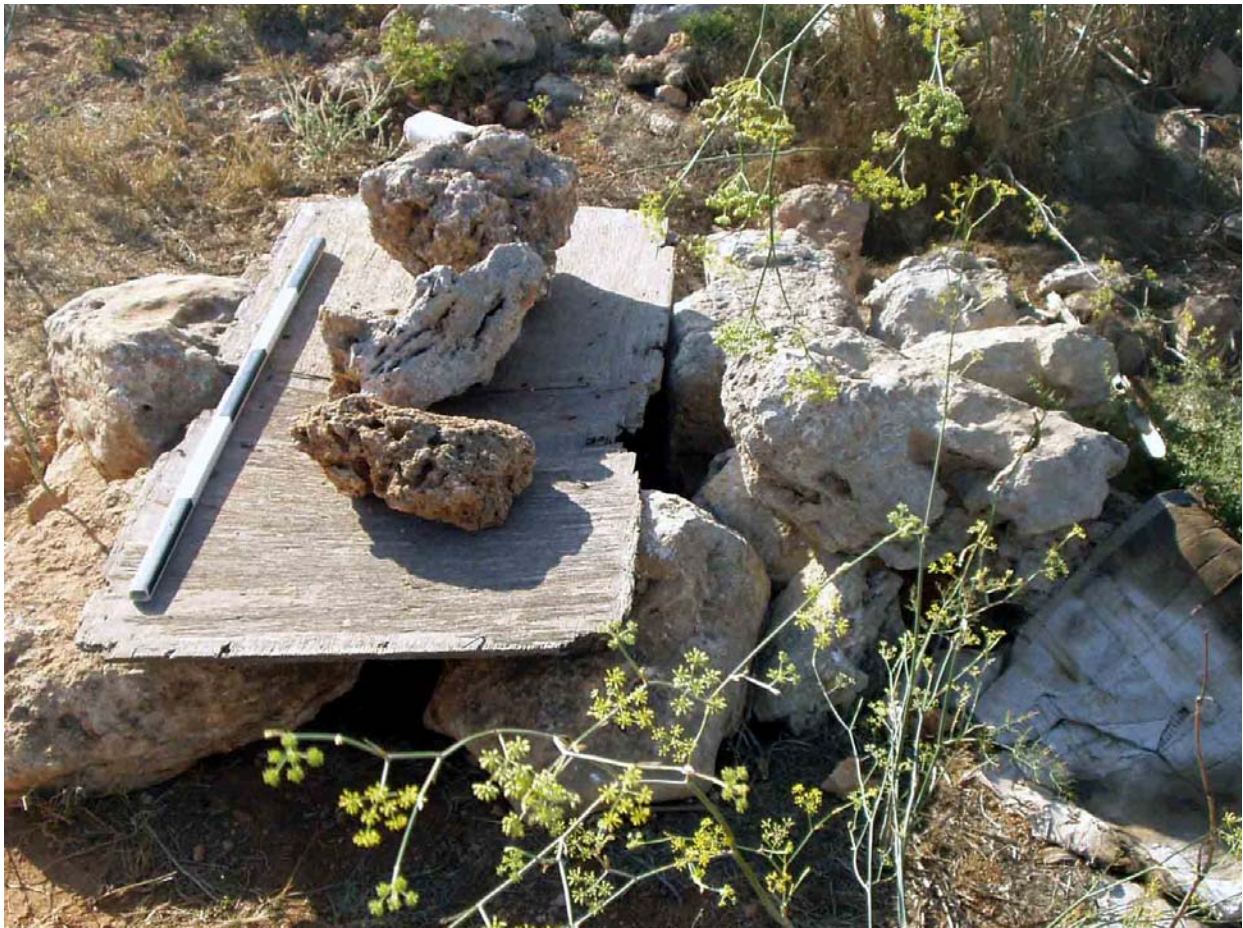
Location Ix-Xatba, Manikata	Category Rock-cut	Site Description (Address) Water Channel (b) and Well (a) at Ix-Xatba, Manikata
Eastings 4123	Northings 7831	Period unknown
SS No1 4078	SS No2	Description Water channel (b) dug into the country track leading to a well (a). The well head consists of a built wall, one course high and partly constructed with medium sized boulders as well as with well-dressed squarish stones.
SS No4	SS No3

Condition
Fair

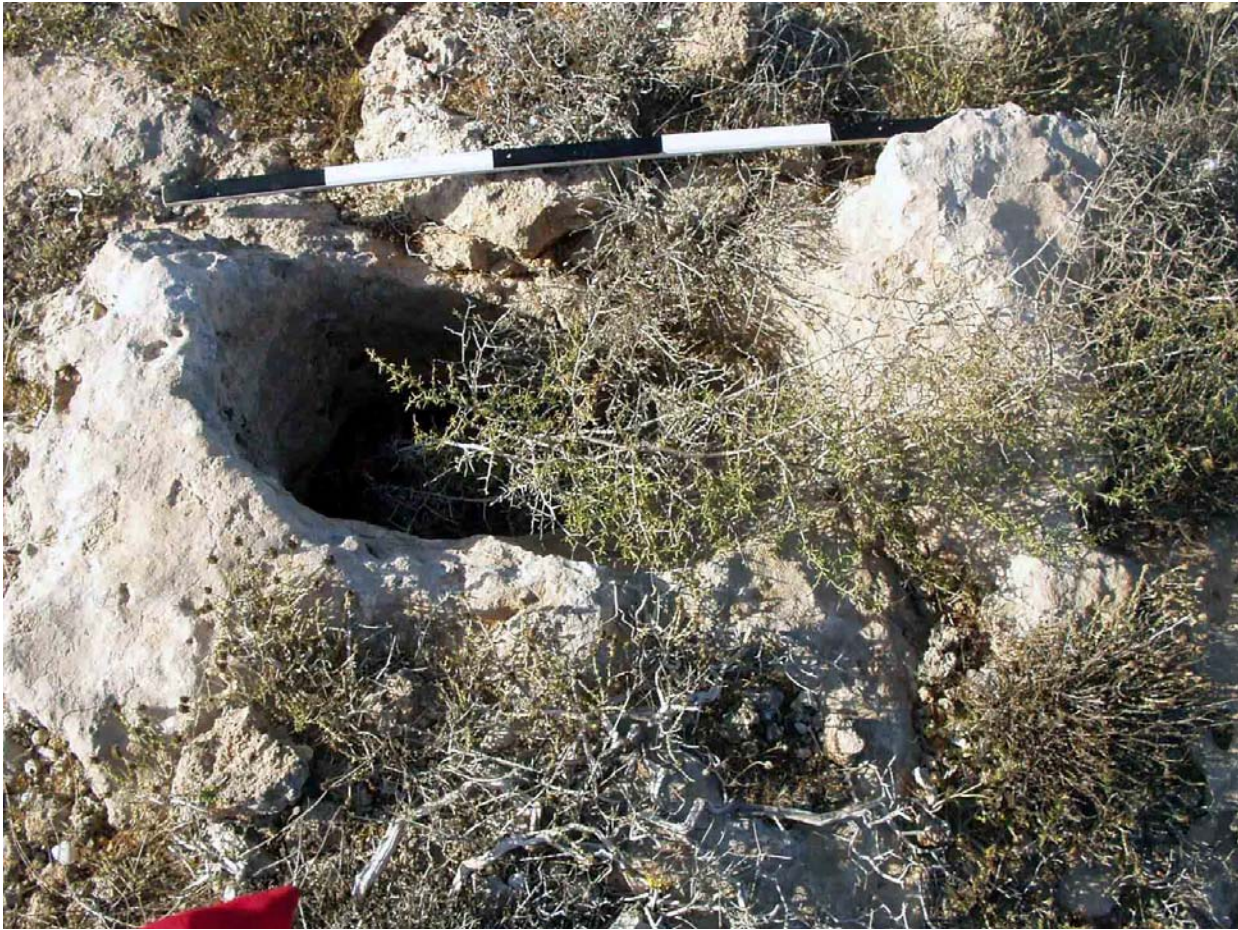
MNK05_024_001

Location Ix-Xagħra I-Ħamra, Manikata	Category Rural	Site Description (Address) Corbelled Hut at Ix-Xagħra I-Ħamra, Manikata
Eastings 4131	Northings 7821	Period unknown
SS No1 4078	SS No2	Description Collapsed circular corbelled hut. In close proximity is a depression in the rock surface probably used to store water.
SS No4	SS No3	
Date of survey sheet: 1992

Bad

Needs reconstruction

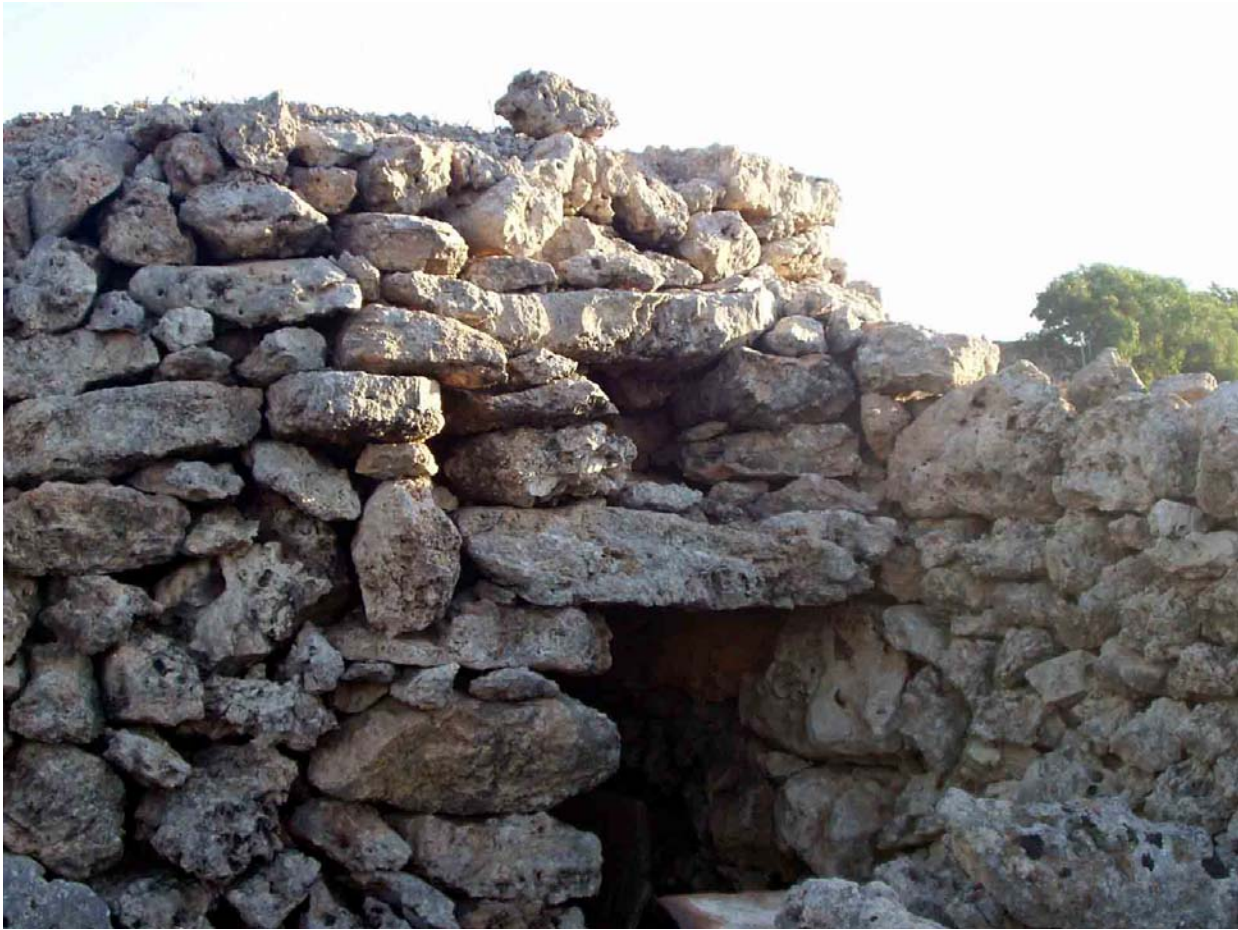
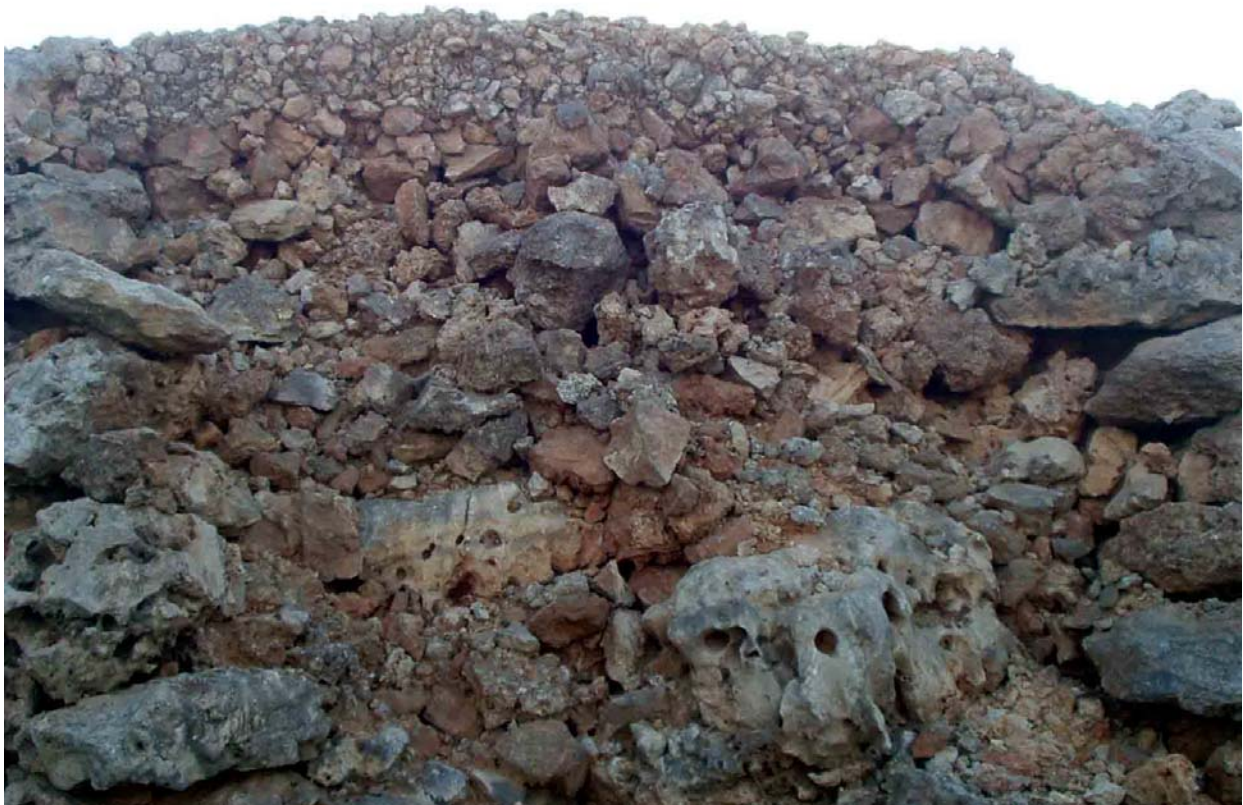
Location Il-Mejjieli, Manikata	Category Rural	Site Description (Address) Corbelled Hut at Il-Mejjieli, Manikata
Eastings 4186	Northings 7820	Period unknown
SS No1 4078	SS No2	Description Small oval corbelled hut built abutting a boundary wall. It has a low entrance with a flat lintel on top of which is a square niche. The entrance faces north and part of the eastern wall has collapsed exposing the section.
SS No4	SS No3	
Date of survey sheet:	1992

Condition
Fair

Needs reconstruction
