Restoration Guidelines No. M002 Re-pointing Limestone Mortar Joints

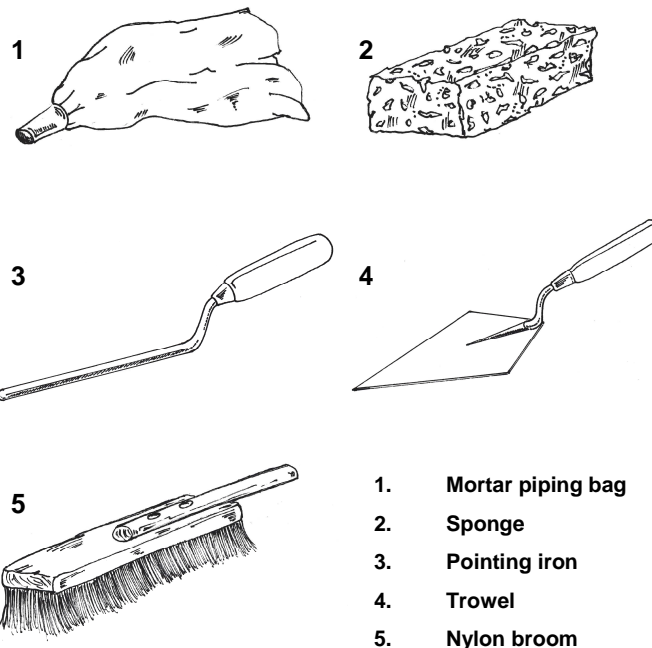
The tools to be used for removal of pointing and re-pointing should be blunt and equal in size to the joint. In some cases, a number of different tools may be required for work on the same building owing to the difference in the width of some joints. Pointing irons and jointing tools are purposely made for this kind of work and are more suited than a general purpose trowel. Removal of pointing from very fine joints should be carried out using a flat blade such as a hacksaw or coping saw blade, without damaging the stone.

Accepted tools for this process include the following:

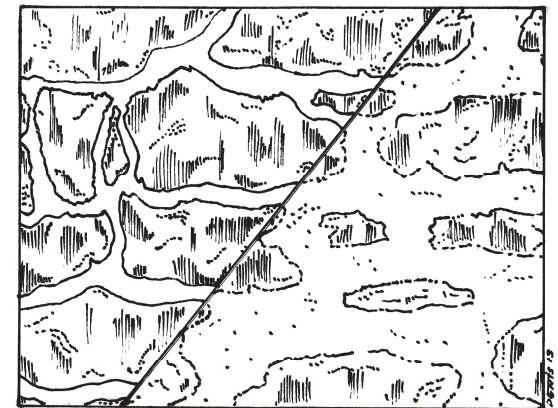
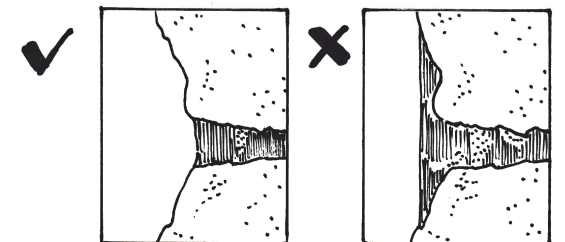
Pointing should always be finished with a slightly recessed (no more than 1 to 2 millimetres) or flush joint. Strap (protruding) or ribbon pointing is not acceptable within historical buildings as they are not considered traditional methods.

See below for acceptable and unacceptable methods for pointing:

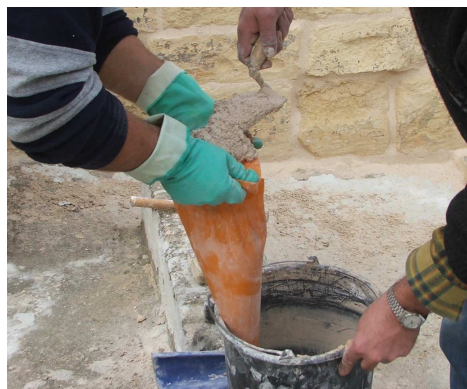
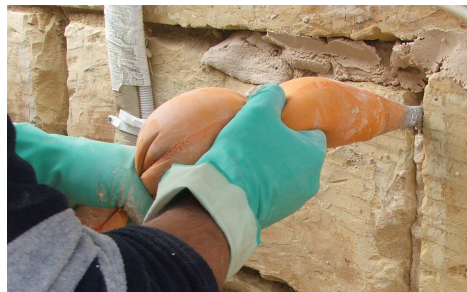
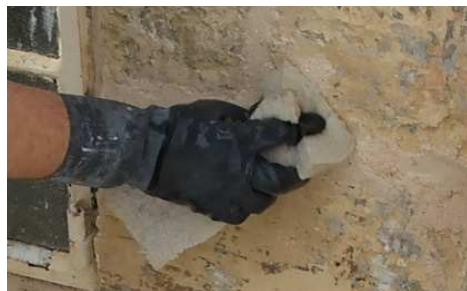
Pointing using a mortar piping bag
