Location Ix-Xagħra l-Hamra, Manikata	Category Military	Site Description (Address) Concrete platform at Ix-Xagħra l-Hamra, Manikata
Eastings 4149	Northings 7789	Period British, 20th century, WWII
SS No1 4077	SS No2	Description Rectangular concrete platform built on the garrigue. It is similar to MNK 05_25, MNK05_029 and MNK05_48. This platform seems to be a base for a tent. It is known that the British used such platforms for hospital tents in their encampments. The dimensions of this platform are 5m by 3.5m.
SS No4	SS No3	
Date of survey sheet: 1992

Location Ix-Xagħra l-Hamra, Manikata	Category Rock-Cut	Site Description (Address) Possible tomb shaft and quarrying at Ix-Xagħra l-Hamra, Manikata
---	-----------------------------	---

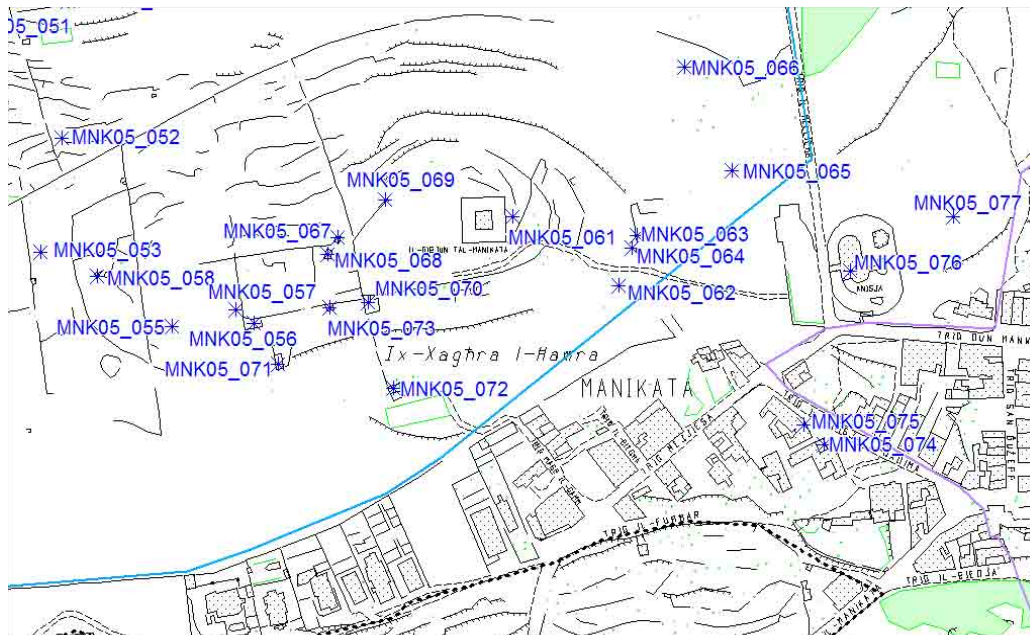
MNK05_061

Condition
Good

Proposed Protection
Grade 3

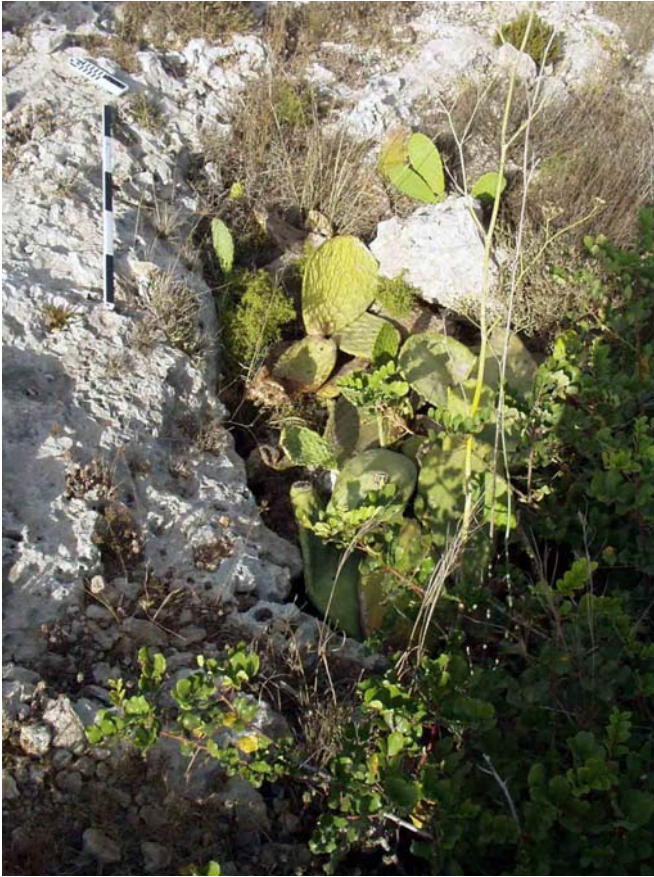
MNK05_062_001

SS No1 4077	SS No2	Description Possible tomb shaft with a carob tree and other vegetation growing in it. Since it is overgrown its exact nature cannot be determined. However, the straight ledge indicates the possibility of the presence of a tomb. The surrounding area is also characterised by quarrying activity.
SS No4	SS No3

The presence of quarrying (MNK05_66), cart ruts (MNK05_65), and a similar feature in the area (MNK05_64) are typical of this cultural landscape.

Condition
Fair

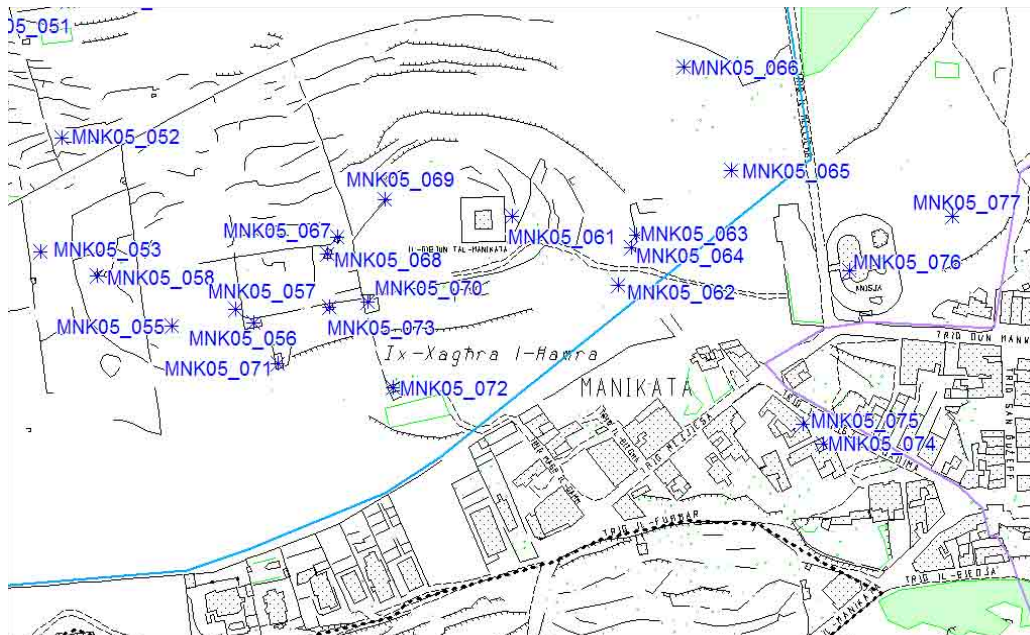
MNK05_063

Location Ix-Xagħra l-Hamra, Manikata	Category Rural	Site Description (Address) Corbelled hut at Ix-Xagħra l-Hamra, Manikata
Eastings 4157	Northings 7787	Period unknown
SS No1 4077	SS No2	Description Circular corbelled hut with its entrance facing north-west. The doorway has a flat lintel and a triangular open niche above it. The lower course of the hut's interior has been hewn out of the rock. The hut leads to a quarry that has been transformed into a field.
SS No4	SS No3

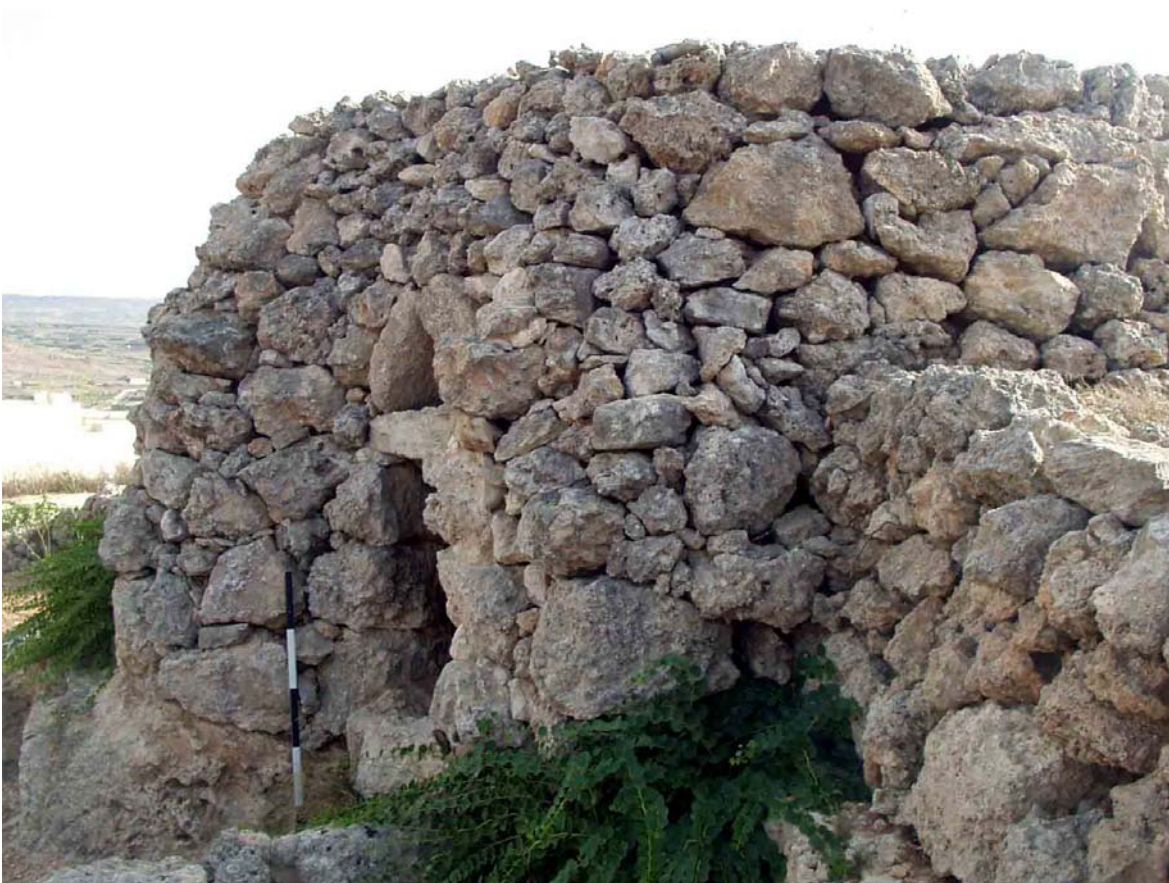
Good

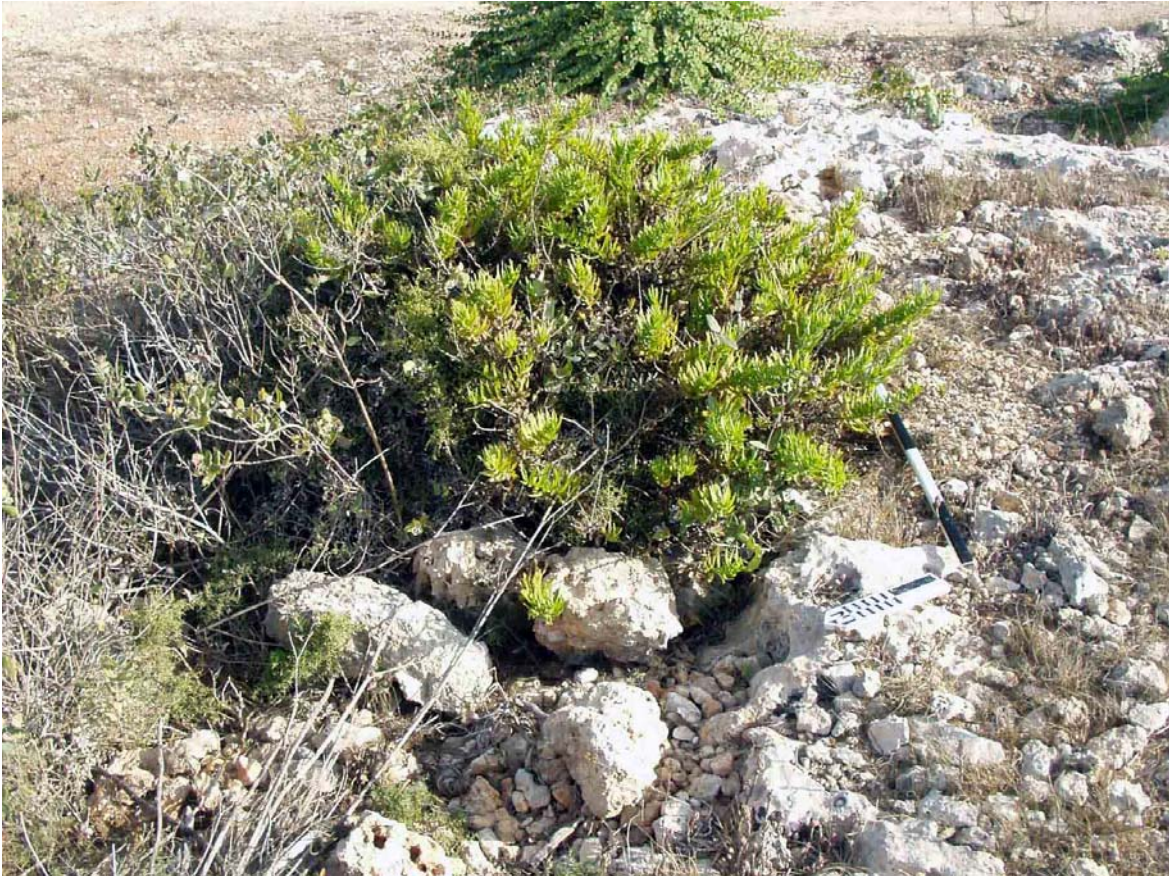
MNK05_064

Location Ix-Xagħra l-Hamra, Manikata	Category Rock-cut	Site Description (Address) Possible tomb shaft at Ix-Xagħra l-Hamra, Manikata
Eastings 4156	Northings 7786	Period Classical Period
SS No1 4077	SS No2	Description Possible tomb shaft with regular edges SW of corbelled hut MNK05_063. Since it is overgrown its exact nature cannot be determined. However, the straight ledge indicates the possibility of the presence of a tomb.
SS No4	SS No3

The presence of quarrying (MNK05_66), cart ruts (MNK05_65), and a similar feature in the area (MNK05_62) are typical of this cultural landscape.

Condition
Fair

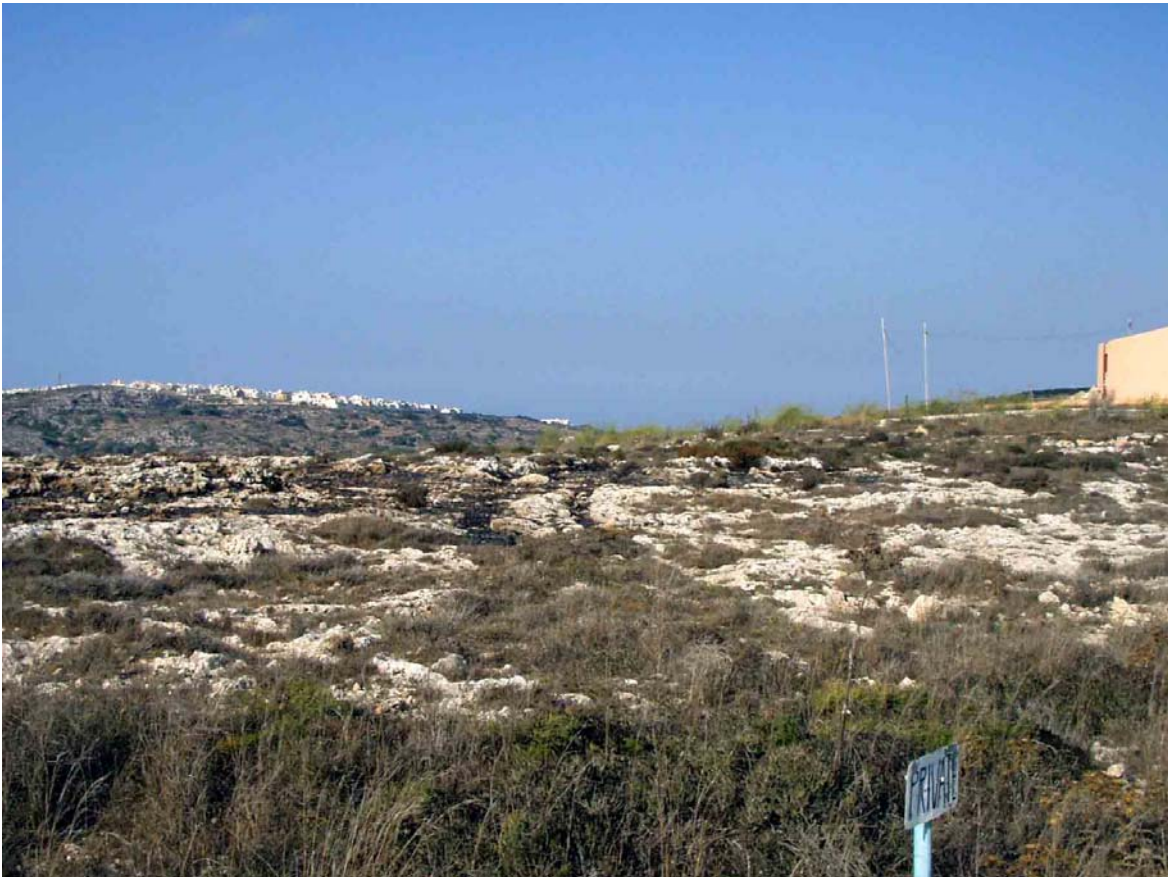
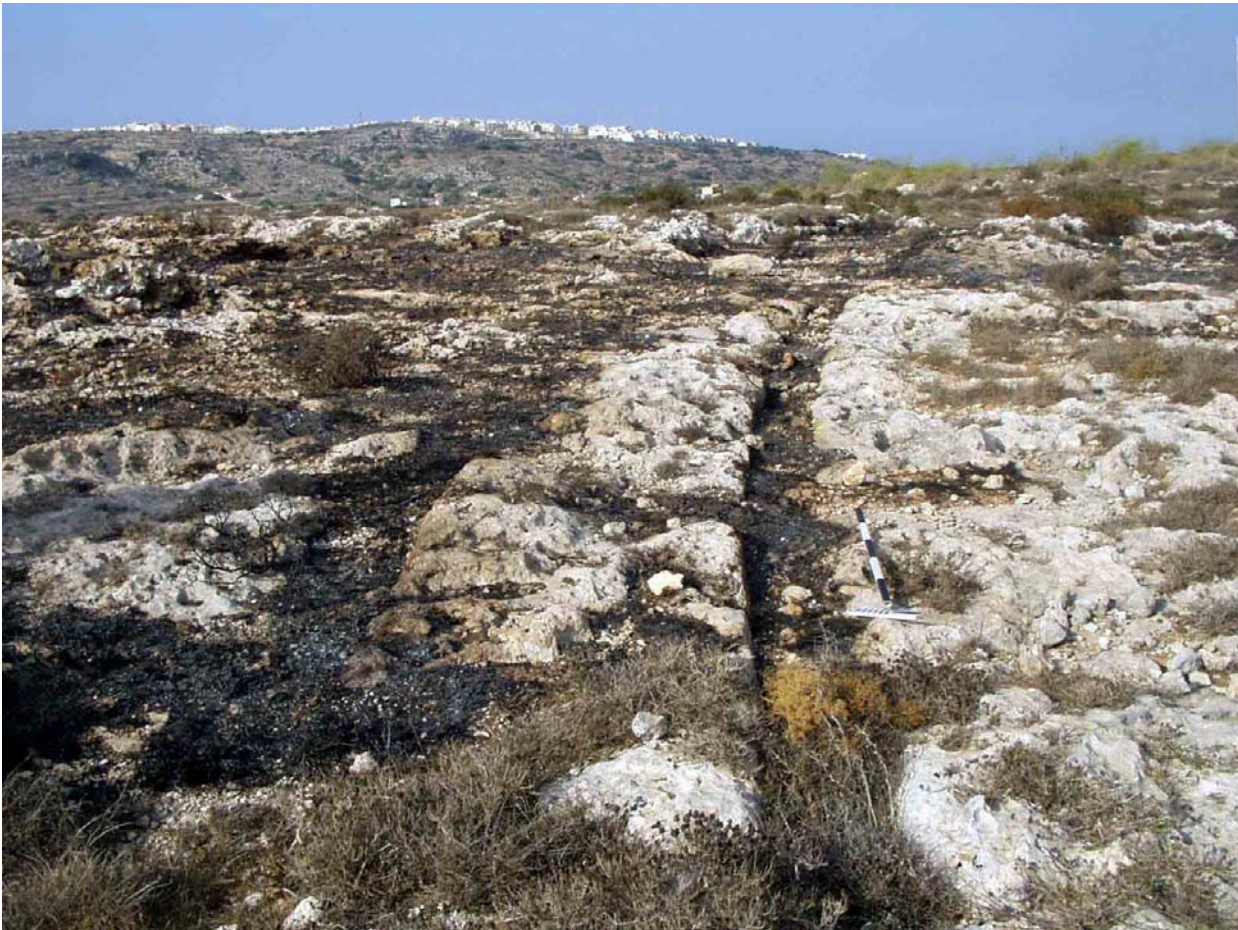
Location Ix-Xaghra I-Hamra, Manikata	Category Rock-Cut	Site Description (Address) Cart ruts at Ix-Xaghra I-Hamra, Manikata
Eastings 4163	Northings 7791	Period unknown
SS No1 4077	SS No2	Description Three pairs of cart ruts running in a NW-SE direction. The average width of the ruts is 1.75m with a single rut measuring 0.25m in width and 0.10m in depth. The baulk between the ruts measures 1.10m.
SS No4	SS No3

The presence of two possible tomb shafts (MNK05_62 and MNK05_64) and quarrying (MNK05_66) are typical of this cultural landscape.

Condition
Fair

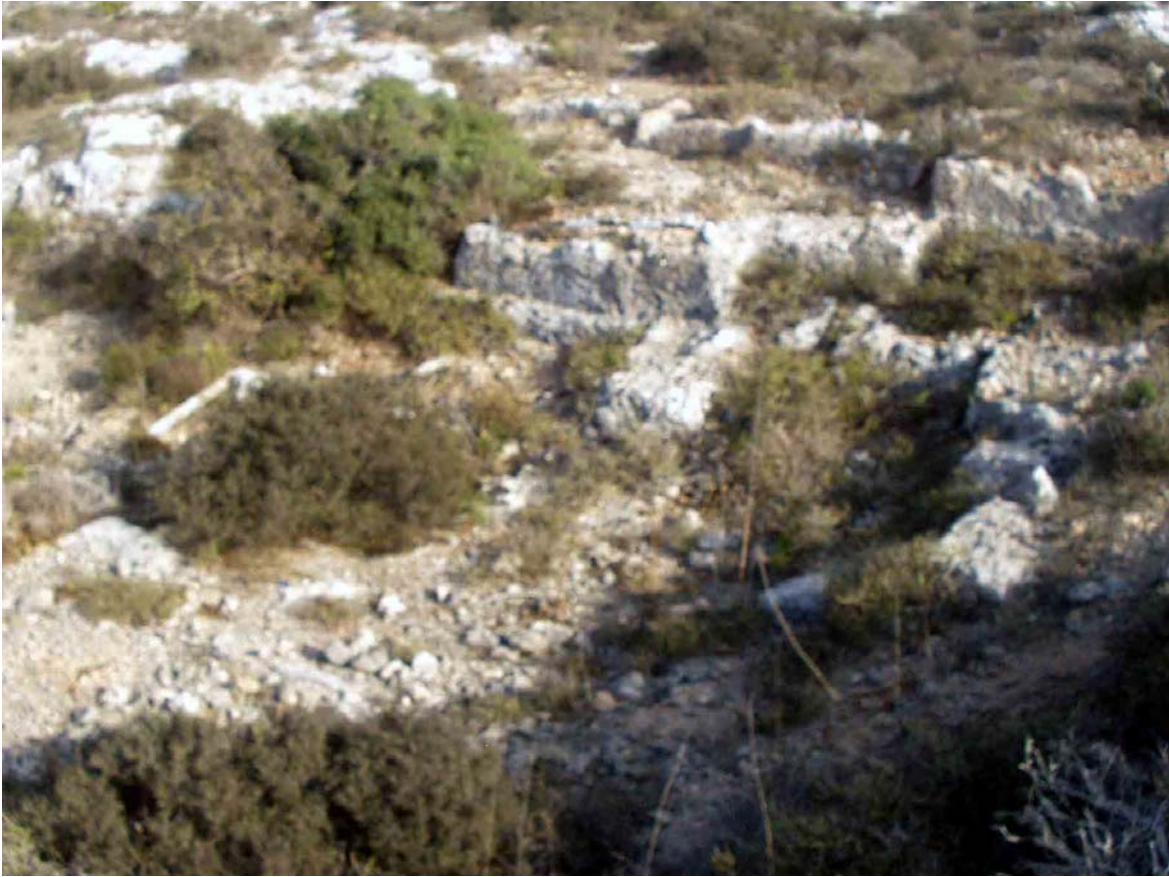
Location Ix-Xaghra I-Hamra, Manikata	Category Rock-Cut	Site Description (Address) An area of quarrying interrupting cart ruts at Ix-Xaghra I-Hamra, Manikata
Eastings 4160	Northings 7798	Period unknown
SS No1 4077	SS No2	Description Quarrying interrupting a pair of cart ruts running in a NW-SE direction. The area shows clear signs of the wedges used to extract stone typical of the early modern period. There are also a number of stone heaps typical of quarrying.
SS No4	SS No3

The presence of two possible tomb shafts (MNK05_62 and MNK05_64) and cart ruts (MNK05_65) are typical of this cultural landscape.

Condition
Good

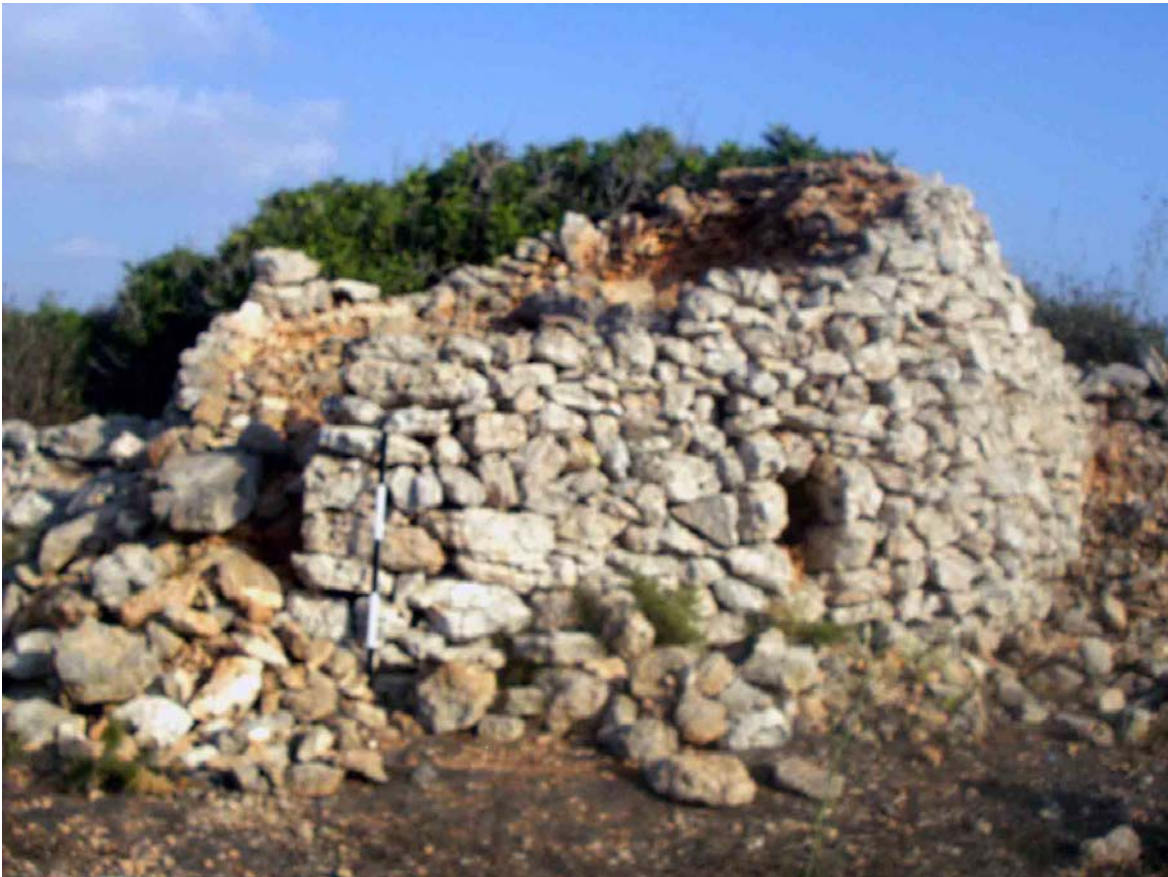
MNK05_067

Location Ix-Xagħra l-Hamra, Manikata	Category Rural	Site Description (Address) Corbelled hut at Ix-Xagħra l-Hamra, Manikata
Eastings 4137	Northings 7787	Period unknown
SS No1 4077	SS No2	Description Collapsed circular corbelled hut. The door, which has collapsed, faced north. It has a window in the eastern wall.
SS No4	SS No3

Bad

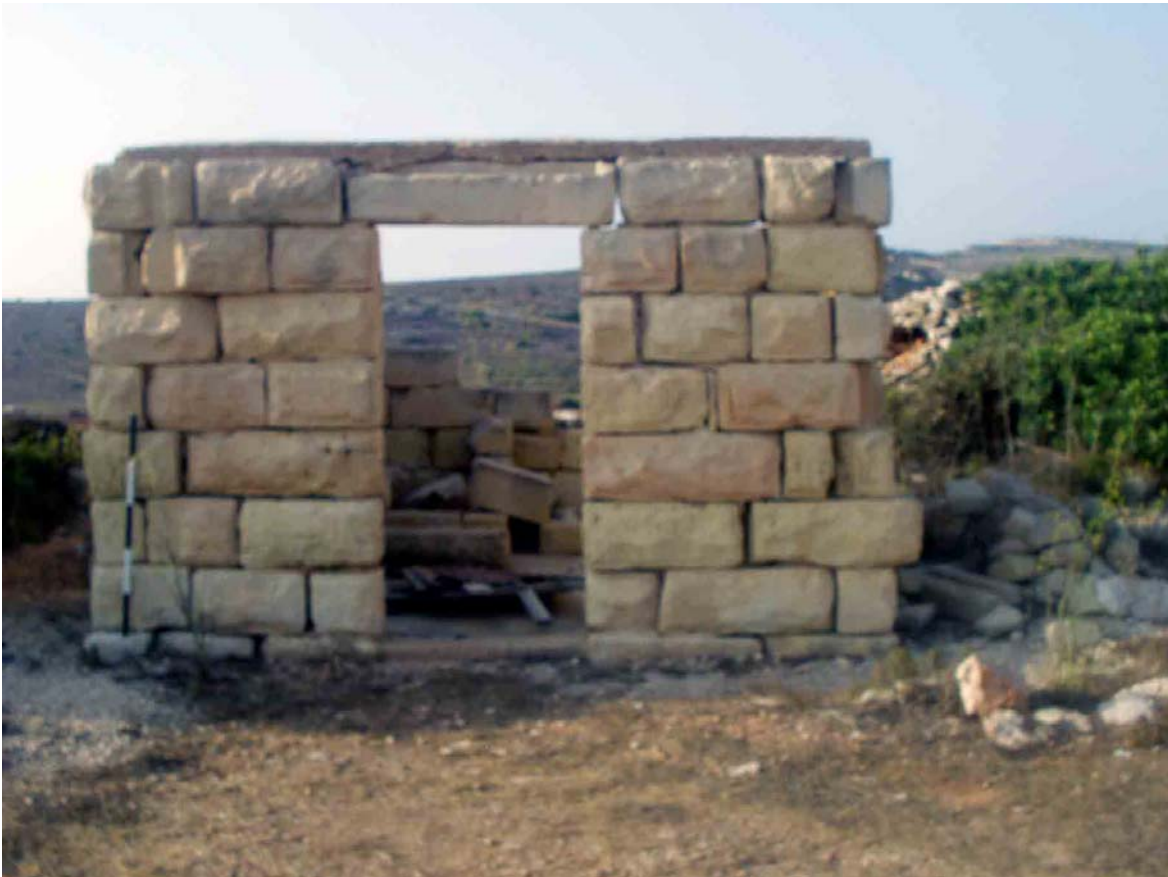
MNK05_068

Location Ix-Xaghra l-Hamra, Manikata	Category Military	Site Description (Address) Room at Ix-Xaghra l-Hamra, Manikata
Eastings 4136	Northings 7786	Period British Period
SS No1 4077	SS No2	Description A room with collapsed roof built in fake rustication. The roof was slanting. It has no apertures besides a door facing south.
SS No4	SS No3

Condition
Bad

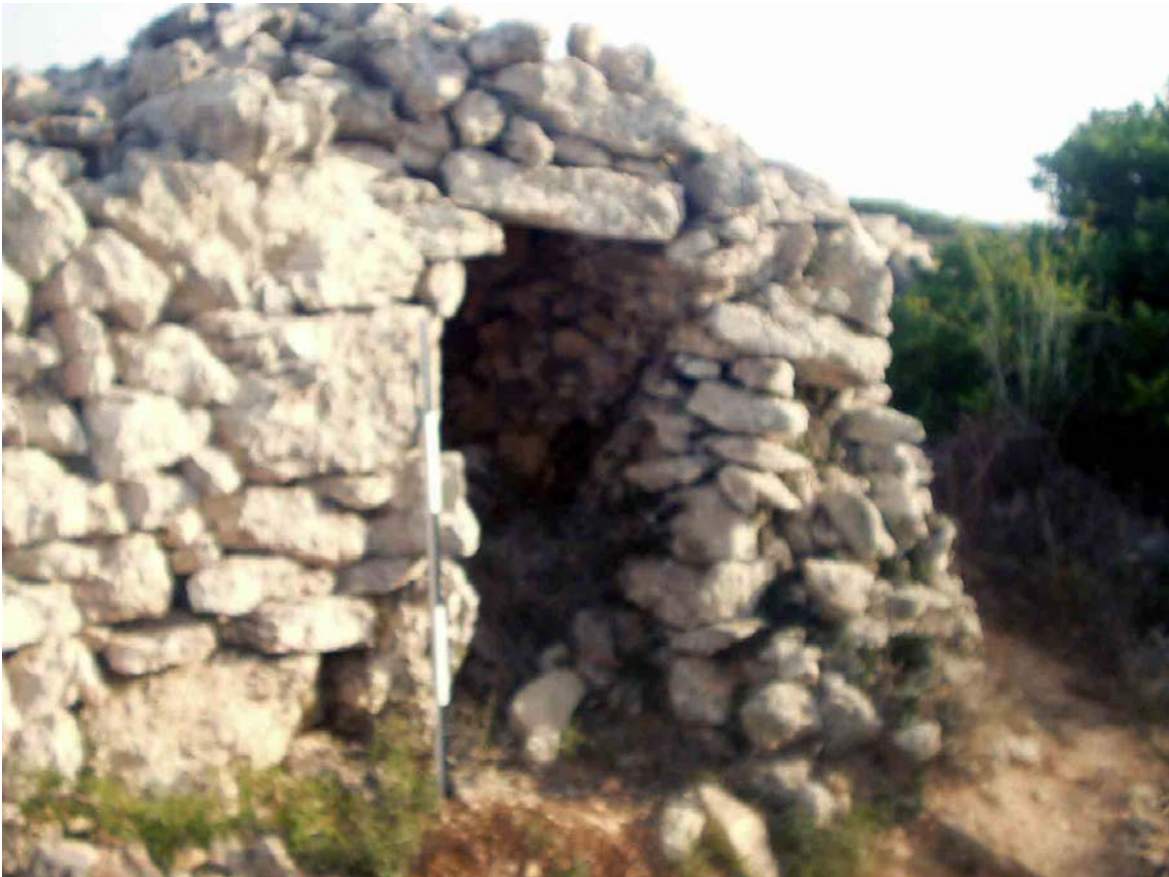
MNK05_069

Location Ix-Xagħra l-Hamra, Manikata	Category Rural	Site Description (Address) Small corbelled hut at Ix-Xagħra l-Hamra, Manikata
Eastings 4140	Northings 7790	Period unknown
SS No1 4077	SS No2	Description Very small corbelled hut built within a rubble wall. The hut is oval in shape and is extremely small. However, it has a flat lintel on the doorway, which faces north, and a corbelled roof, whose central slab has collapsed.
SS No4	SS No3

This is an atypical corbelled hut. However, given that its was roofed using the corbelling method, it has to be considered as a corbelled hut.

Condition
Fair

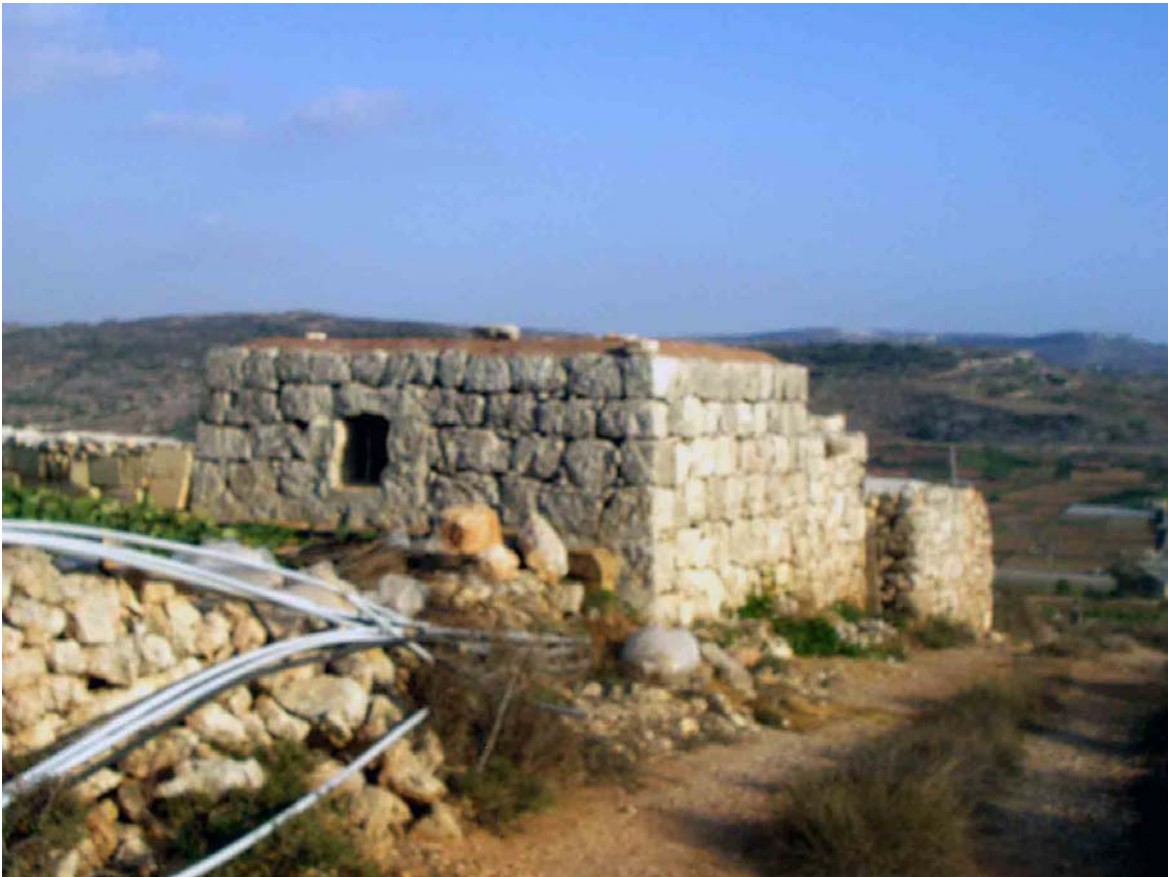
MNK05_070_001

Location Ix-Xaghra l-Hamra, Manikata	Category Rural	Site Description (Address) Small farmhouse at Ix-Xaghra l-Hamra, Manikata
Eastings 4139	Northings 7783	Period unknown
SS No1 4077	SS No2	Description Small farmhouse with three rooms built adjacent to each other in different periods and a rock-hewn animal pen to the west of the structure. The northernmost one seems to be the oldest one, and is built with worked ashlar blocks in the dry stone technique. The animal pen has a manger on the northern wall.
SS No4	SS No3	
Date of survey sheet: 1992

The interior of the structure could not be recorded because the farmhouse was locked and therefore inaccessible.

Good
