Location Ix-Xagħra I-Famra, Manikata	Category Rock-Cut	Site Description (Address) Quarrying at Ix-Xagħra I-Famra, Manikata
Eastings 4081	Northings 7793	Period unknown
SS No1 4077	SS No2	Description Traces of quarrying with tool marks, small holes and relatively straight-edged rocks.
SS No4	SS No3	
Date of survey sheet: 1992

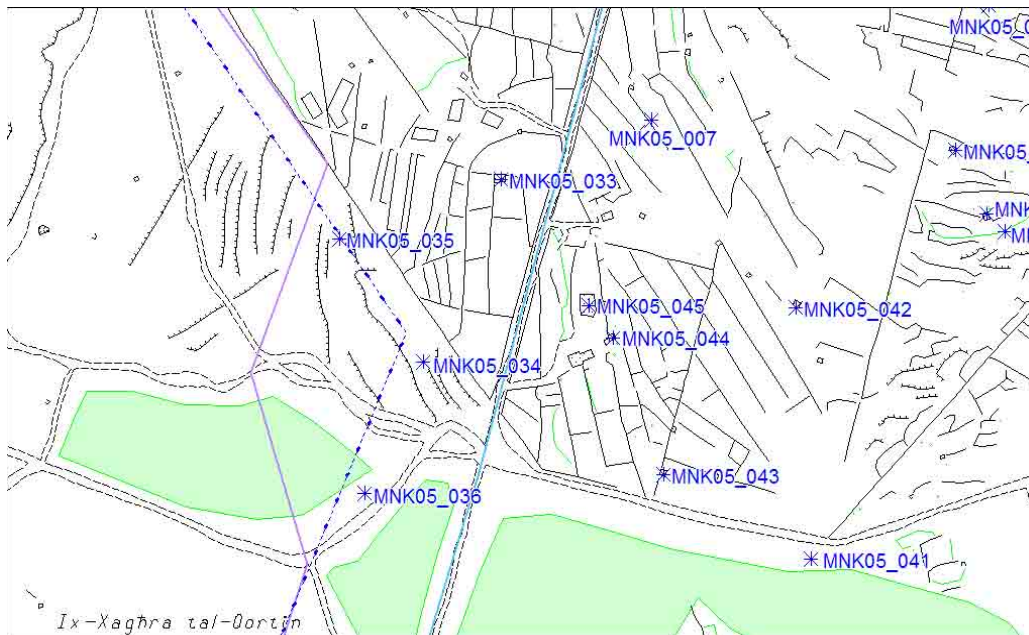
MNK05_041_001

Good

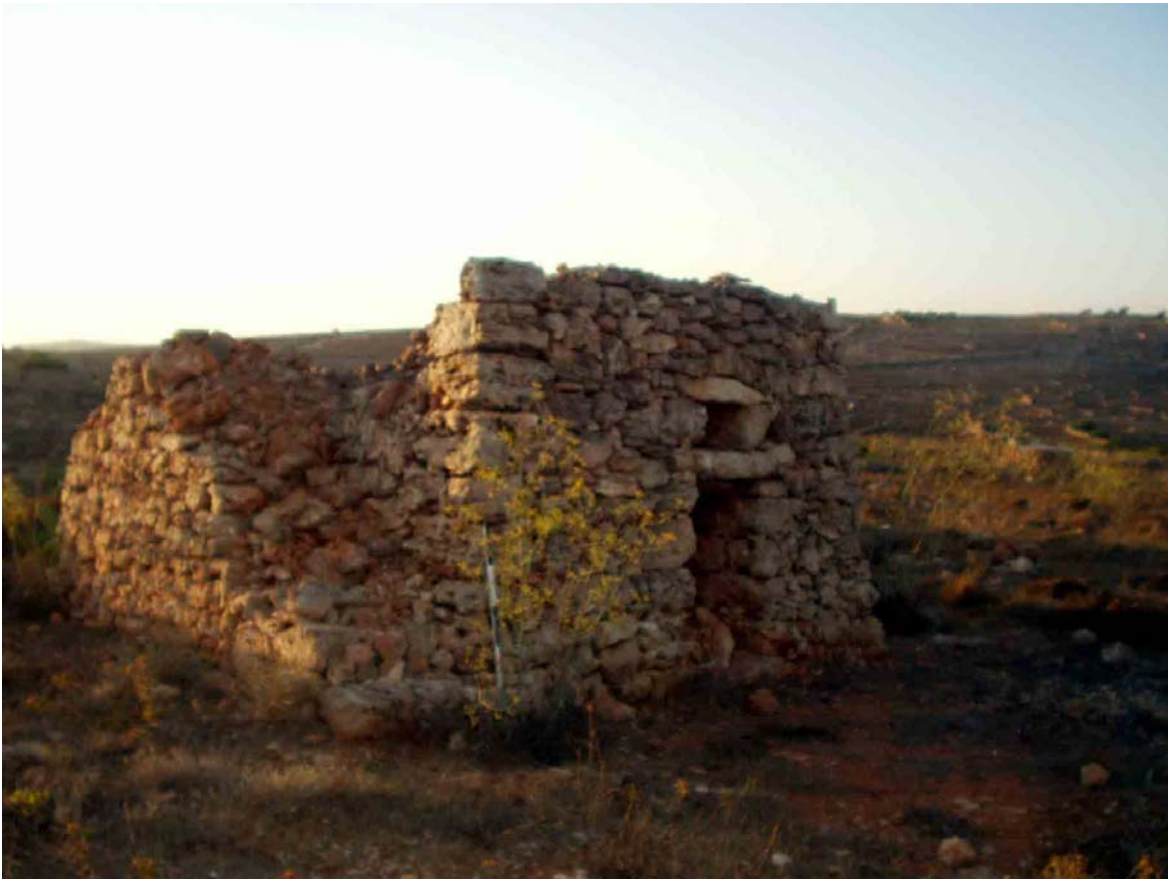
Location Tal-Qortin, Manikata	Category Rural	Site Description (Address) Corbelled-Hut at Tal-Qortin, Manikata
Eastings 4080	Northings 7801	Period unknown
SS No1 4078	SS No2	Description Partly-collapsed square plan corbelled hut with an external staircase on its southern wall. The doorway faces east and is surmounted by a niche. There is a square depression on its northern wall. It is overgrown and its depth cannot be determined. It is fed by a water channel.
SS No4	SS No3	
Date of survey sheet: 1992

Fsadni 1999:31 lists this hut as the only square one with a staircase. At the time of publishing, the hut was still intact (1999:32 pl.20), hence the collapse occurred in the last decade.

Bad; in need of reconstruction

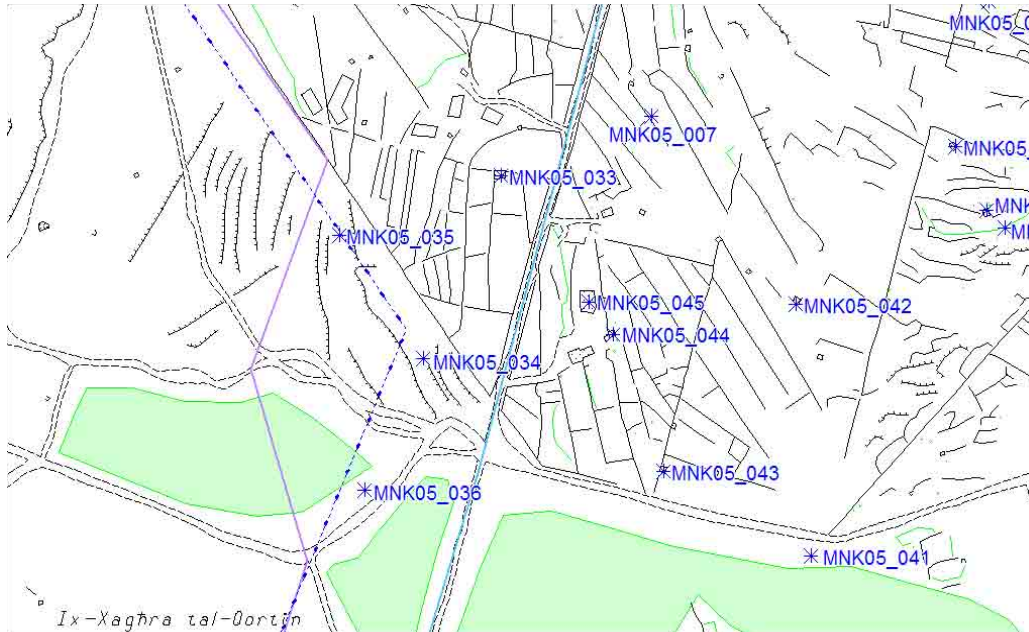
Location Tal-Qortin, Manikata	Category Rural	Site Description (Address) Corbelled-Hut at Tal-Qortin, Manikata
Eastings 4072	Northings 7799	Period unknown
SS No1 4077	SS No2	Description Square plan corbelled hut with a corbelled ceiling and a flat lintel with an arched niche. It has worked corner stones and a window on its southern wall. The entrance faces west.
SS No4	SS No3

Good, in need of cleaning

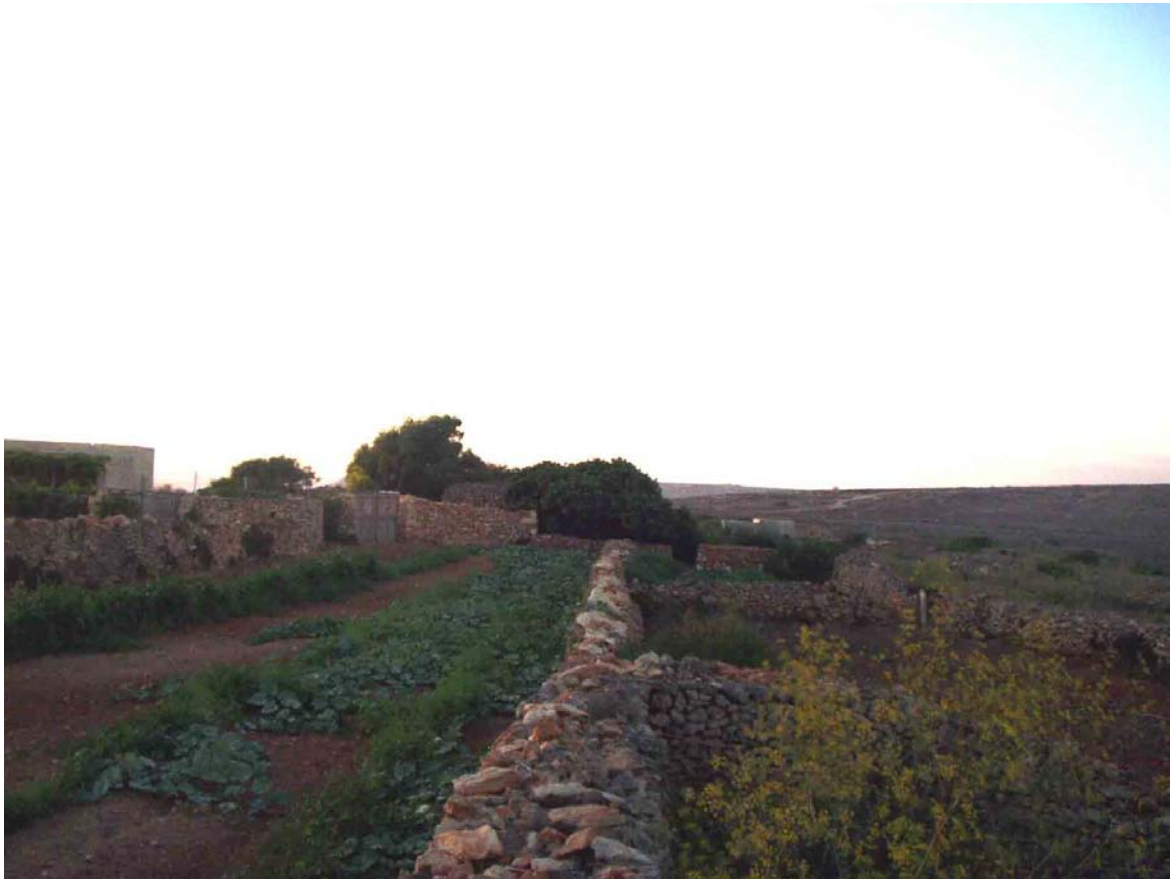
Location Tal-Qortin, Manikata	Category Rural	Site Description (Address) Field room at Tal-Qortin, Manikata
Eastings 4068	Northings 7807	Period unknown
SS No1 4078	SS No2	Description Inaccessible field room built in the dry-stone technique
SS No4	SS No3	
Date of survey sheet: 1992

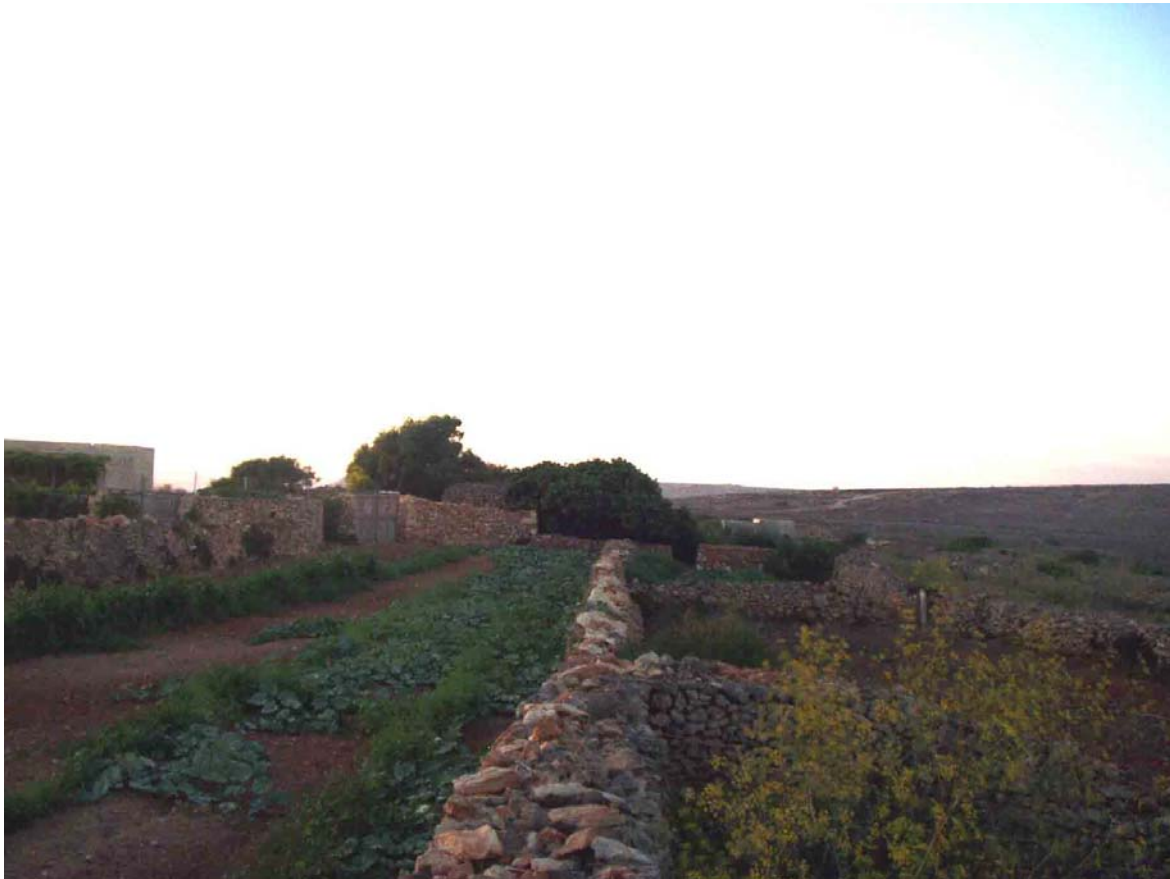
Location	Category	Site Description (Address)
Tal-Qortin, Manikata	Rural	Structure at Tal-Qortin, Manikata

SS No1	SS No2	Description
4078		Inaccessible field room built in the dry-stone technique

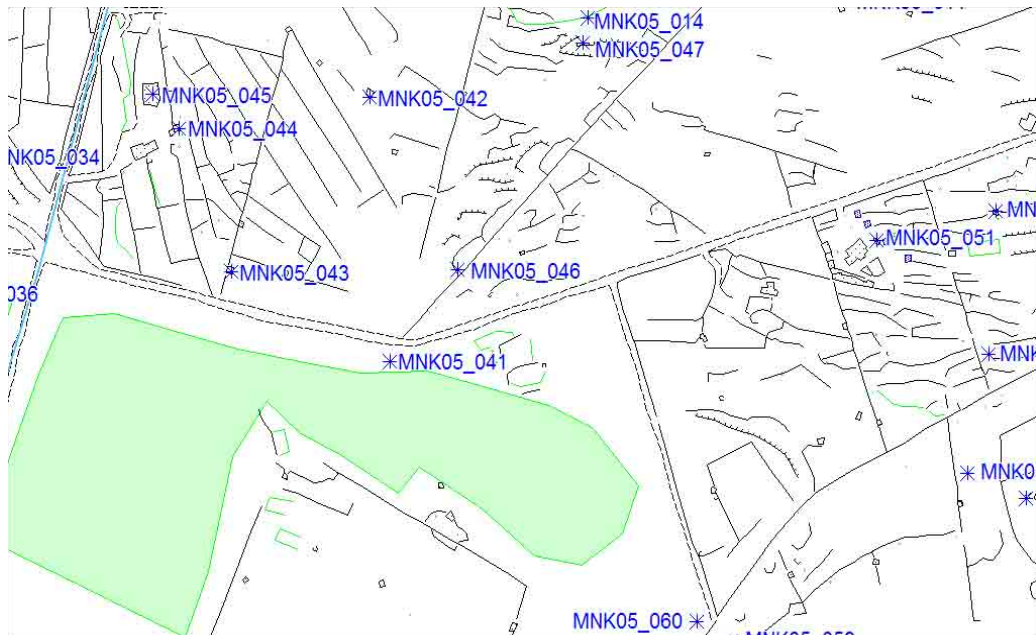
Location Ix-Xaghra I-Hamra, Manikata	Category Rural	Site Description (Address) Corbelled hut at Ix-Xaghra I-Hamra, Manikata
Eastings 4086	Northings 7798	Period unknown
SS No1 4077	SS No2	Description Small collapsed circular corbelled hut. The entrance faced north and the western wall was part of a rubble wall. About 10m west of the hut is a 1.5m diameter depression in the rock surface. There are other depressions in the area similar to others in the vicinity of other corbelled huts of the area under study. One of these depressions was covered with boulders and in fact had water at the date of survey.
SS No4	SS No3	
Date of survey sheet:	1992

Condition
Collapsed

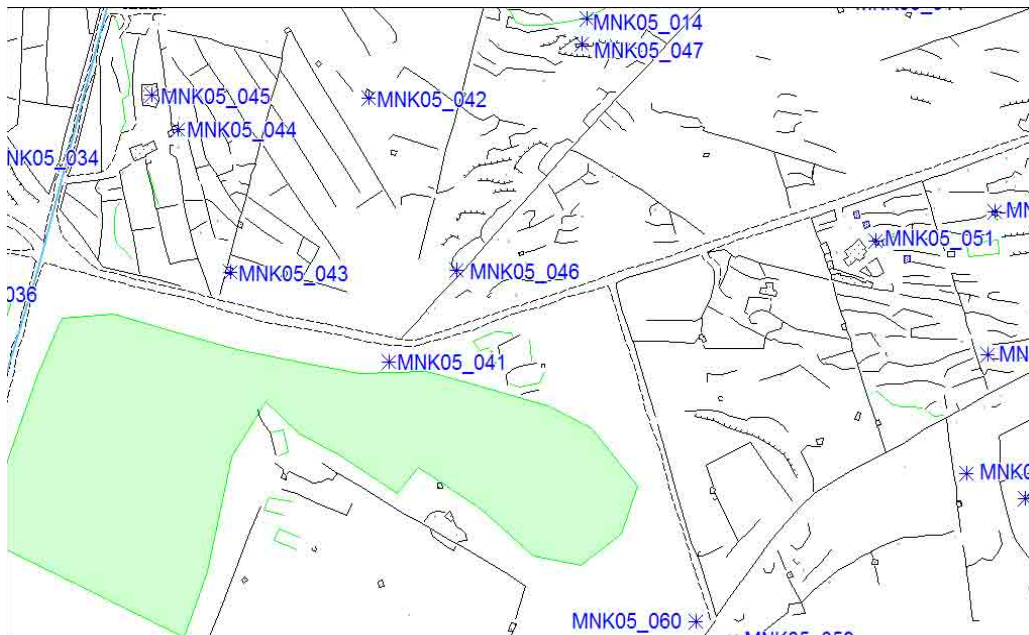
Location Ix-Xagħra I-Ħamra, Manikata	Category Rock-Cut	Site Description (Address) Quarrying marks at Ix-Xagħra I-Ħamra, Manikata
Eastings 4094	Northings 7812	Period unknown
SS No1 4078	SS No2	Description Surface quarrying marks like tool marks, straight ledges and channels. Some tool marks are also evident.
SS No4	SS No3	
Date of survey sheet: 1992

Parts of the quarried area has been filled with soil and transformed into a field in the past.

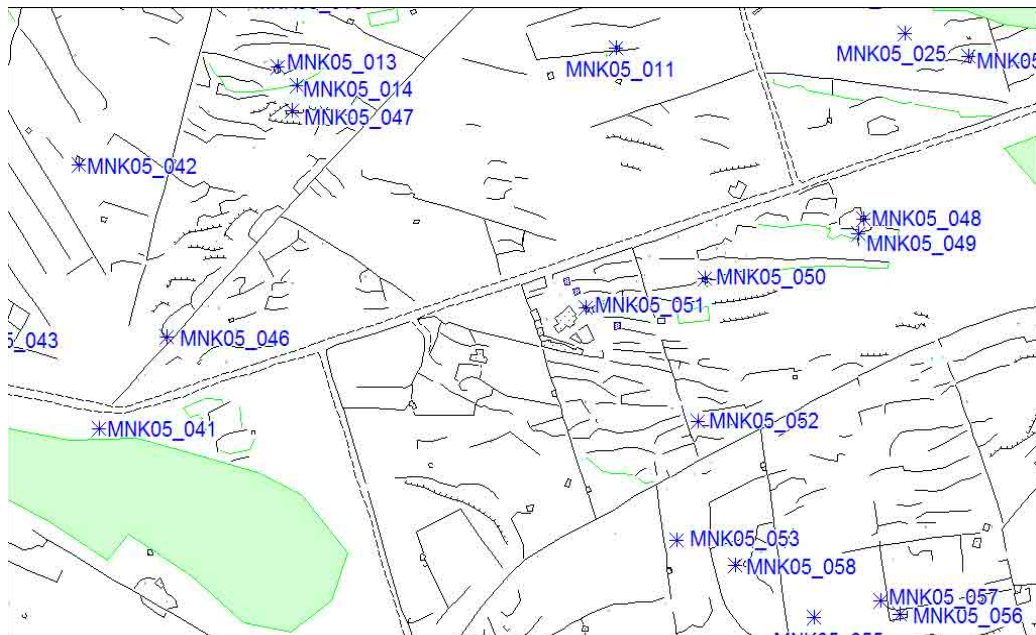
Location Ix-Xagħra I-Ħamra, Manikata	Category Military	Site Description (Address) Concrete platform at Ix-Xagħra I-Ħamra, Manikata
Eastings 4129	Northings 7806	Period British, 20th century, WWII
SS No1 4078	SS No2	Description Rectangular concrete platform built on the garrigue. It is similar to MNK 05_25 and MNK05_029. This platform seems to be a base for a tent. It is known that the British used such platforms for hospital tents in their encampments. The dimensions of this platform are 2.70m by 1.85m.
SS No4	SS No3	
Date of survey sheet: 1992

Condition
Good

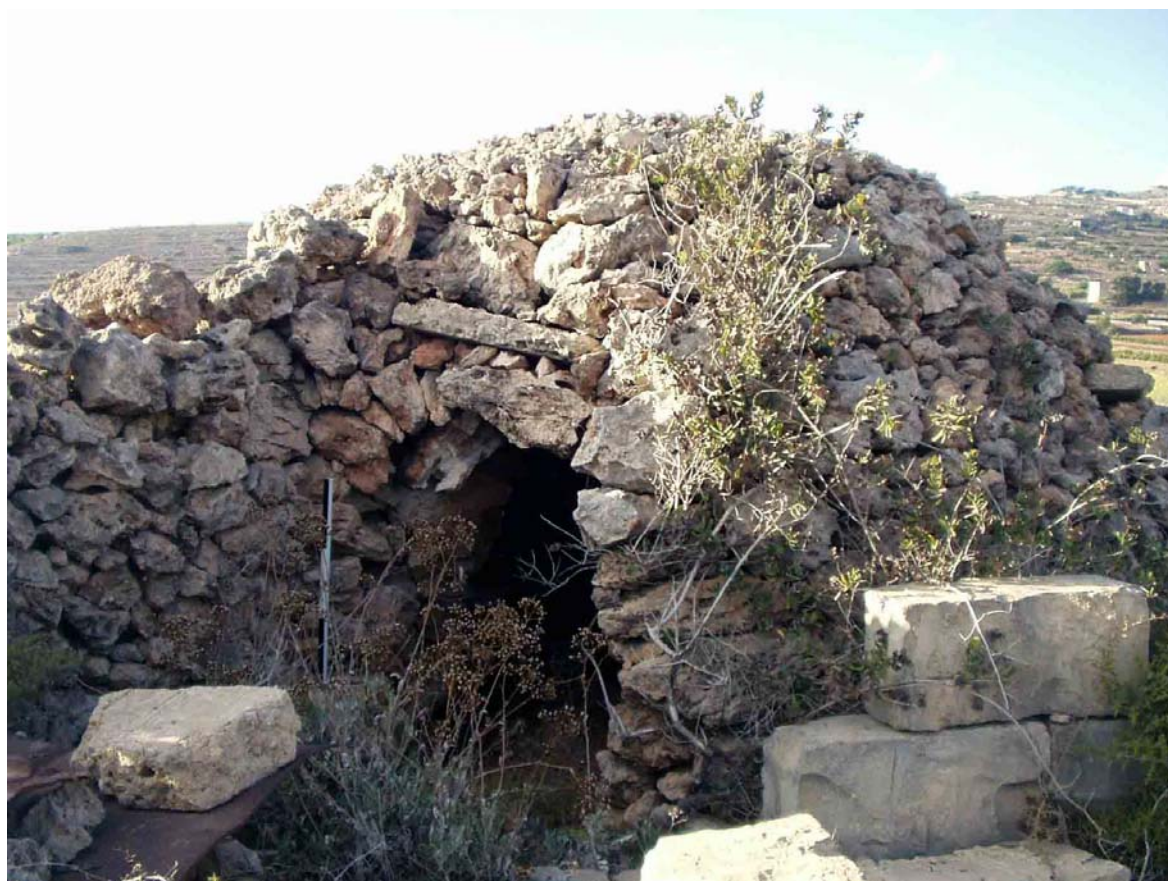
Location Ix-Xagħra I-Ħamra, Manikata	Category Rural	Site Description (Address) Corbelled hut at Ix-Xagħra I-Ħamra, Manikata
Eastings 4129	Northings 7805	Period unknown
SS No1 4078	SS No2	Description Small circular corbelled hut built against a rubble wall and forming an enclosure. The entrance faces southwest and in the northwest wall there is a small window. The entrance has a circular lintel. It seems that in a relatively recent time a concrete fragment was inserted above the lintel. In the enclosure the base of a second enclosure or room in dressed Globigerina Limestone stones has been built.
SS No4	SS No3	
Date of survey sheet: 1992

Good

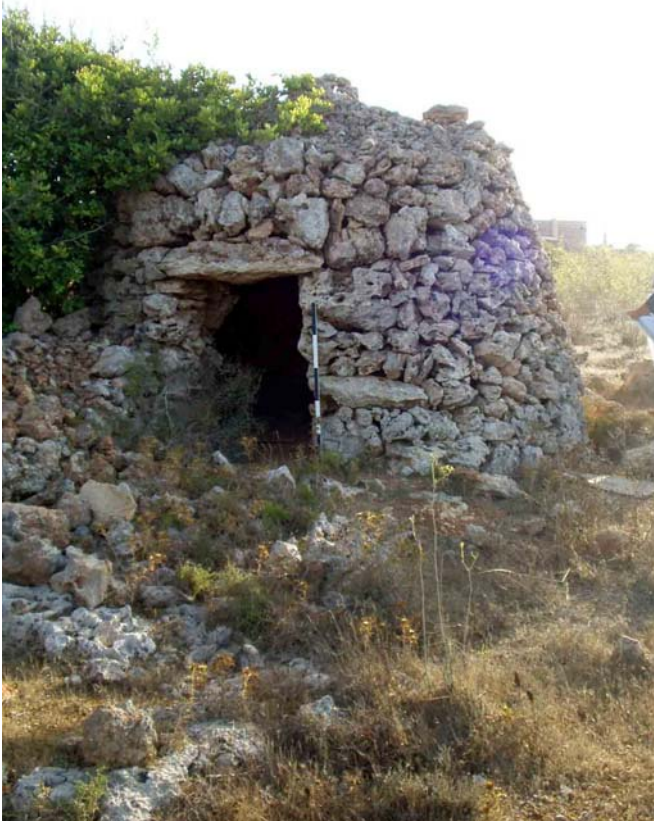
MNK05_050

Location Ix-Xagħra I-Ħamra, Manikata	Category Rural	Site Description (Address) Corbelled hut at Ix-Xagħra I-Ħamra, Manikata
Eastings 4120	Northings 7801	Period unknown
SS No1 4078	SS No2	Description Small circular corbelled hut with its entrance facing east. The entrance has a flat lintel and there is a window in the northern wall. The southern wall was built within a rubble wall.
SS No4	SS No3

Good
